# Runway excursion involving Cessna 210N, VH-WPD

Urapunga (ALA), Northern Territory, 23 August 2012

**ATSB Transport Safety Report**  
Aviation Occurrence Investigation  
AO-2012-107  
Final – 21 March 2013

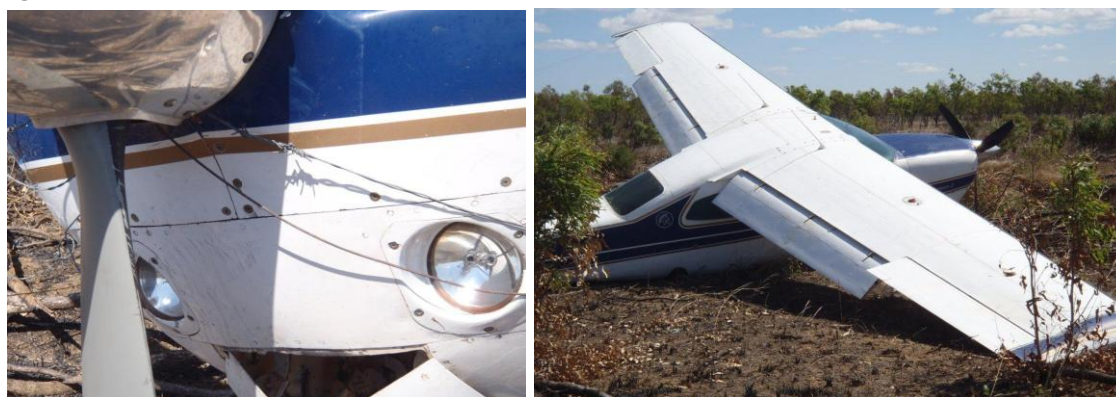
**Figure 1: Accident site**

The pilot stated that sun glare increasingly restricted visibility during the landing and he was unsure the amount of runway used. The aircraft touched down and the pilot applied heavy braking in short bursts. The pilot reported that the aircraft only slowed a little on the runway gravel surface and then the aircraft departed the end of the runway and travelled through two fences before coming to a stop. The aircraft came to rest on the right side of the fuselage, right wing and right horizontal stabiliser. The pilot secured the aircraft and the pilot and two passengers evacuated the aircraft. The pilot received minor injuries while evacuating the aircraft from barbed wire that had become entangled around the front of the aircraft (Figure 1). The two passengers were uninjured.

The operator inspected the runway, which was in good condition with a hard surface. The inspection found that the touchdown point was over half way down the runway. A runway edge marker had been run over by the left main landing gear tyre, before the aircraft came back onto the runway and then exited the end of the runway. The operator determined that the distance from the runway end to the second fence line was about 80 m. The flaps were observed to be at the full flap setting.

- During training greater emphasis will be placed on go-around procedures and identify situations when it would be used.
- Particularly during training increase awareness to consider the planning of circuit entry and ensure a backup is considered if conditions are not what was expected.
- Go-around procedures are practiced during in command under supervision (ICUS) training.
