Runway excursion involving Cessna T210, VH-DQI

Cape Leveque Western Australia, 30 December 2012

ATSB Transport Safety Report
Aviation Occurrence Investigation
AO-2013-001
Final – 21 March 2013

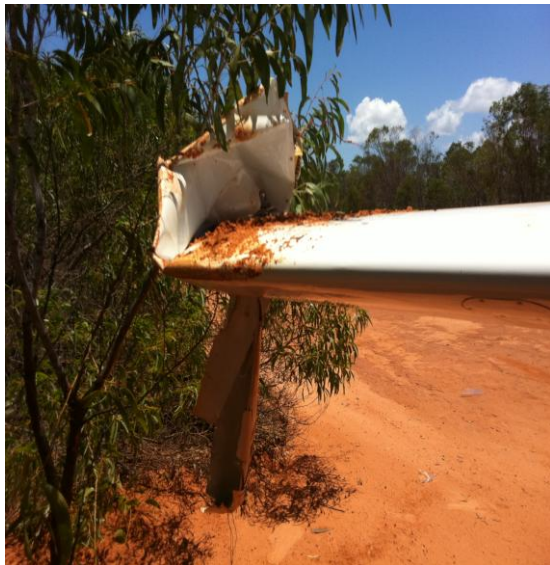
Figure 1: Right wing and nose gear damage

At about 1125 Western Standard Time¹, DQI was the first aircraft to depart. Early in the take-off run on runway 13, at a speed of about 20 knots, DQI veered to the left. The pilot applied right rudder to straighten the aircraft and continued with the takeoff. DQI was now about 1 m left of the runway centreline. About half way down the runway and at about 45 knots, DQI veered sharply to the left again. The pilot tried to correct the veer with full right rudder, but the aircraft did not respond. He then retarded the throttle and applied the brakes. The left wing of the aircraft clipped trees along the edge of the airstrip and DQI swung almost 90°, striking the right wing on the ground. The nose-wheel collapsed in the soft sand on the edge of the airstrip, resulting in the propeller striking the ground.

The pilot ensured the aircraft was safely shut down, and then assisted the passengers. One passenger received minor injuries and the aircraft sustained substantial damage.

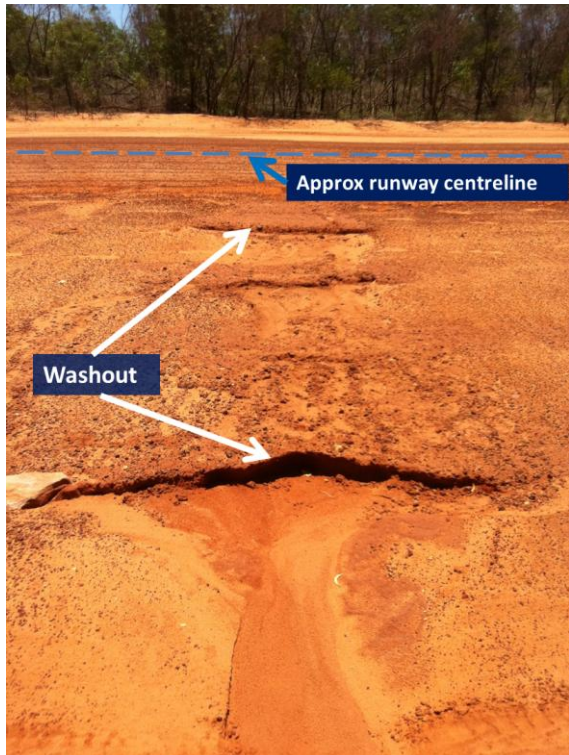
Figure 2: Washout on edge of airstrip

After the accident, the pilot of the second aircraft inspected the airstrip and reported substantial washout on the edge of the strip inside the cone markers (Figure 2).

The aircraft operator reported that Cape Leveque management closed the airstrip the day after the accident to grade the surface and repair the washouts.
