# Airspace incursion involving unmanned airship, Airship 11

2.7 NM E of Moorabbin Airport, Victoria, 28 October 2012

**ATSB Transport Safety Report**  
Aviation Occurrence Investigation  
AO-2012-143  
Final – 21 March 2013

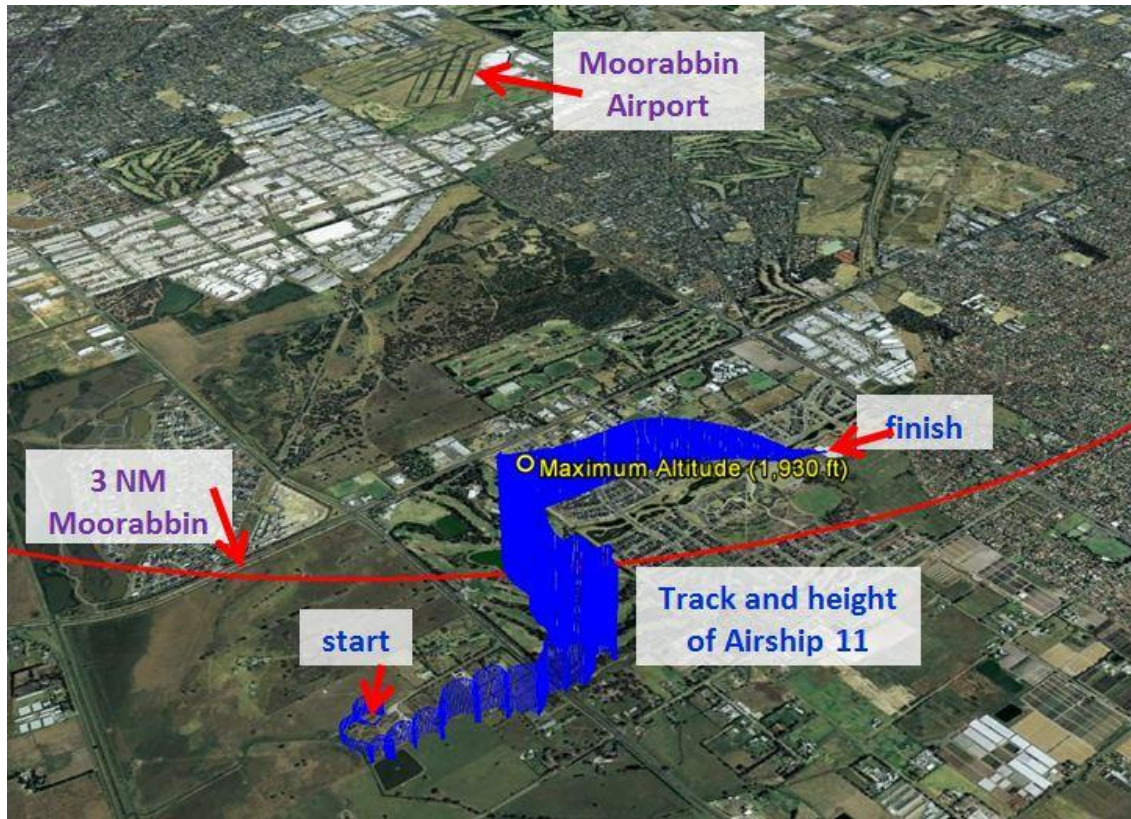
**Figure 1: Track and height of Airship 11**

The PIC elected to land the airship, however, the rearward centre of gravity resulted in the airship climbing. The PIC also noted that the airship's elevator controls were not responding. When climbing through 200 ft, the PIC determined that control of the airship had been lost although the data link was still functioning. The PIC reduced engine power to the idle position (the flight termination procedure<sup>5</sup>), but the airship continued to climb and track in a north-westerly direction toward the Moorabbin control area (Figure 1).

At about 1428, the air traffic controllers at Moorabbin observed the airship about 2 NM to the south-east at about 1,000 ft. This was also confirmed by the pilot of an aircraft operating in the Moorabbin circuit.

Data provided to the ATSB by the airship operator indicated that the airship reached an altitude of 1,930 ft and, at its closest, was 2.7 NM from Moorabbin Airport.
