Collision with terrain involving Robinson R22, VH-LLF

130 km west of Halls Creek, Western Australia | 3 October 2012

ATSB Transport Safety Report
Aviation Occurrence Investigation
AO-2012-133
Final – 22 March 2013

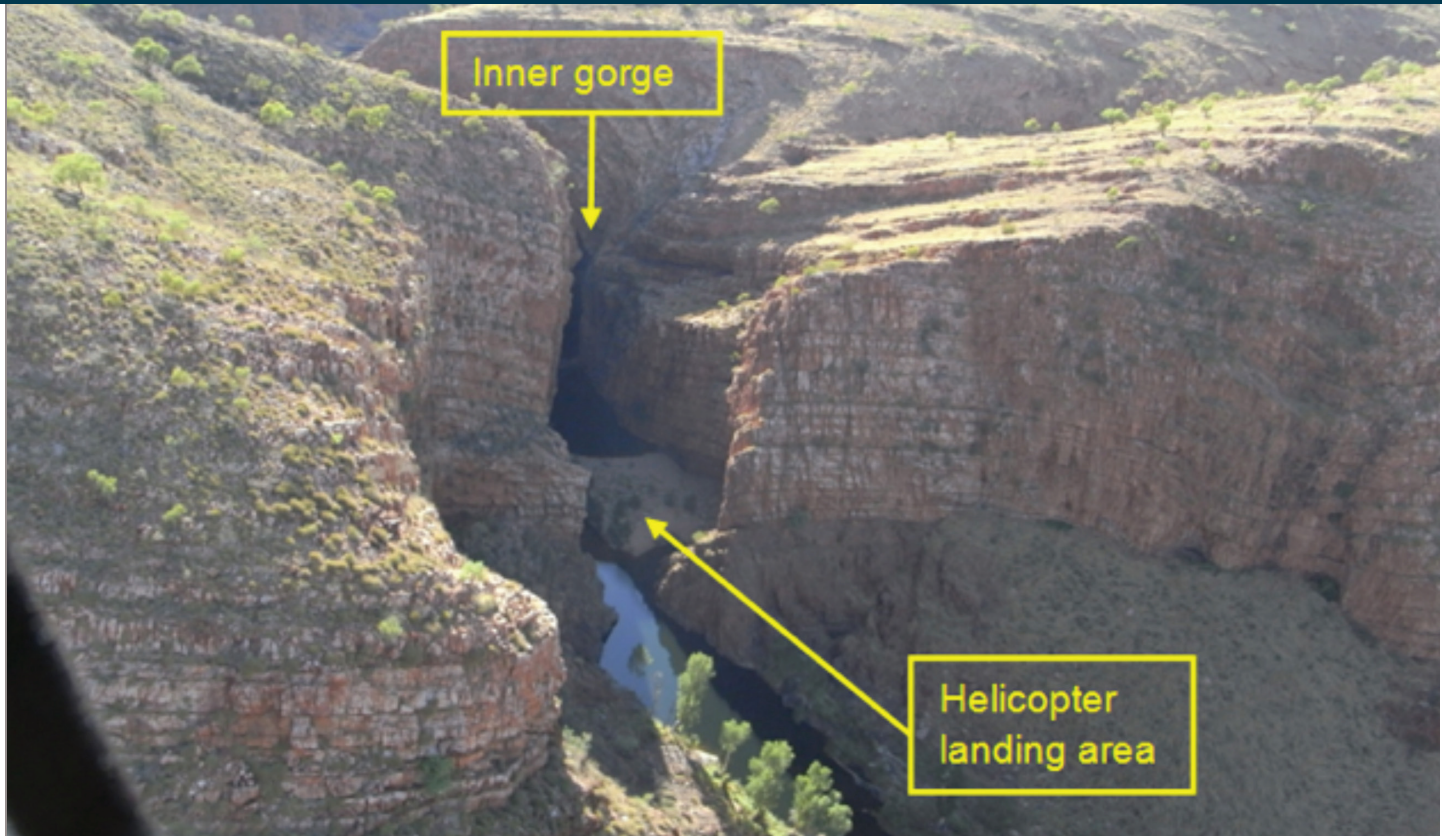
Accident site

The pilot descended into the gorge and then during the ascent the helicopter tail contacted a rock overhang about 30 m above the gorge pool and separated, resulting in loss of control, collision with the surrounding rocks, and submersion. The pilot did not survive.

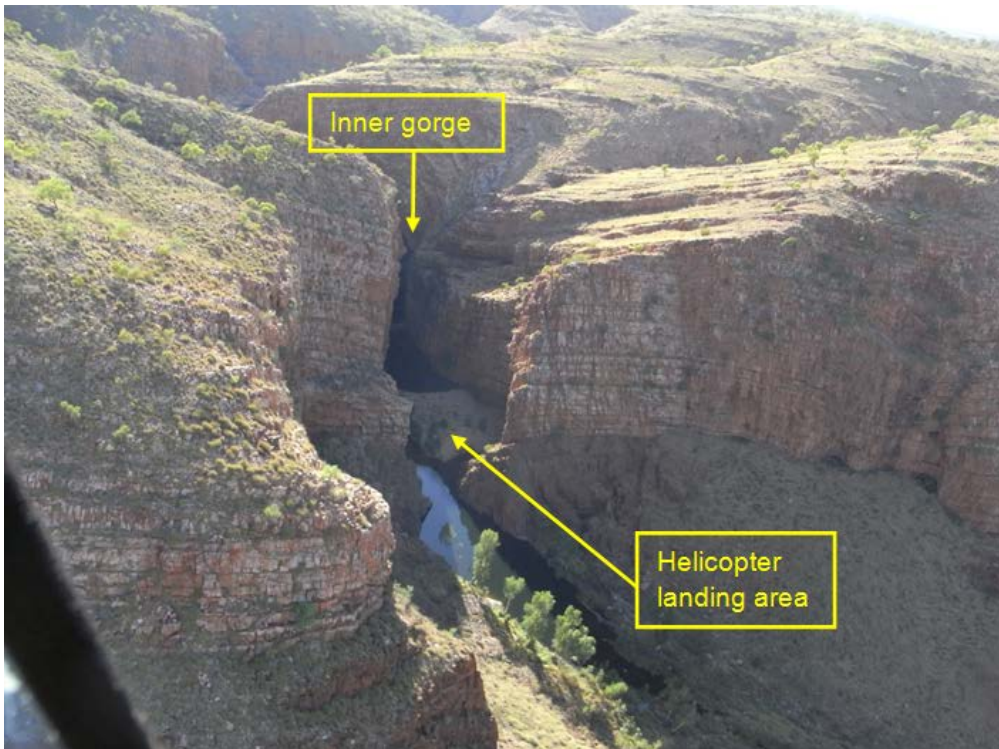
Figure 1: Aerial view along the gorge

In the daylight remaining, it was decided to take two station personnel for a sightseeing flight over the station property. With a passenger on board each helicopter, the pilots overflew the yarded cattle and other parts of the property. At about 1545, the pilots landed on a section of river bed in the Margaret River for some fishing. After about 30 minutes on the ground, it was decided to return to Louisa Downs. Once airborne, the pilots arranged to visit a gorge that had been spotted during the muster. The gorge was about 2 minutes flying time away from the fishing spot on the Gliddon River, not far from where it runs into the Margaret River. On arrival, the pilots surveyed the area from the air before landing on a pebble-covered sandbar in a relatively open part of the gorge (Figure 1).

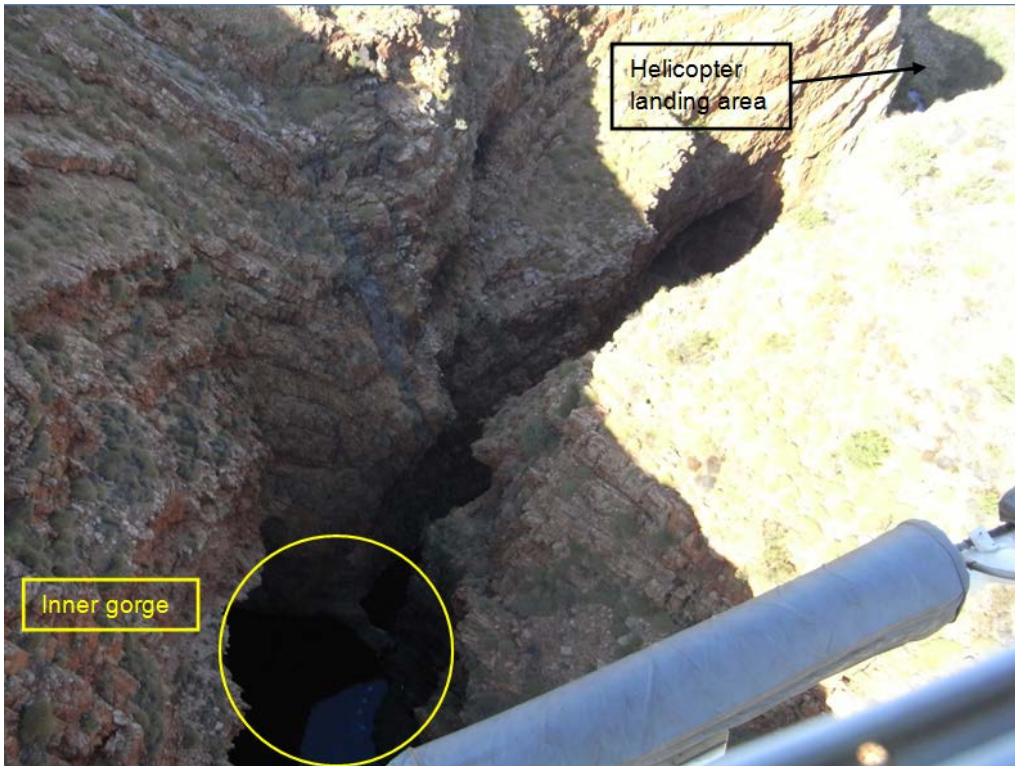
Figure 2: Overhead view of the inner gorge

One of the pilots and a passenger swam further into the narrower and obscured part of the gorge (Figure 2), leaving the other pilot and passenger with the helicopters. At some point the pilot who remained at the helicopters indicated that he wanted to explore the gorge further, and departed alone in the helicopter, registered VH-LLF (LLF).

The pilot and passenger swimming in the inner gorge heard a helicopter start up and, unaware of the pilot's intentions, thought it was a prompt to return to the helicopters. The swimmers were still in the inner gorge when the pilot of LLF descended into the same area and hovered above the water. The pilot was observed to manage a steady hover and did not show any signs of discomfort. The swimmers exited the inner gorge area and were part-way across the pool, when they turned around to see LLF ascending. The helicopter appeared to be operating normally with no indication of any technical problem. In view of the two swimmers and the passenger located on the sandbar, the tail of the helicopter contacted an overhanging rock formation and a section of the tail boom separated from the fuselage. The helicopter rolled to the left and descended out of view.

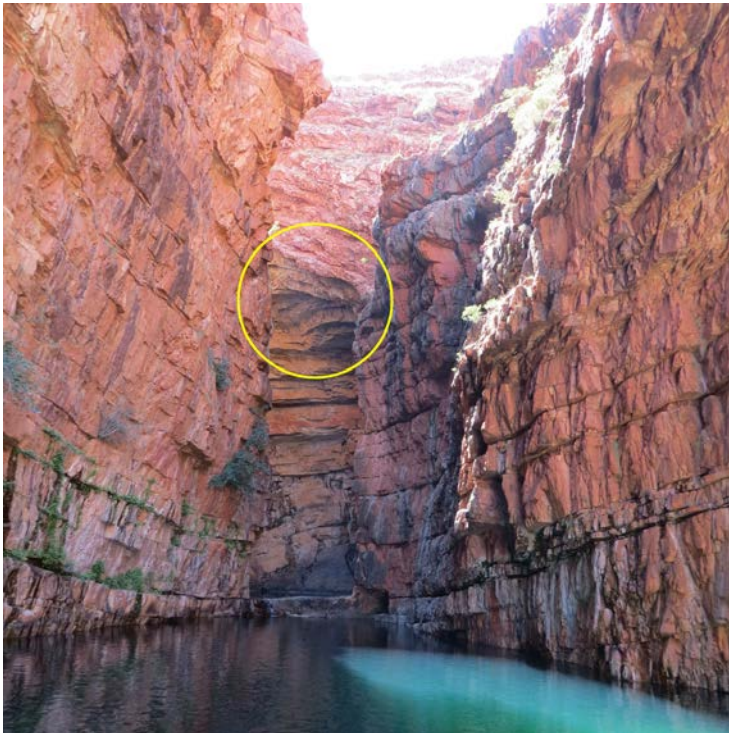
Except for a narrow opening that allowed access from the outer gorge pool where the helicopters were parked (Figure 3), the inner gorge was enclosed by walls varying in height from about 30 to 50 m. At the base of the gorge was a pool about 40 m across. Wall profile varied from concave through vertical to convex, such that there was at least 40 m between opposite wall surfaces in the lower part of the gorge. That provided a cavern-like space in which the pilot was able to manoeuvre the 8.8 m long R22. However, about 30 m above the pool was a rock overhang that substantially reduced the clearance between the walls adjacent to the pool. The helicopter's tail contacted that overhang.

Figure 3: View from the helicopter landing area across the outer pool, showing part of inner gorge with the rock overhang circled

This fatal accident was the result of the helicopter tail contacting a rock overhang and separating, with consequent loss of control, collision with the surrounding rocks, and submersion in the gorge pool.
