# Loss of control involving Robinson R22, VH-HTD

Princess Charlotte Bay, Queensland, 9 December 2012

**ATSB Transport Safety Report**

AO-2012-167

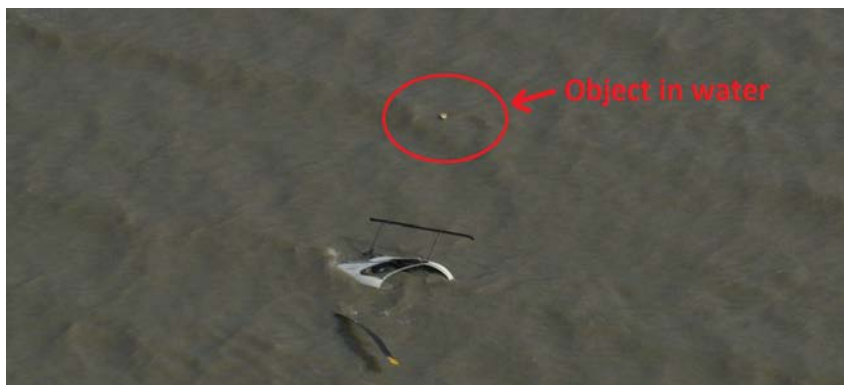
**Figure 1: VH-HTD**

As the pilot approached the object, he initiated a flare<sup>2</sup> to reduce the airspeed and rate of descent. During the flare, the tail rotor contacted the water and the helicopter began to rotate to the right about the yaw axis. The pilot attempted to manoeuvre closer to the shoreline, however the helicopter began to rotate faster and the pilot was unable to regain control. The pilot closed the throttle and the helicopter settled into the water and rolled over to the right. The pilot exited through the passenger door without injury and swam to shore.

| Damage: | Destroyed | |
