Airspace related event involving Beech 1900C, VH-KFN and Aerospatiale AS350 B2, VH-VRW

Newman aerodrome, Western Australia, 6 September 2012

ATSB Transport Safety Report
Aviation Occurrence Investigation
AO-2012-118
Final – 23 April 2013

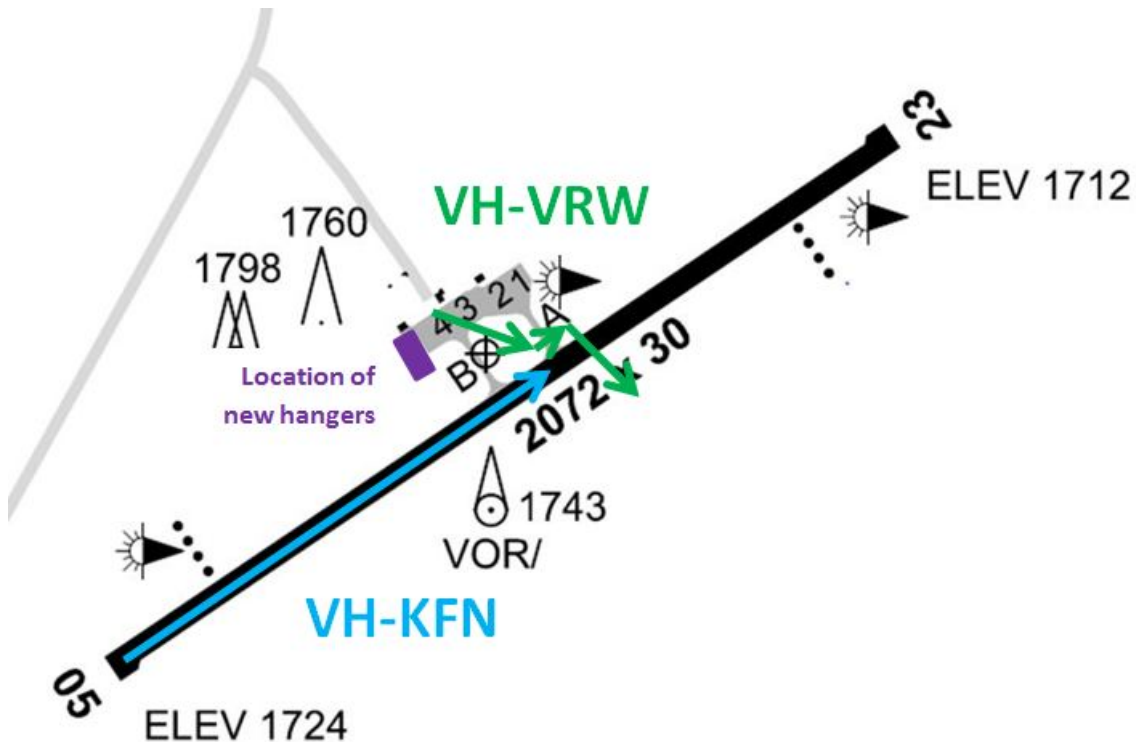
Figure 1: Track of VH-KFN (blue) and VH-VRW (green)

As the aircraft passed about 300 to 450 m down the runway, at a speed of about 80 knots, the PIC of KFN saw VRW tracking across the GA apron towards the runway. As KFN passed a point about 100 m before taxiway Bravo (Figure 1), the PIC of KFN observed VRW enter the runway strip, turn left and takeoff parallel to runway 05. Shortly after, the co-pilot had called V_1 ² and V_R ³ (108 and 109 knots respectively). The PIC of KFN believed the path of VRW could conflict with KFN if they became airborne and, although KFN was at about 120 knots, he elected to reject the takeoff. As the aircraft slowed, the PIC of KFN observed VRW turn right and cross the runway about 200 m in front of KFN and about 200 ft above ground level.

Following the incident, the Newman Airport Manager advised that a number of hangars had recently been built to the west of the GA apron that obscured the view from the GA apron to the threshold of runway 05. The new hangars were also thought to be responsible for blocking radio transmissions between aircraft on the GA apron and those on the threshold of runway 05.

Due to possible shielding effects from aircraft hangars along the south-western edge of the GA Apron, helicopter traffic is to adhere to unmanned airfield procedures during arrivals and departures. The circuit is to be joined as per these procedures for approaches on the runway in use, or parallel on the western side thereof. During departures helicopters are to air taxi onto TWY B for departures on the runway in use, or parallel to and on the western side. Departing turns tracking towards the east are only to be executed once clear of the circuit. No departures to the east across the runways should be executed.
