# Loss of control involving Robinson R44 helicopter, VH-COK

Jaspers Brush Aerodrome, New South Wales | 4 February 2012

**ATSB Transport Safety Report**  
Aviation Occurrence Investigation  
AO-2012-021  
Final – 3 May 2013

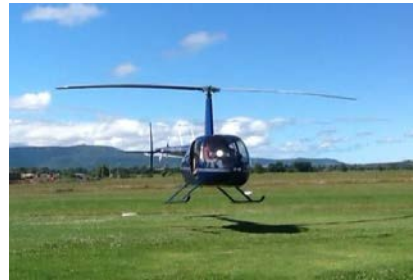
VH-COK early in the lift off

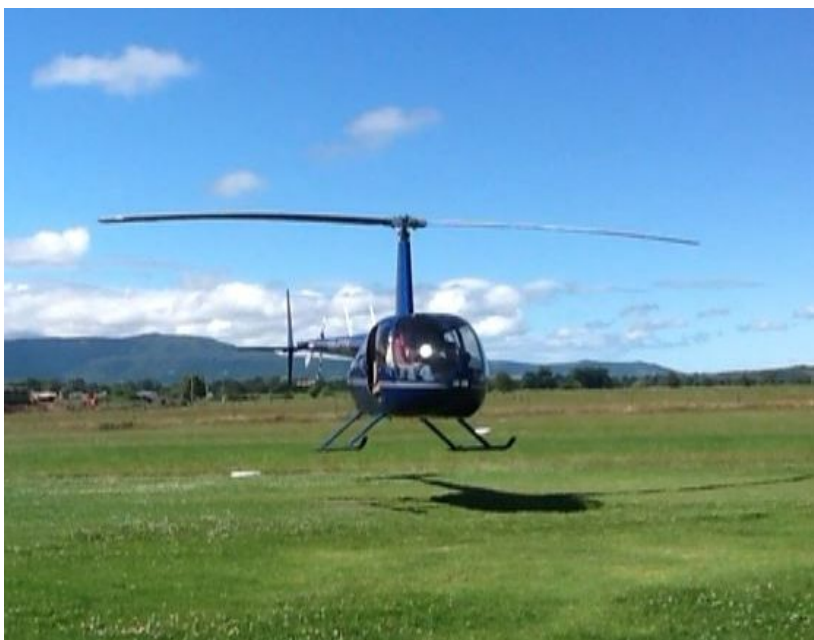
After establishing the hover, the pilot turned the helicopter about 90° left to depart in the approximate direction of Jervis Bay (Figure 1). During the turn for departure, the pilot's door opened about halfway (Figure 2).

**Figure 1: Helicopter hovering prior to turning left and commencing departure<sup>2</sup>**

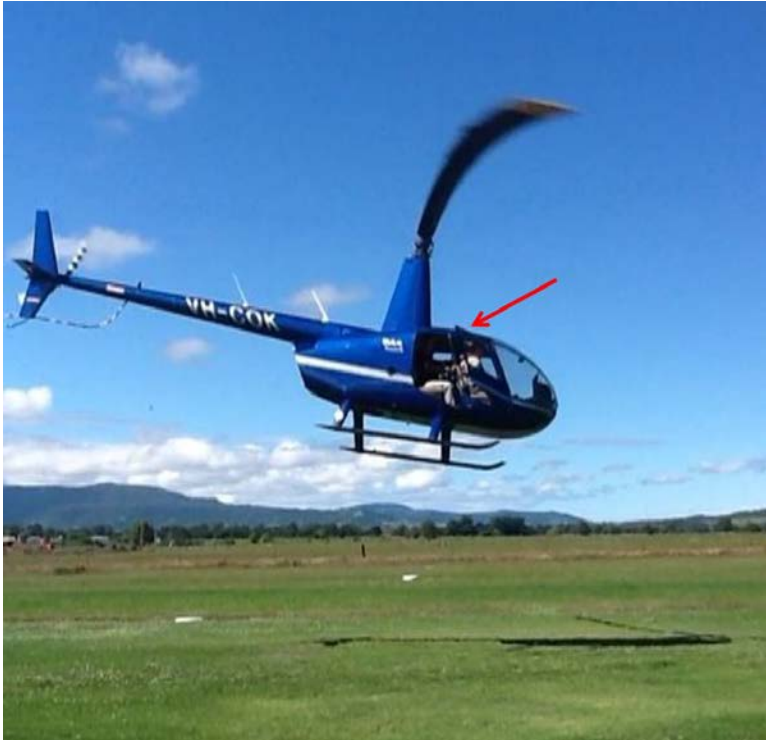
**Figure 2: Pilot's door (arrowed) open as helicopter turned left**

The first indication of a problem in the operation of the helicopter was the pilot's door opening to about a halfway position when the helicopter turned left soon after lift-off. In the absence of any defects or anomalies in the door latching mechanism, the pre-flight check of closing and latching the door must have been overlooked or ineffective. There was no clear reason for this, but the pilot probably wanted to expedite the departure to avoid a delay to the operation to be filmed. Also, lacking in this situation was the visual cue of incomplete door closure because the gas spring unit held the door closed until some combination of airflow and centrifugal force sprung it open during the turn.

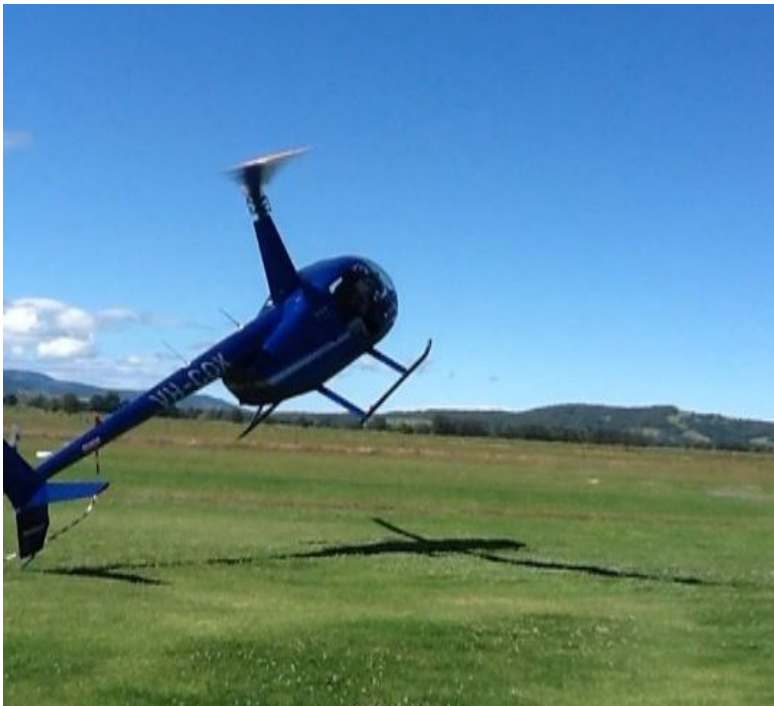
About 5 seconds after lift-off, at about 10 feet above ground level, the helicopter abruptly pitched nose-up and moved backwards with the tail skid striking the ground (Figure 3). One witness, who was positioned close to the helicopter at the time, indicated that as the helicopter turned and the pilot's door opened he saw the pilot extend an arm and grab the door in an apparent attempt to close it. The witness reported that at the same time as the pilot's arm was seen, the helicopter pitched up.

**Figure 3: Helicopter pitched up with the tail skid contacting the ground**

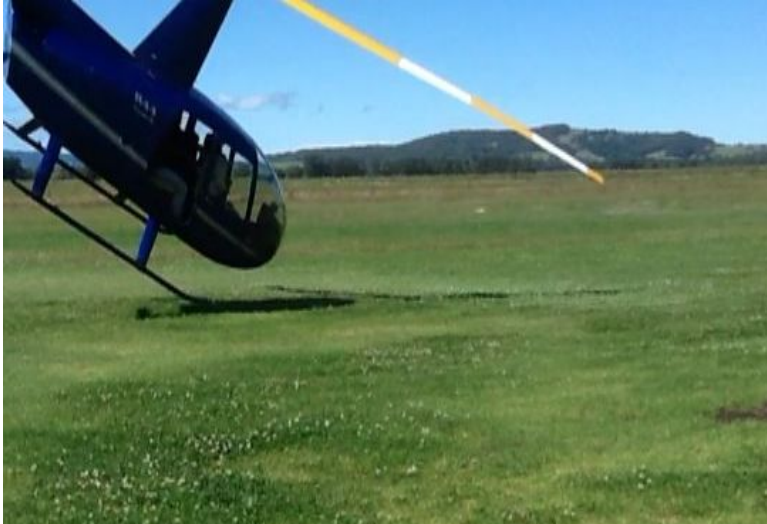
The helicopter then rapidly pitched steeply nose forward and rolled to the right, before the front of the right skid and both main rotor blades contacted the ground (Figure 4).

**Figure 4: Helicopter pitched nose-down with the front of the right skid contacting the ground. Note pilot’s door closed in toward the fuselage**

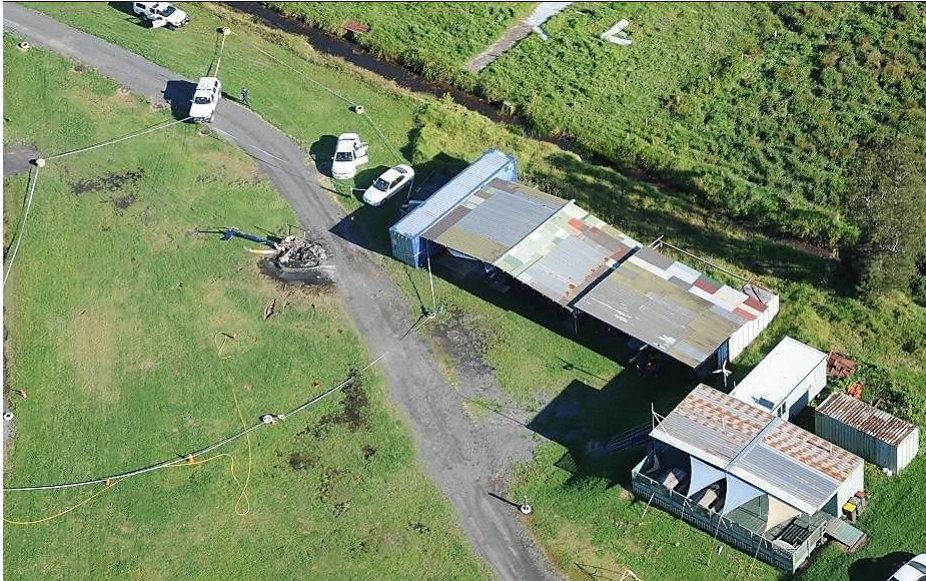
**Figure 11: Aerial view of the accident site**

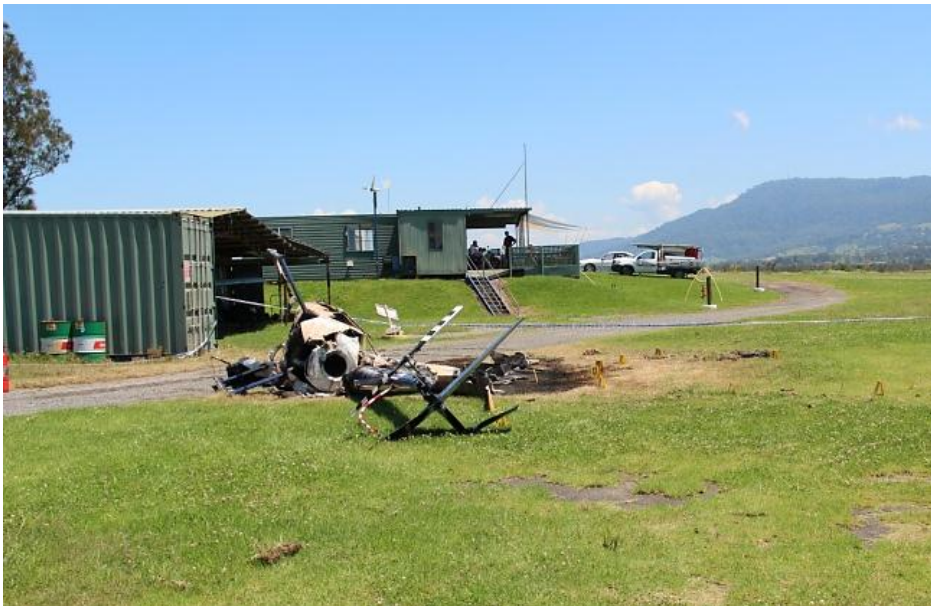
**Figure 12: Helicopter wreckage from the ground**

Most of the aluminium alloy flight control tubes had been burnt away, precluding a full examination of the flight control system. However, examination of the helicopter's main and tail rotor flight control connections, engine control connections, main and tail rotor drive and remaining fuselage structure, revealed no evidence of any pre-existing anomalies.

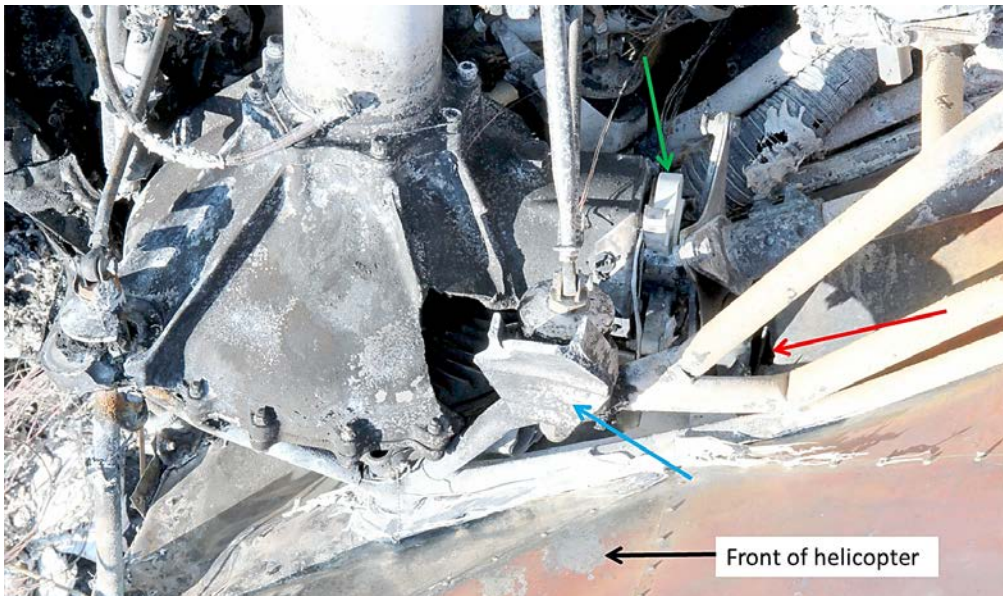
The fracture during the impact sequence of the rear left gearbox mount had broken away a significant section of the gearbox casing, exposing the gearbox internals. The movement of the gearbox rotated the casing section around the mount fitting and outward toward the inner wall of the adjacent main fuel tank (Figure 13). The flexible coupling connecting the gearbox input to the input-drive shaft remained intact, with the coupling and shaft having been forced down into the stainless steel, horizontal firewall while under rotation by the movement of the gearbox.

The rotor brake assembly and attached rotor brake activation micro switch assembly had been significantly damaged by the impact and fire (Figure 13).

**Figure 13: Gearbox mount damage as noted on site with the broken section of the gearbox casing rotated outward toward the main fuel tank inner wall (blue arrow). The damaged rotor brake and micro switch assembly (green arrow) and flexible coupling cut into the firewall (red arrow) are also shown**

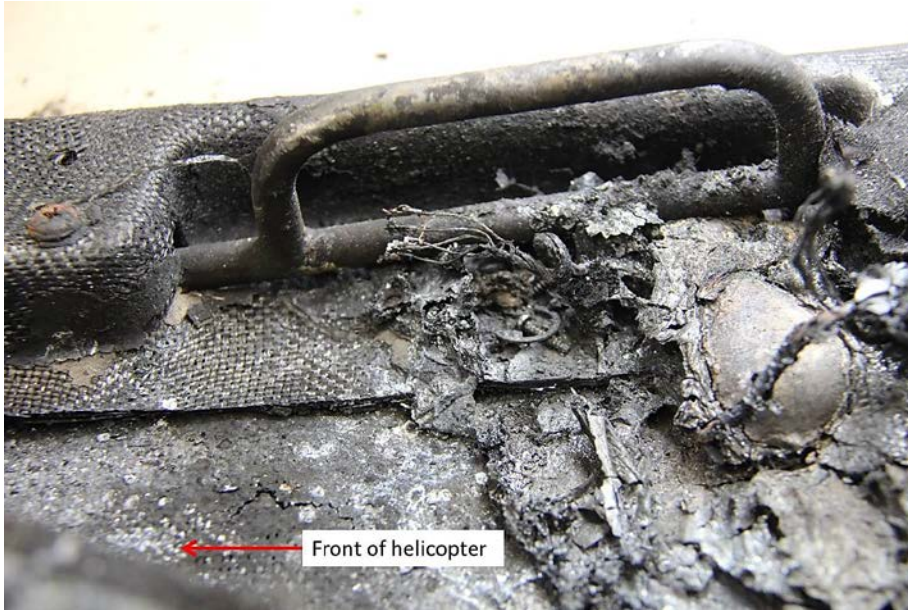
The accident-damaged pilot's door was returned to the Australian Transport Safety Bureau (ATSB) for examination of the latching mechanism. Recognising that the position of the pilot's door handle may have been affected by the impact sequence, the examination of the latching mechanism found that the internal door handle was positioned about two-thirds rearward, in the up or unlatched position (Figure 14). This position was also reflected on the outside door handle, with the upper rod protrusion in the fully unlatched condition (Figure 15).

In this position, if the door was seated home, it would be partly latched at its rearward point. If ajar, the protruding rod would have prevented closure of the door.

**Figure 14: Pilot’s door internal handle position as noted post-accident**

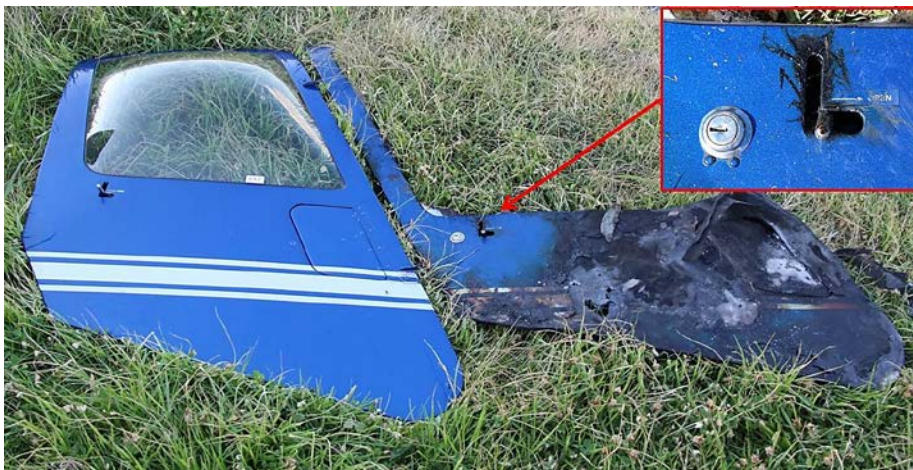
**Figure 15: Rear right door alongside pilot’s door (burnt) as noted on-site. Note the position of the external door handle**

Examination of the door-latching mechanism showed that all latching components were in their correct relative positions, although heat affected. On that basis, it was concluded that the door-latching mechanism was likely to have been functional prior to the accident.
