Collision with terrain involving Piper PA25-235/A9, VH-GWS

Near Hallston, Victoria | 1 May 2012

ATSB Transport Safety Report
Aviation Occurrence Investigation
AO-2012-061
Final – 9 May 2013

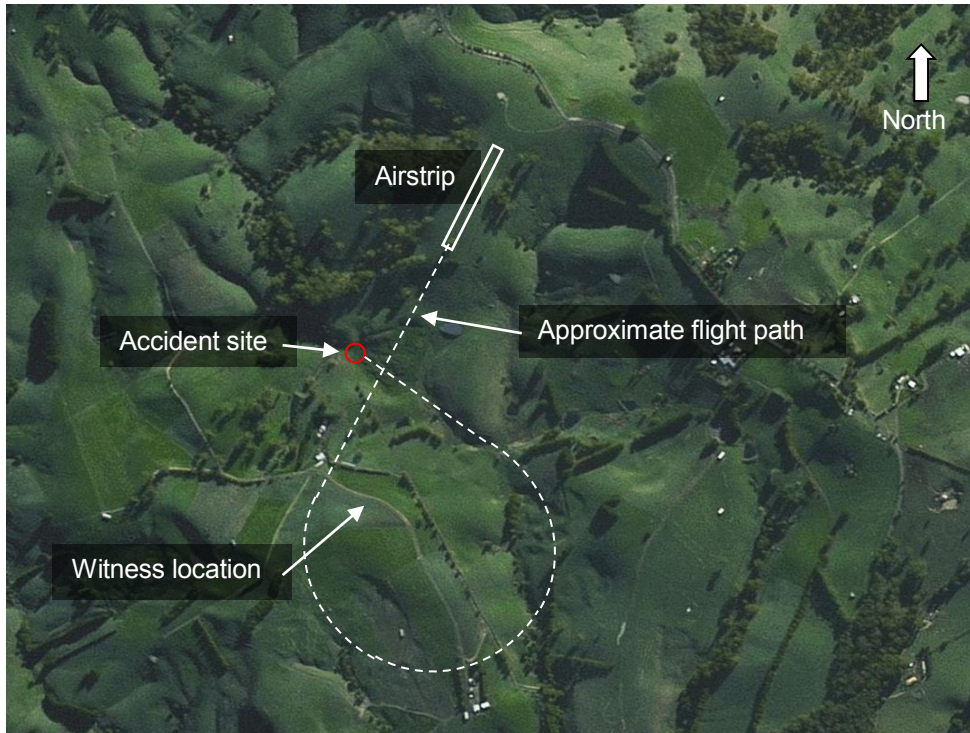
Figure 1: Accident location

Witnesses to the south-west of the airstrip (Figures 1 and 2) observed the aircraft become airborne and fly overhead at a very low altitude before disappearing from view. Shortly thereafter, the aircraft reappeared to the east of the witnesses and was observed descending into a gully while releasing some of the fertilizer load. The witnesses reported that the engine was making a continuous, even noise for the duration of the flight, but that it was noticeably quieter than other aircraft that had previously used the same airstrip.

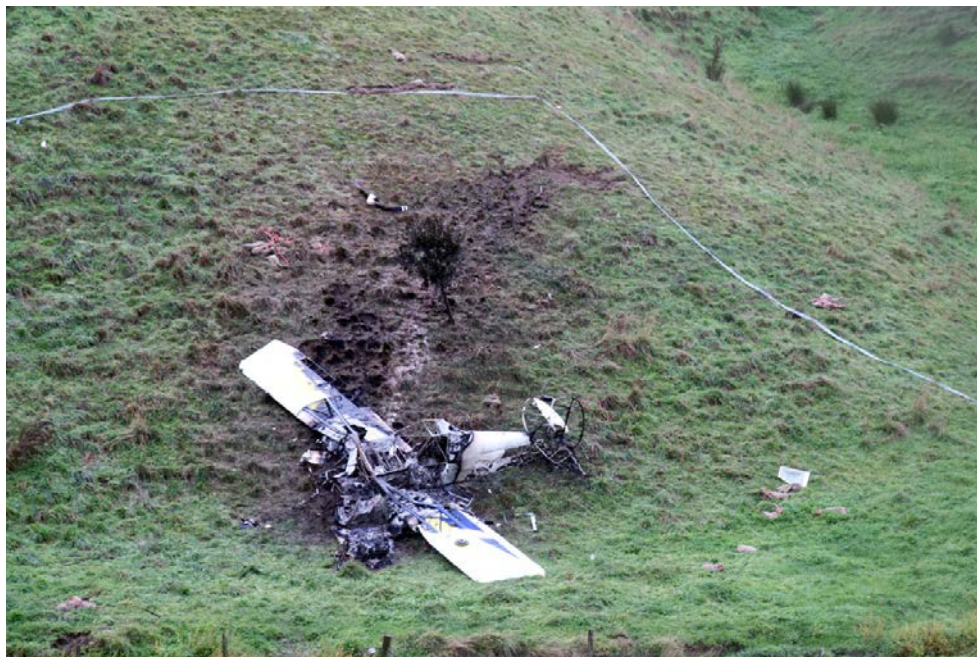
Figure 4: Accident site

The aircraft was situated in a gully, near the base of an incline of approximately 30° (Figures 3 and 4). Ground scars at the point of impact were consistent with the aircraft contacting the soft terrain in a left wing down attitude, slightly greater than the slope of the terrain. The aircraft came to rest near the base of the incline, approximately 16 metres from the point of first impact. It remained upright and was oriented roughly in the direction of travel. Granulated superphosphate was found scattered along the ground scars as well as back along the flight path, which was consistent with the witness accounts that some product had dropped from the aircraft before it struck terrain. A significant quantity of the fertiliser load was also found in the remains of the hopper.

The fuselage forward of the cockpit sustained significant damage from the impact and a post-impact fire consumed the majority of the fuselage and inboard wing sections. There was no damage observed that could not be attributed to the impact or to the fire.

The accident site characteristics suggested the aircraft impacted terrain with a low forward speed, but at a high angle relative to the slope of the terrain. This scenario would have produced greater deceleration forces than if the terrain was flatter and the angle of impact shallower.
