Helicopter winching accident involving an Agusta Westland AW139 helicopter, VH-SYZ

16 km WSW of Wollongong Airport, New South Wales | 24 December 2011

ATSB Transport Safety Report

AO-2011-166

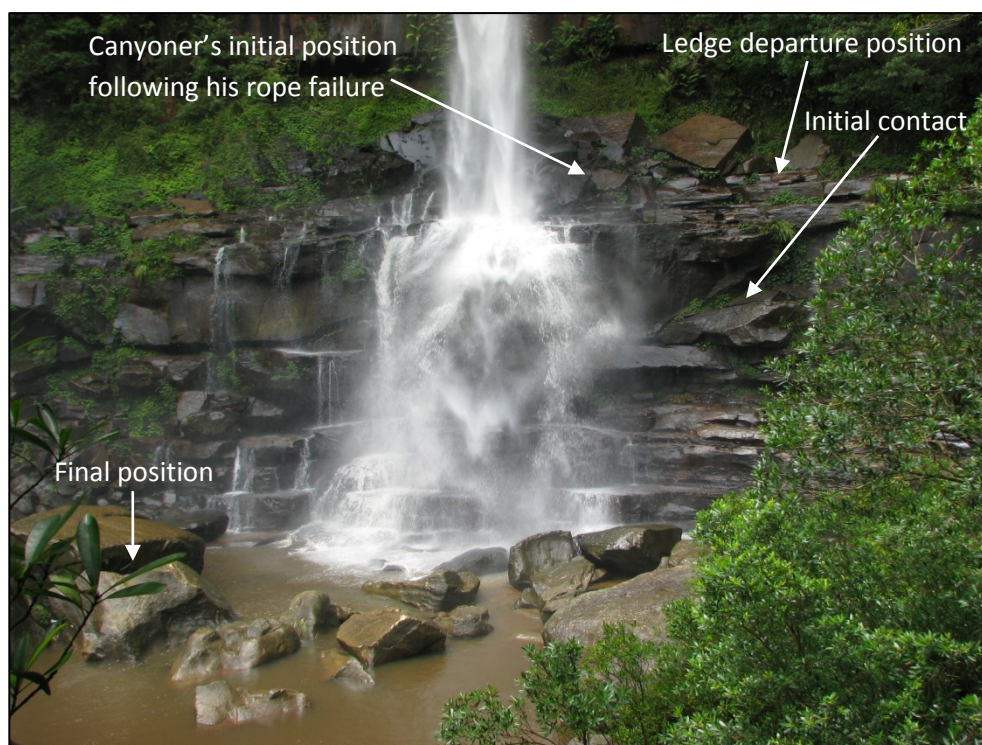
Figure 7: Rock ledge

The ACM reported that a short time later the duty paramedic and patient appeared to move out from the ledge in a controlled manner however, after about 2 m of horizontal movement the ACM assessed that what he perceived as the red stabilising rope appeared to fail. The patient and paramedic fell several metres onto a lower ledge before swinging towards a position under the helicopter. In response, the ACM winched in the cable at full speed and directed the pilot to move the helicopter left. The ACM recalled that he was concerned that the patient and duty paramedic might swing back and contact the rock ledge. However, during the initial swing from the ledge towards the helicopter, they impacted a second rock at the base of the waterfall that was displaced about 26 m laterally and 15 m vertically down from the rock ledge and came to rest (Figure 7).

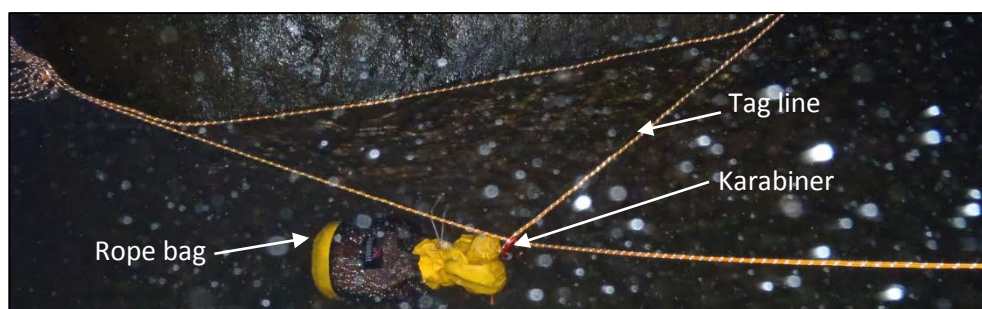
Figure 16: Tag line

The rescue personnel who accessed the site on 25 December 2011 observed the tag line and its associated bag in the vicinity of where the duty paramedic and patient came to rest after the fall (Figure 16). They recalled there being a loop knot and a free-running karabiner¹⁹ on the tag line, and that the weak link (see the section titled *Role equipment*) remained connected and intact.

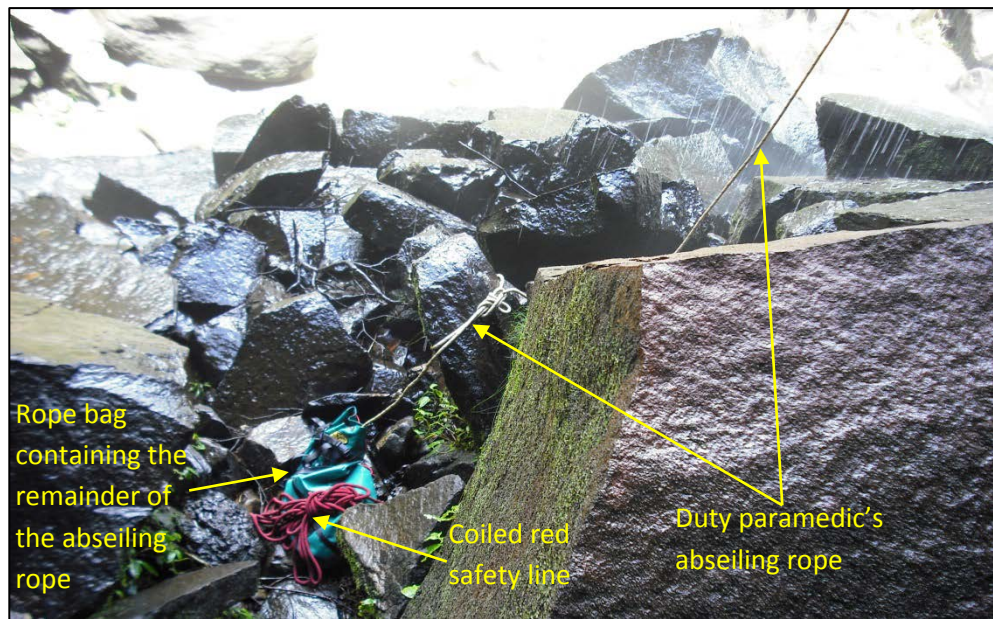
Figure 17: Duty paramedic's ropes

The two NPWS field officers who accessed the rock ledge on 31 December 2011 stated that they observed an abseiling rope, subsequently identified to be the one used by the duty paramedic, running up to the top of the waterfall with the lower end tied to a rock immediately adjacent to the waterfall (Figure 17). Advice from other SCAT paramedics indicated that the rope was probably tied to the rock to prevent it being a hazard to the helicopter during the retrieval.

The NPWS officers also observed a red rope, coiled up on a green rope bag that contained the remainder of the duty paramedic's abseiling rope. They advised that, although they observed and photographed a number of ropes on the ledge, they did not touch any of the equipment that had been used by the canyonsers or the duty paramedic.

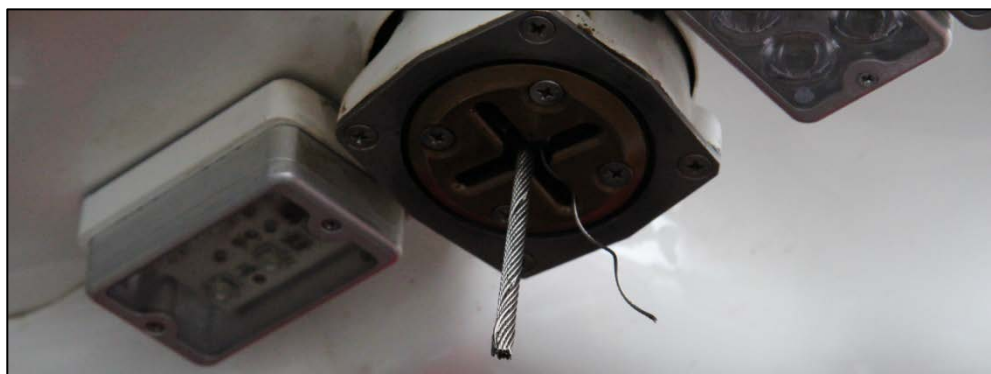
Figure 18: Severed end of winch cable

The helicopter was examined by the ATSB at the operator's Wollongong base on 26 December 2011. The condition of the end of the exposed winch cable was consistent with its being severed with manual cutters (Figure 18).

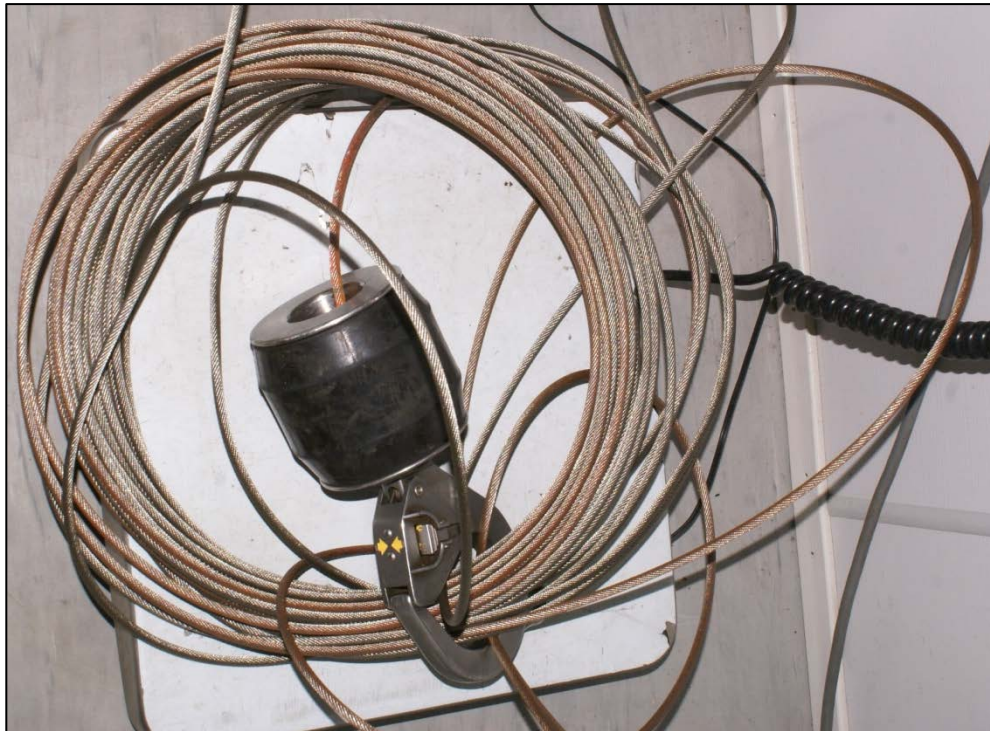
Figure 19: Severed winch cable and hook

The severed winch cable and hook were visually examined and, having identified that the winch hook was not defective or damaged, the ATSB returned it to the helicopter operator (Figure 19). The winch cable was retained for further examination.

A number of kinks were observed in a section of the severed cable that was attached to the winch hook. The circumstances surrounding the kinking of the cable could not be identified.

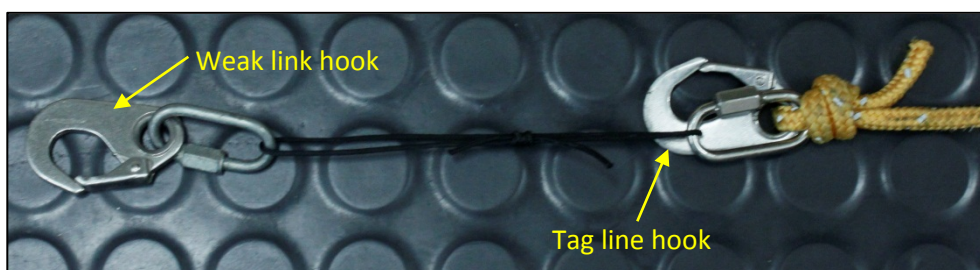
Figure 21: Tag line weak link

The tag line that was used to assist the delivery of the winch hook to the ledge was a 6 mm diameter rope that was about 120 m long and contained a hi-visibility reflective tape to aid night visibility (Figures 16 and 21). It also incorporated a weak link with a breaking strength of 140 kg (Figure 21). The tag line itself was capable of supporting 560 kg prior to failure.
