# Wirestrike involving an Ayres Thrush S2R-T34, VH-HAH

7 km SE of Condobolin aerodrome, NSW, 19 February 2013

**ATSB Transport Safety Report**  
Aviation Occurrence Investigation  
AO-2013-033  
Final – 17 May 2013

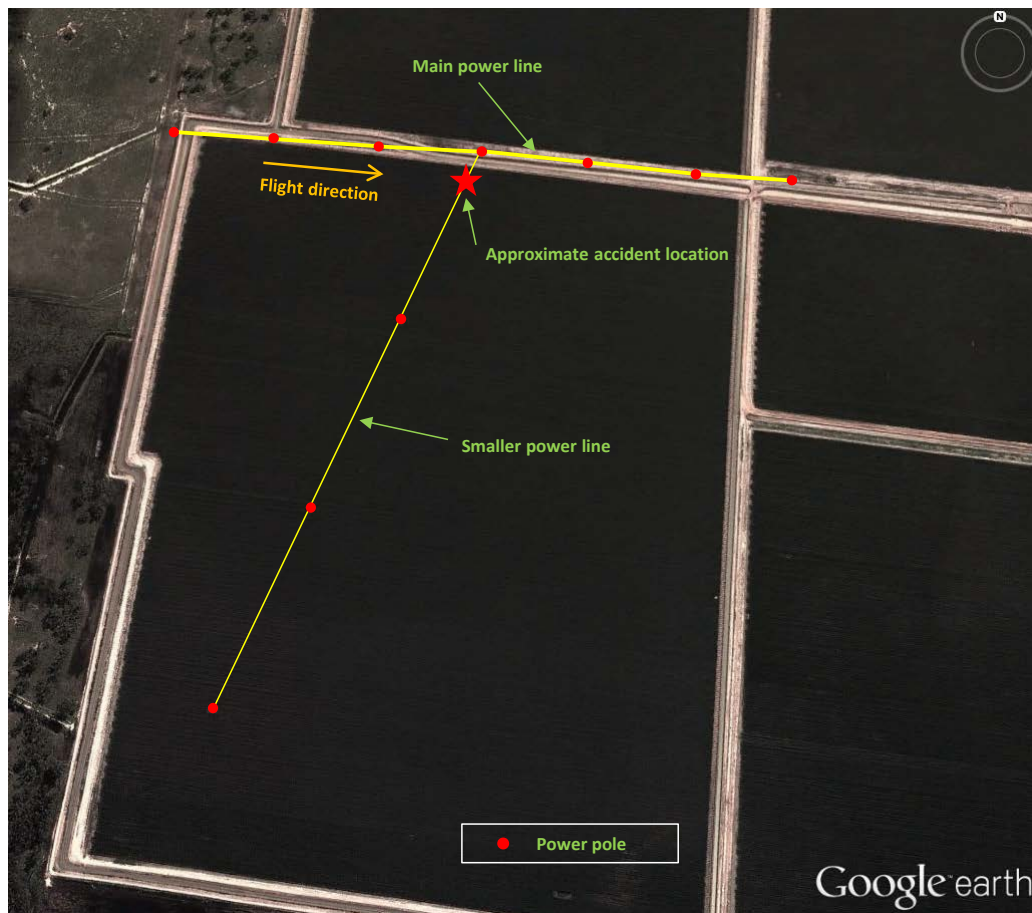
**Figure 1: Representation of field being sprayed**

The pilot was carrying out the final spray run (clean-up run), to use the last of the spray product on the edge of the field, before returning to the loading airstrip that was located about 1 km away. The pilot was flying from west to east, parallel to the main power line (Figure 1), which was located beside the field, outside of the area being sprayed. Another smaller power line with three wires ran diagonally across the field from the main power line and went for about 1 km across the field to a farm yard. When the pilot had run out of product, he pulled up to gain altitude before returning to the loading airstrip, when he struck the smaller power line that ran diagonally across the field. Two of the wires were cut by the aircraft's wire protection system and the third wrapped around the propeller hub, arresting the aircraft and pulling it around in a half circle, where it came to rest on the ground (Figure 2). The aircraft sustained serious damage, while the pilot was uninjured.

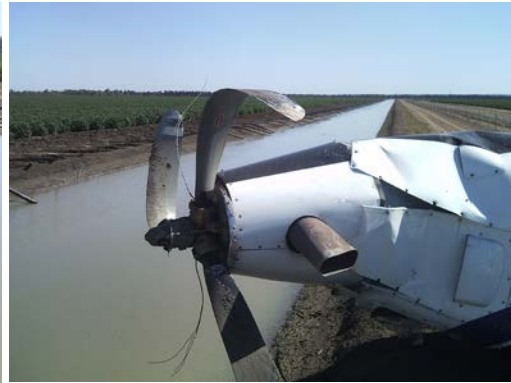
**Power line wrapped around propeller**
