Partial power loss (both engines) involving Piper PA-39, VH-RMA

52 km NW of West Wyalong, New South Wales, 9 December 2012

ATSB Transport Safety Report
Aviation Occurrence Investigation
AO-2012-166
Final – 17 May 2013

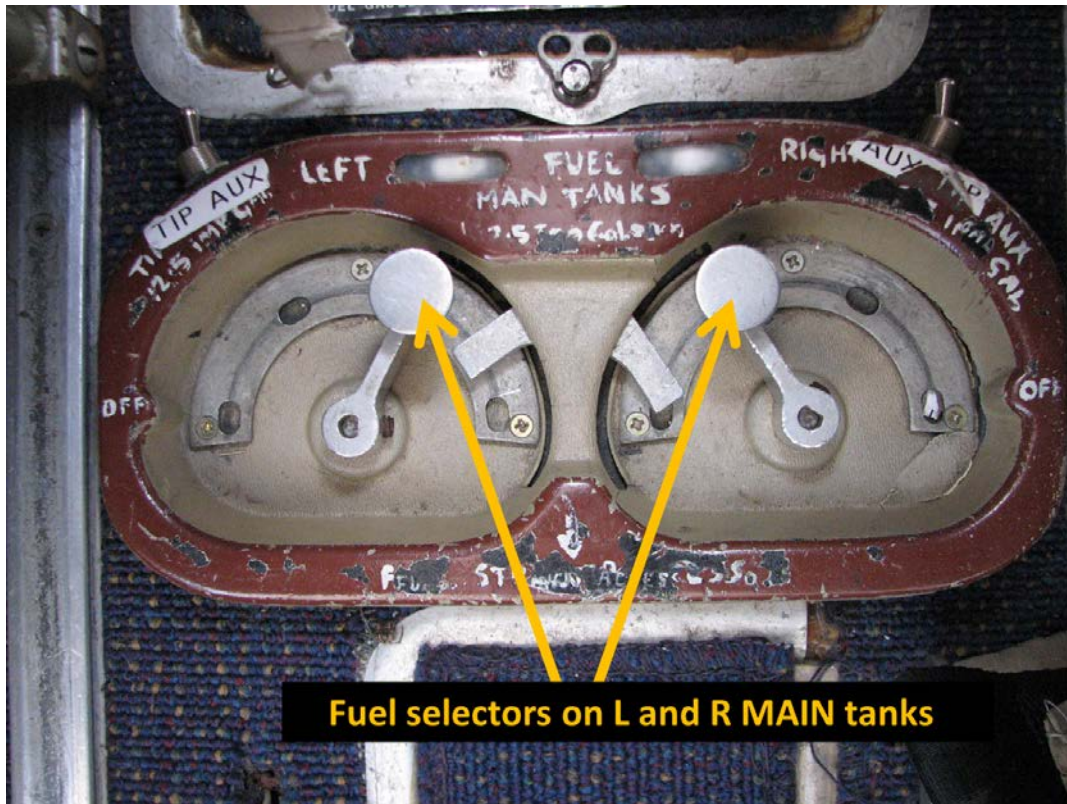
Figure 1: VH-RMA fuel selectors

At about 1530, and 75 NM from Griffith, he prepared for a descent from 4,500 ft above mean sea level (AMSL) to 2,500 ft AMSL. He set the fuel selectors onto the main tanks (Figure 1), reduced the manifold pressure (MAP) on both engines, and left the propeller controls set at 2,300 revolutions per minute (RPM). The pilot increased the MAP on both engines, intending to arrest the descent and fly level, as the aircraft approached 2,500 ft AMSL. He then noticed an uncommanded decrease in the left engine RPM to 2,000. He moved the left propeller lever to the maximum position of 2,700 RPM; however, the RPM failed to respond, staying at 2,000, and the aircraft continued to descend.

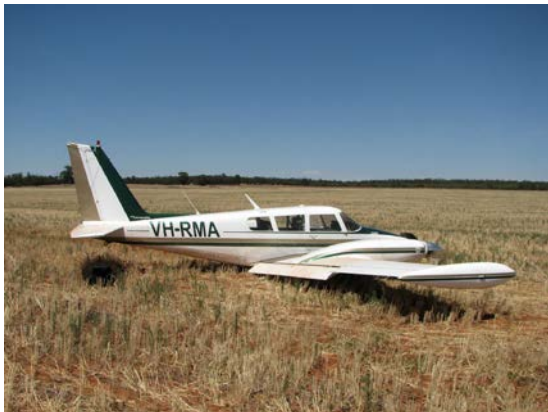
Figure 2: Accident site

An insurance representative attended the accident site (Figures 2 and 3) and noted that there was sufficient fuel remaining in the main fuel tanks to complete the flight. An assessment for contaminants such as water could not be undertaken at the accident site. The reason for the reported performance loss on either engine could not be definitively determined.
