Engine failure involving a Cessna 182R, VH-OWZ

Kununurra Airport, Western Australia, 22 January 2013

ATSB Transport Safety Report
Aviation Occurrence Investigation
AO-2013-023
Final – 17 May 2013

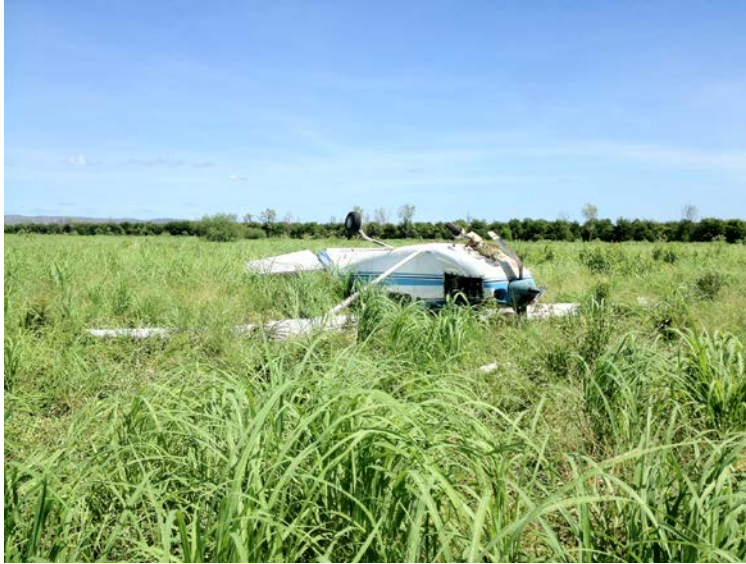
Figure 2: Aircraft at the accident site

The pilot then selected the auxiliary fuel pump on, but the engine did not respond. He lowered the landing gear and extended full flaps. The main landing gear touched down in long grass and the aircraft decelerated rapidly. When the nose gear touched down, it dug into boggy ground and the aircraft flipped over, coming to rest inverted (Figure 2). The pilot and passenger received minor injuries and the aircraft sustained substantial damage.

An engine tear down was not performed and the reason for the engine failure could not be determined.

- *Fuel contamination procedures:* They will create a log for all company aircraft that will contain details of any water contamination found in fuel drains. In addition, after heavy rain is experienced, all aircraft fuel tanks will be tested for water contamination.
- *Emergency response equipment:* Equipping a vehicle with an 'accident kit', which includes fire extinguishers, a fire suit, and first aid kit for use in an on-airport emergency.
