Wheels up landing involving a Cessna 337F, VH-JUP

Exmouth (ALA), Western Australia, 25 February 2013

ATSB Transport Safety Report
Aviation Occurrence Investigation
AO-2013-040
Final – 17 May 2013

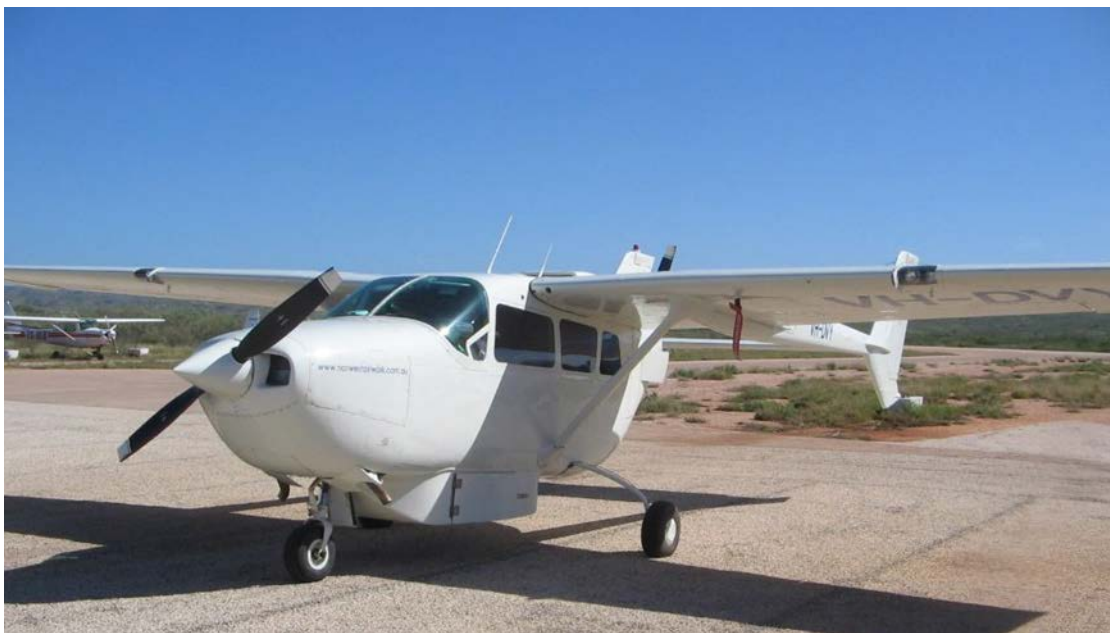
Figure 1: A Cessna 337 with cargo pod fitted

The passengers and pilot exited the aircraft without injury. The fiberglass cargo pod (Figure 1) fitted to the aircraft was damaged. The aircraft hull was undamaged; however, the rear propeller contacted the ground.
