Foundering of the general cargo ship *Tycoon*

Christmas Island | 8 January 2012

ATSB Transport Safety Report
Marine Occurrence Investigation
292-MO-2012-001
Final – 23 May 2013

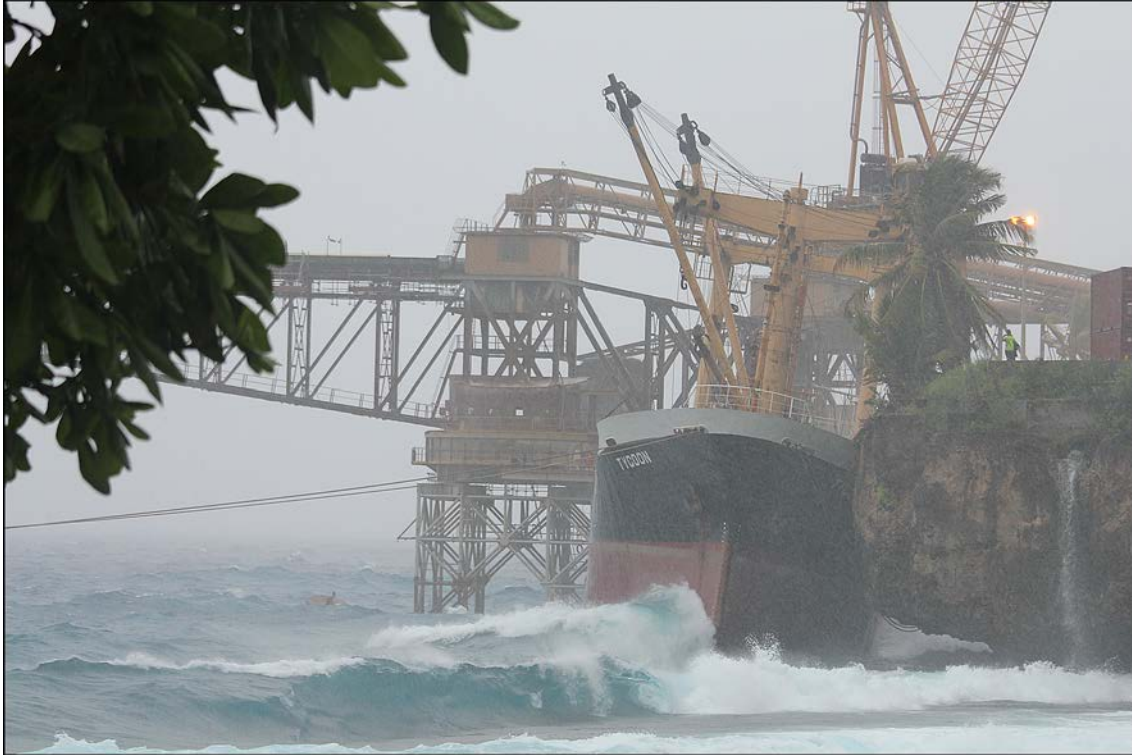
Figure 3: *Tycoon* as seen from the jetty at about 0630

At about 0630, the pilot and some stevedores joined the stevedore manager on the jetty. They decided that they could not launch the barges in the prevailing weather conditions. The pilot then contacted *Tycoon*'s master on VHF channel 16 and told him to heave in on the lamgar buoy line (line 2 in Figure 2) in an attempt to move the ship's bow out to seaward. He also told the master to heave in on the remaining after starboard breast line to the south breast buoy in an attempt to stop the ship from impacting the rock face and crane pylon.

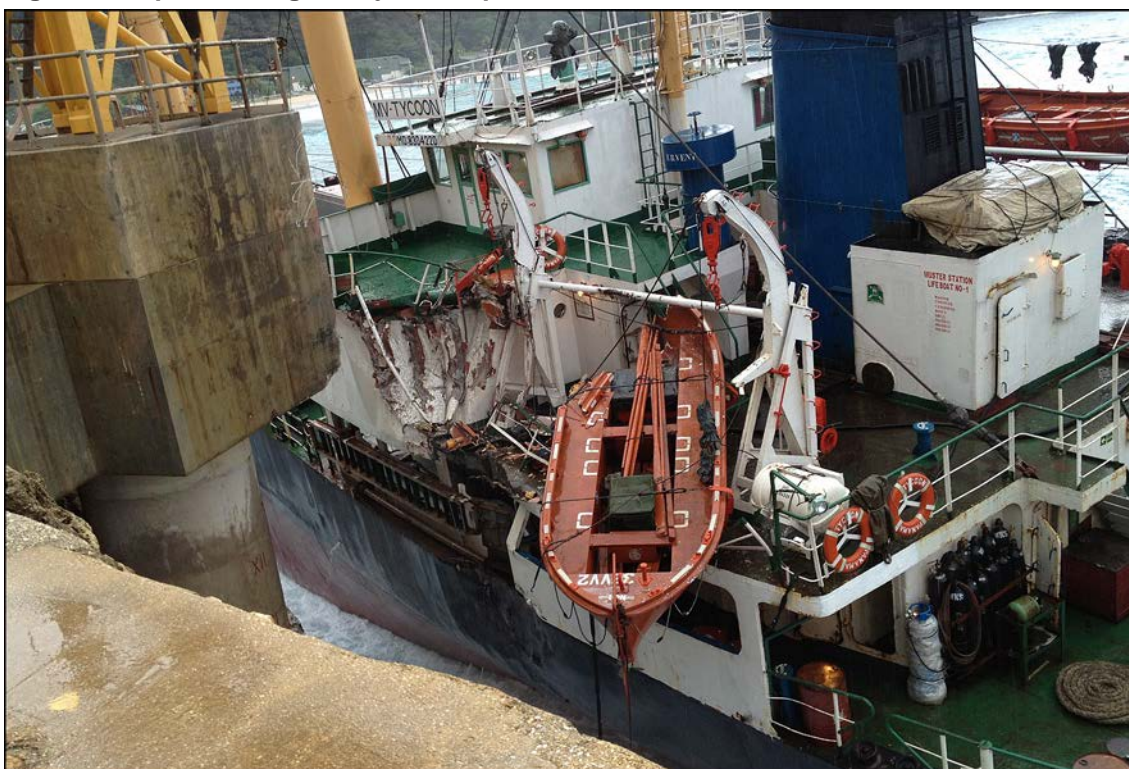
Figure 4: Impact damage to *Tycoon*'s port side

By this time, the ship had suffered severe damage to the port side of the accommodation. The port lifeboat had been smashed and was hanging from its davits (Figure 4).

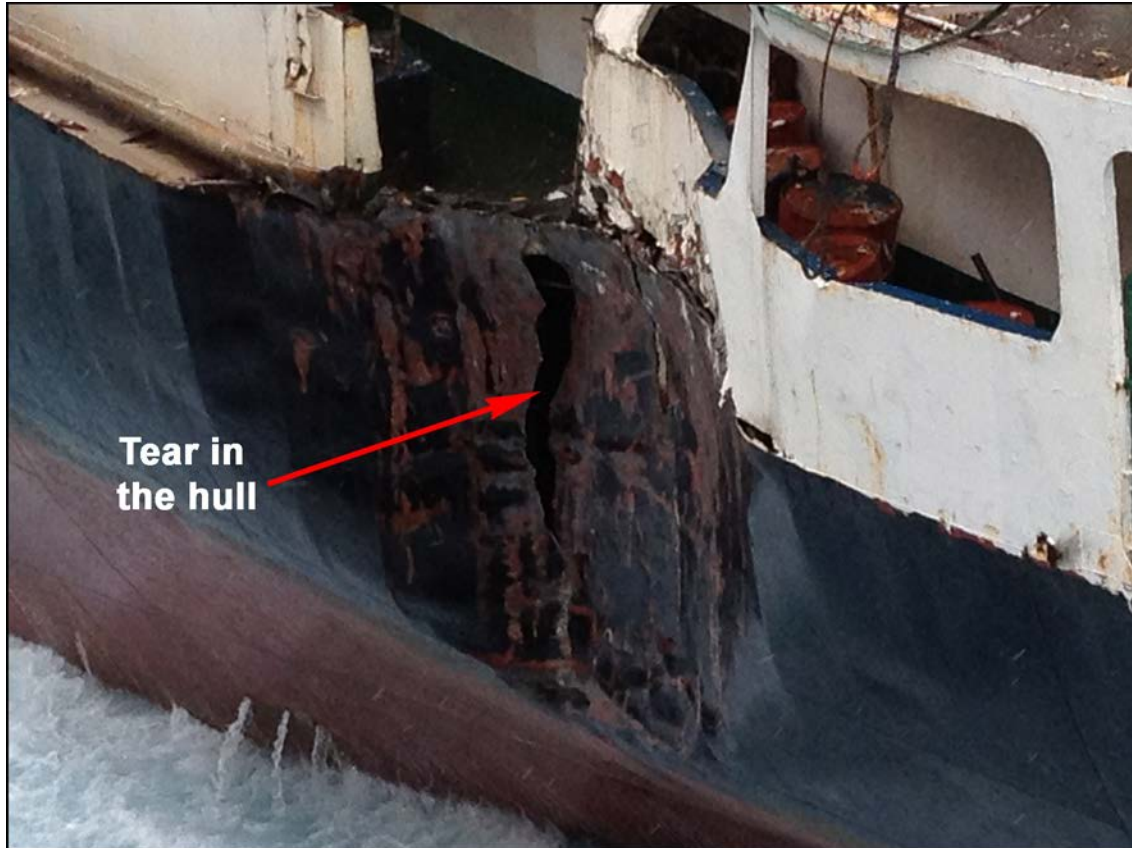
Figure 5: Tear in the hull in way of the engine room

The rain and seawater started to enter the engine room through the tear in the hull and when the master was advised of this, he told the engine room staff to evacuate the engine room and come to the bridge. He also told the crew on the after deck to stop what they were doing and also come to the bridge.

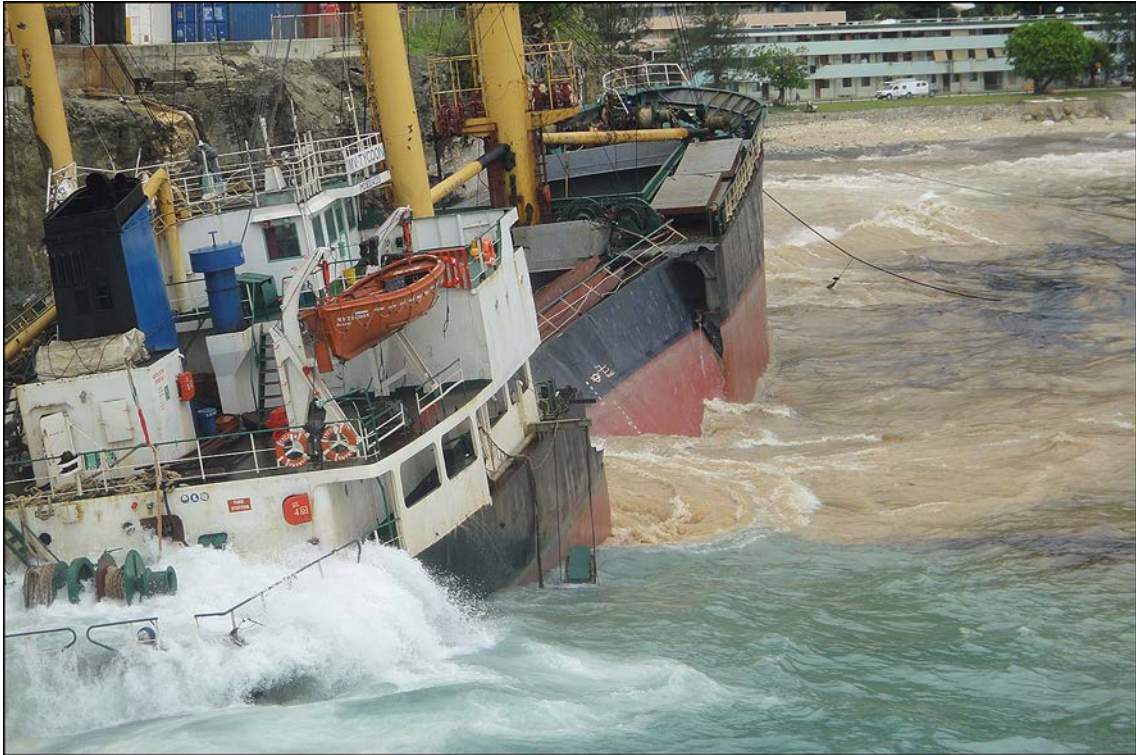
Figure 7: Failure of the ship's hull at number 2 hold

At about 1100 on 9 January, the ship suffered a catastrophic hull failure in way of number two hold. The starboard side of the hold collapsed inward exposing the contents of the hold to the sea (Figures 7 and 8). Damage to the hull in way of the engine room allowed oil and other pollutants to be washed into the sea.

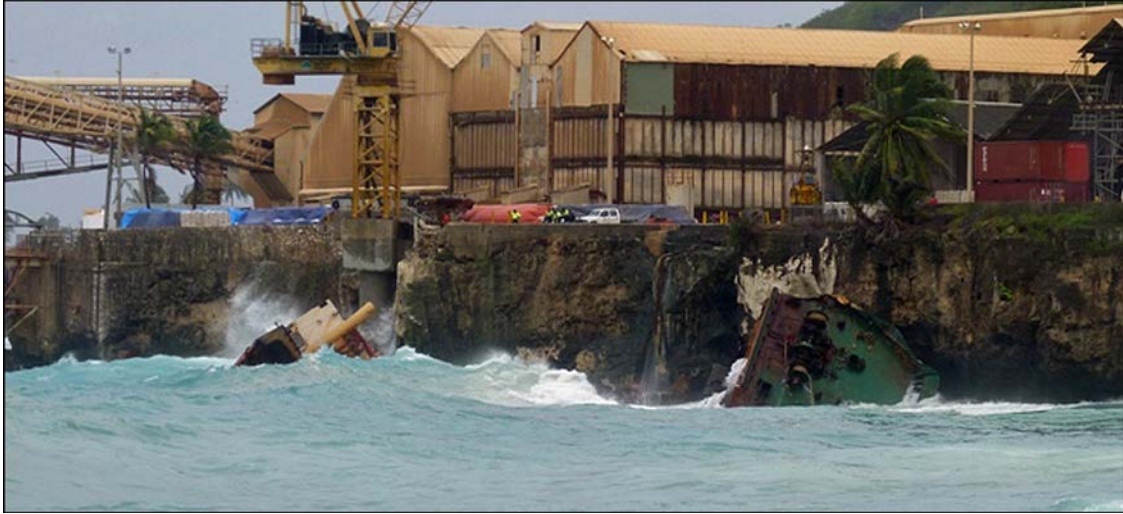
Figure 9: The wreck of *Tycoon* on 7 March 2012

Despite repeated attempts by AMSA over the next several months to negotiate with *Tycoon*'s owners to remove the wreck from Flying Fish Cove, it remained in situ with no salvors appointed. The ship continued to be pounded by the sea and swell and it broke up under the action of the waves (Figure 9).

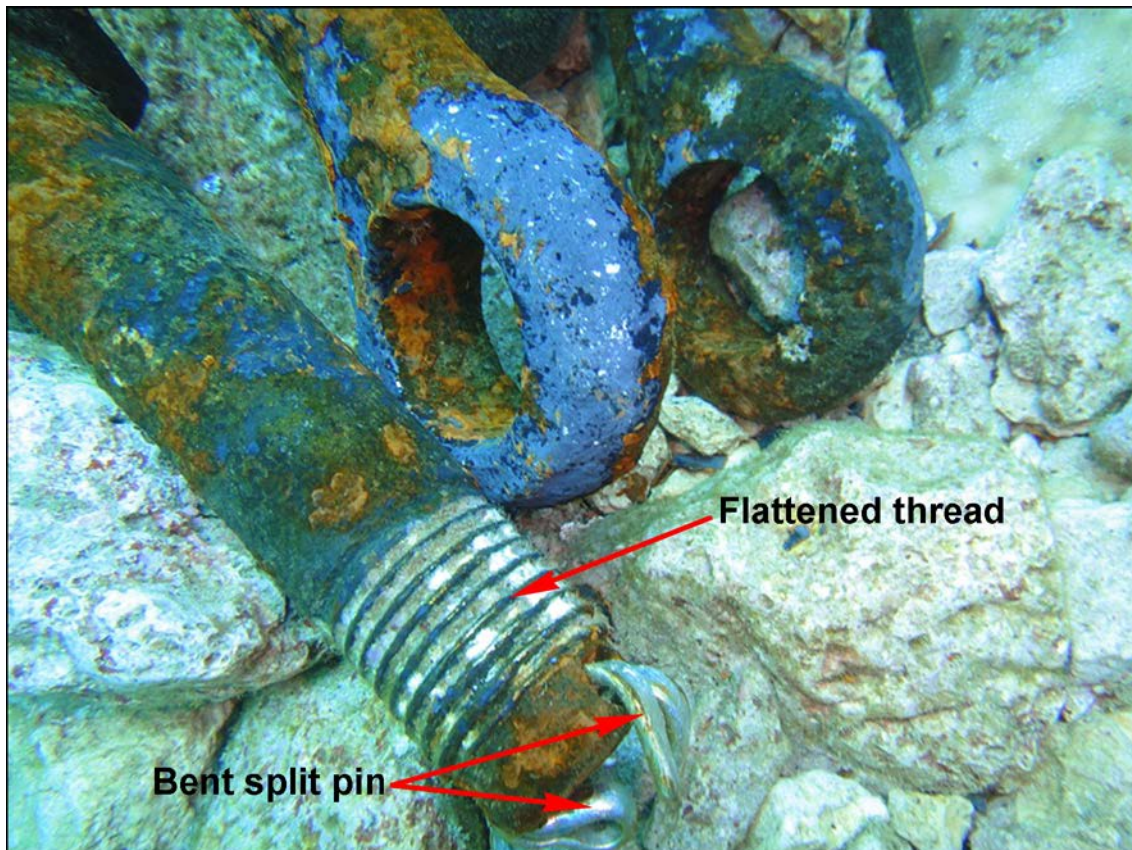
Figure 13: The cantilever line's underwater shackle and pin

The diver followed the cable from the anchor to the shackle that had secured the cable to the floating cantilever line and identified that the shackle pin retaining nut was missing and that the pin had worked its way out of the shackle (Figure 13).

Since the retaining nut could not be found, it was not possible to definitively conclude how it came off. However, it is likely that over time the nut loosened, allowing the pin to move laterally in the shackle. The shackle pin moving back and forth would have caused the nut to loosen further and would have slowly worn the shackle pin/nut threads. Eventually, the nut would have become completely unscrewed and it would have been sitting hard against the retaining split pin. Then, the lateral movement of the shackle pin would have started to exert a force on the split pin, eventually bending it. When the split pin was bent sufficiently to allow the retaining nut to come off, the shackle pin was free to work its way out of the shackle.

Therefore, on 8 January 2012, when the cantilever line shackle failed, it had been 18 months since the underwater components of the cantilever line had been inspected.

While the port operator staff thought that they had replaced the cantilever joining shackle with one of the newer upgraded design, they had no record that confirmed this and the underwater video footage taken on 16 January 2012 revealed that this was not the case.

In summary, the port operator did not have a complete set of records relating to the various components of the inner mooring system. Furthermore, having identified an issue with shackle pins coming loose, the port operator and its staff had not implemented a program of systematic replacement of all joining shackles with the newer more robust locking arrangement.

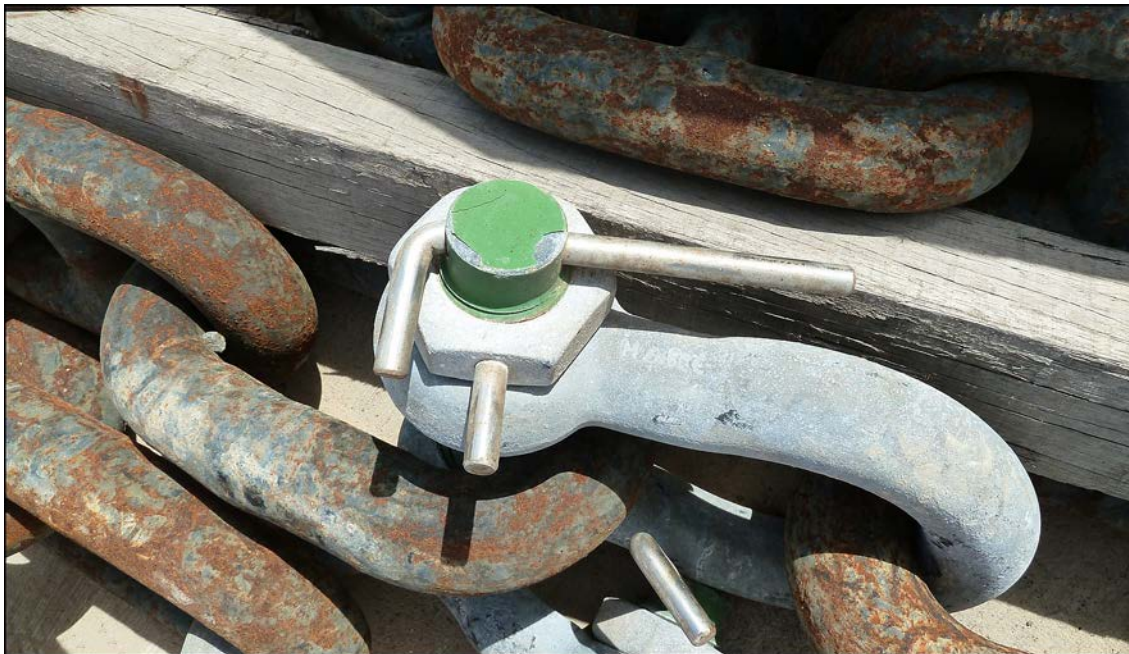
Figure 16: A new joining shackle with the improved 'locking pin' arrangement

The port operator's staff had identified that, in the prevailing conditions, simply putting a split pin through the shackle pin was not an effective way to prevent the nut from coming free. As a result, it was their practice during maintenance activities to replace these types of shackles with newer shackles which employed a much more robust locking arrangement to reduce the risk of the nut coming free (Figure 16).
