Loss of ground control involving a PZL-Mielec M18A Dromader, VH-TGY

7 km ESE of Brewarrina aerodrome (Rumleigh), NSW, 22 February 2013

ATSB Transport Safety Report
Aviation Occurrence Investigation
AO-2013-043
Final – 29 May 2013

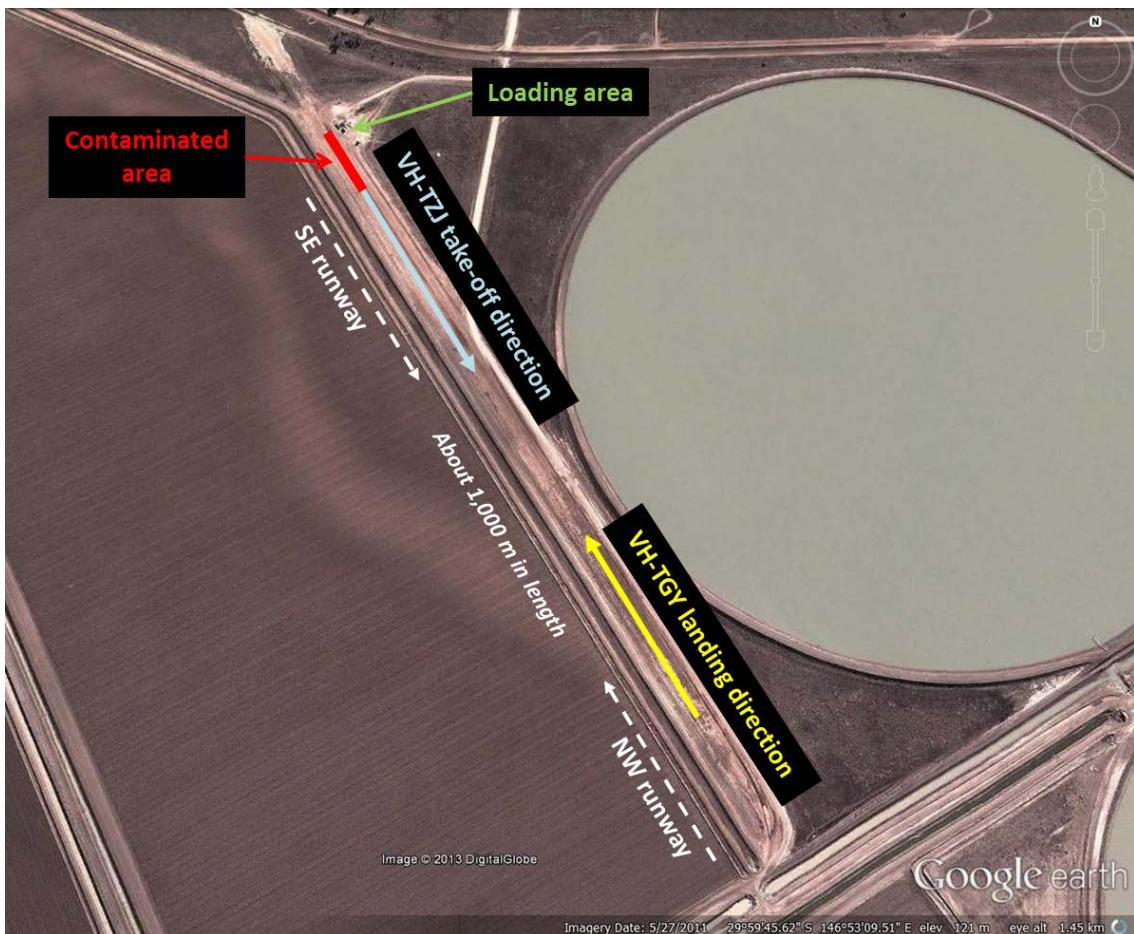
Figure 1: Rumleigh airstrip

Shortly after, TZJ landed at Rumleigh and was loaded with 2,700 L of water/chemical. As the take-off run on the south-eastern runway was commenced, TZJ's fire-bombing door³ unexpectedly released and the water/chemical load was jettisoned onto the ground, contaminating the runway (Figure 1).

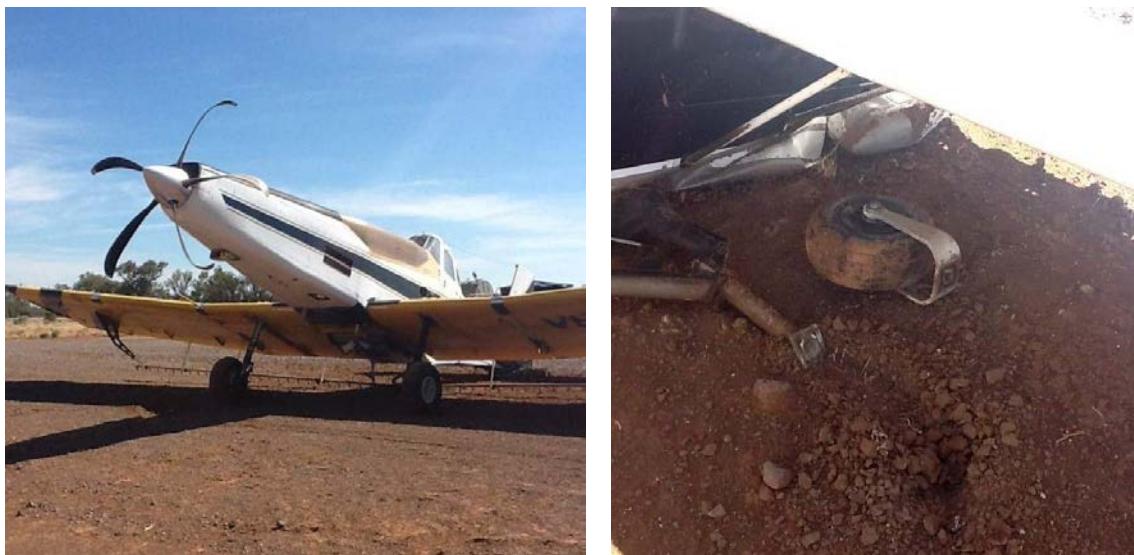
Figure 2: Damage to VH-TGY

When approaching the runway end at a reasonably slow speed, but faster than his normal taxi speed, the pilot of TGY suddenly observed mud spraying up from the aircraft's wheels. The aircraft then commenced sliding and turning to the left. When the left wheel contacted dry ground, the aircraft swung further left and tipped forward, resulting in the propeller contacting the ground. The aircraft then tipped backwards and the tail wheel assembly detached. TGY came to rest at 90° to the runway direction. The pilot of TGY exited and spoke to the mixers, who advised that the fire-bombing door in TZJ had malfunctioned and released the 2,700 L load, contaminating the runway. TGY sustained minor damage (Figure 2).

The contamination covered a 100-150 m area at the northern end of the runway. As the runway surface was dirt/clay, the water/chemical had soaked in and created a layer of mud. Consequently, the pilot of TZJ reported that, when he landed to re-load, he had difficulties sighting the contaminated area on the runway surface.

The aircraft operator reviewed the incident and believed that a reasonable amount of braking and reverse thrust was being applied when TGY contacted the contaminated area, subsequently resulting in a loss of ground control. The mixers reported to the ATSB that TGY's landing appeared normal and the aircraft's speed was not fast, as also reported by the pilot of TGY.

A reliable communications system can assist with improving the overall efficiency and safety of an operation. This incident highlights the impact ineffective two-way communications can have on aircraft operations, and in that case, the need to consider alternative means for warning pilots of potential ground hazards.
