# Collision on ground involving Cessna 150F, VH-ICE

21 km SW of Mittagong (ALA), NSW, 9 February 2013

**ATSB Transport Safety Report**  
Aviation Occurrence Investigation  
AO-2013-027  
Final – 29 May 2013

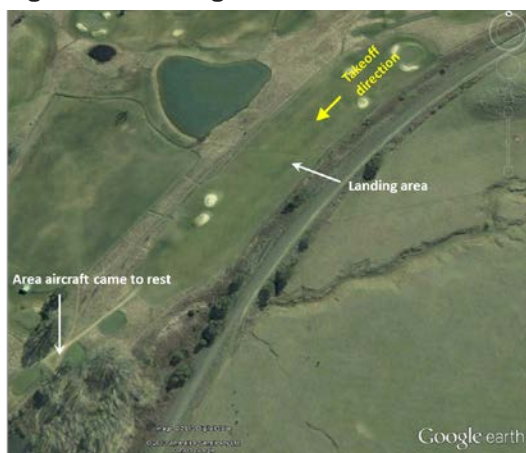
Figure 1: Landing area

After landing to the south, the pilot backtracked along the landing area<sup>3</sup> to conduct a short field take-off in the same direction (Figure 1).

An insurance assessor attended the accident site and reviewed the landing area. The landing area had a hard surface with short grass and 50 ft high trees at the southern end of the fairway. The assessor determined that the effective available take-off length of the landing area was 1,180 ft. Based on performance charts in the approved Cessna 150F owner's manual, the take-off distance required by the unmodified Cessna 150 F was 1,583 ft. There was no available performance data that took into account the installation of the 160 hp engine.

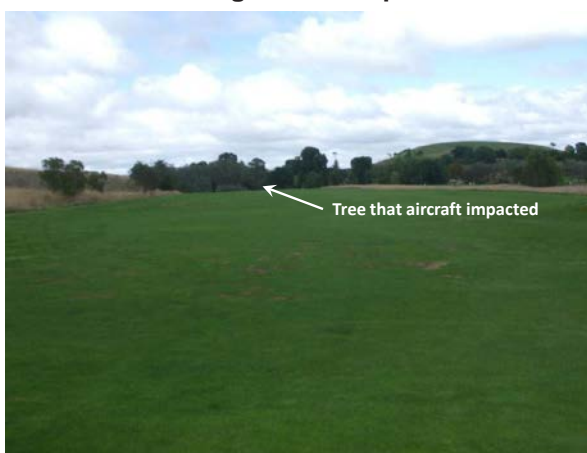
The pilot reported that the aircraft accelerated as normal, however during the take-off run he realised the aircraft would not clear the trees at the end of the landing area and elected to reject the take-off. The pilot reduced the power to idle and applied the brakes, however the remaining distance was insufficient and the left wing impacted a tree, the aircraft turned over and came to rest inverted. The pilot was uninjured and the aircraft sustained substantial damage (Figure 2).

View of the landing area from point of takeoff
