Landing on a closed runway involving a Cessna 310, VH-TWN

Corowa aerodrome, NSW, 20 February 2013

ATSB Transport Safety Report
Aviation Occurrence Investigation
AO-2013-036
Final – 29 May 2013

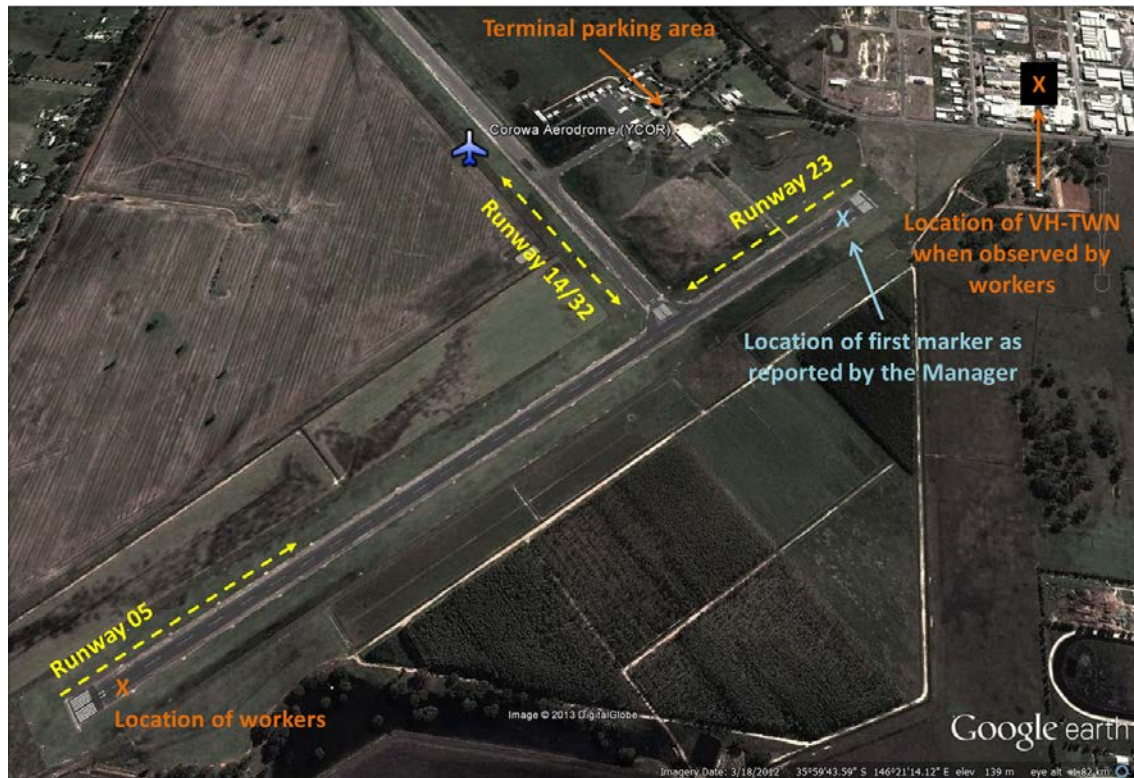
Figure 1: Position of VH-TWN and aerodrome workers

The workers at Corowa were in the process of placing the last unserviceability cross marker near the runway 05 threshold, when they observed an aircraft (TWN) on final approach for runway 23 (Figure 1). The workers vehicle, with its headlights and flashing safety light on, was also positioned on the runway facing the direction of TWN. The workers and vehicle vacated the runway.

At about 0825, TWN landed on runway 23. Immediately after landing, when about 90-120 m along the runway, the pilot observed an unserviceability cross marker on the ground. The aircraft was taxied to the parking area via runway 14/32, during which time the pilot checked the NOTAM for Corowa and noted that runway 05/23 was closed due to WIP.

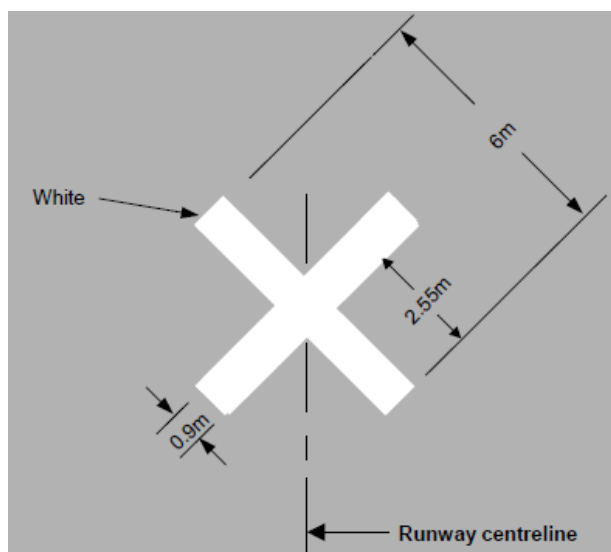
Figure 2: A ‘smaller’ unserviceability marking

According to MOS 139, the unserviceability marker used on runway 05/23 was considered a 'smaller' marking (Figure 2). These types of markings are to be displayed at each end of the unserviceability and in the intermediate area at intervals of no more than 200 m. The Aerodrome Manager reported that there was 10-11 unserviceability markers placed on the runway, with the first marker placed near the runway 23 number. Consequently, the spacing between each unserviceability marker was per the requirements of MOS 139.

The Aerodrome Manager also reported that each cross arm was 6 m long and 0.75 m wide. The crosses were made from white canvas and were nailed to the runway.
