# Runway incursion between a Cessna 206, VH-TOC, and an airport safety vehicle

Mount Isa Airport, Queensland, 24 February, 2013

**ATSB Transport Safety Report**  
Aviation Occurrence Investigation  
AO-2013-037  
Final – 29 May 2013

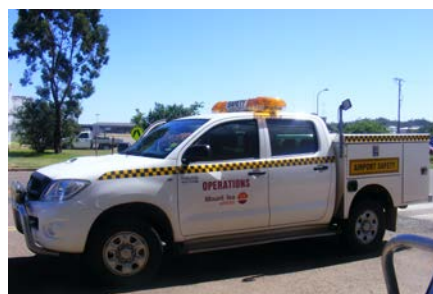
Vehicle with safety stickers

Mount Isa Airport Pty. Ltd. had planned to place yellow and black checkered safety stickers on the side and rear of the vehicle. As a result of this occurrence, that action was immediately implemented.

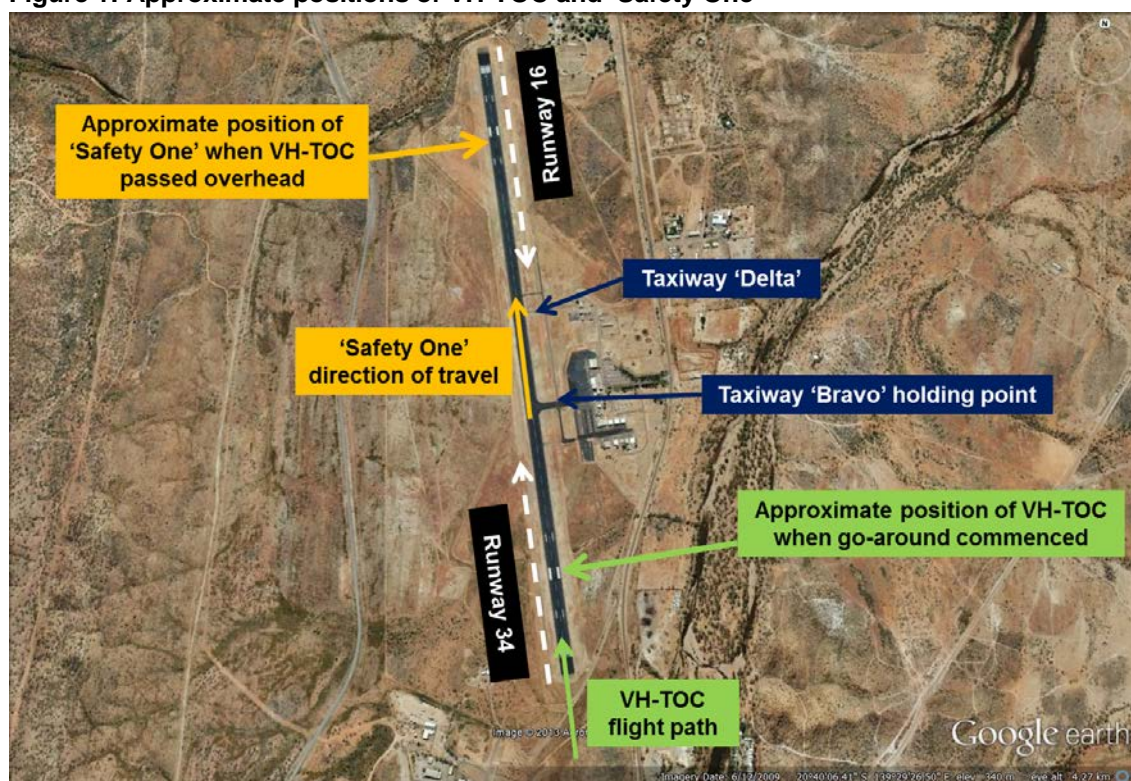
**Figure 1: Approximate positions of VH-TOC and 'Safety One'**

When at the taxiway 'Bravo' holding point (Figure 1), the ASO broadcast a call on the Mount Isa common traffic advisory frequency (CTAF) advising that the vehicle was entering the runway; no response was received. The ASO conducted a lookout for aircraft operating within the vicinity, and with none sighted, the inspection was commenced. The vehicle was driven to the runway 34 threshold and then towards the runway 16 threshold at a speed of about 40 km/hr.

At the same time, when on the base leg of the circuit for runway 34, the pilot of TOC observed a vehicle near the runway 34 threshold. He assumed the ASO was conducting a bird inspection and would exit the runway at taxiway 'Bravo', leaving the runway clear for him to land. The pilot continued to transmit his intentions blind.

When on final approach, the pilot configured the aircraft for landing, aiming to touchdown about 300 m beyond the threshold. As he commenced the flare,<sup>7</sup> he noticed that the vehicle had not yet vacated the runway and was travelling in a northerly direction towards the runway 16 threshold. At this time, the vehicle was between taxiways 'Bravo' and 'Delta'. As a result of the vehicle being on the runway, the pilot initiated a go-around.<sup>8</sup>
