Collision on runway between a Grob G103 Twin Astir glider, VH-UIZ and a Cessna 150F, VH-ROZ

Tocumwal Aerodrome, NSW on 9 March 2013

ATSB Transport Safety Report
Aviation Occurrence Investigation
AO-2013-048
Final – 29 May 2013

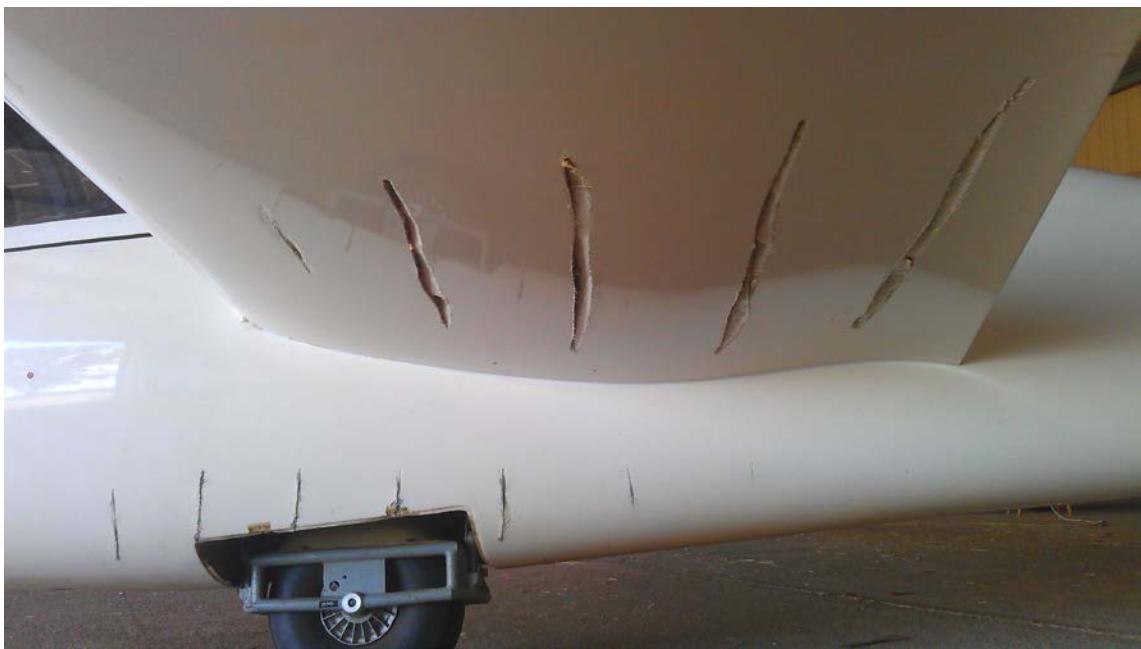
Figure 1: Damage to VH-UIZ

The pilot of UIZ was uninjured and landed the glider well down the runway. Although UIZ was fitted with a FLARM² collision warning system, no alarm was triggered, as the tug aircraft was not fitted with a similar FLARM system. On exiting the glider, the pilot observed damage on the left wing and fuselage. However, he was not aware that he had landed on the tug aircraft until club personnel arrived in an airfield vehicle.

Both gliding clubs operated under the rules and procedures proscribed by the Gliding Federation of Australia (GFA). The investigation conducted by the GFA determined that glider and tug landed together with the glider on top. Propeller strikes caused damage to the underside of the glider's left wing and along the fuselage near the main landing wheel (Figure 1). There was no damage to the C150.
