# Take-off without runway lighting involving, Airbus A320, VH-JQG

Hobart Airport, 14 December 2012

**ATSB Transport Safety Report**

AO-2012-171

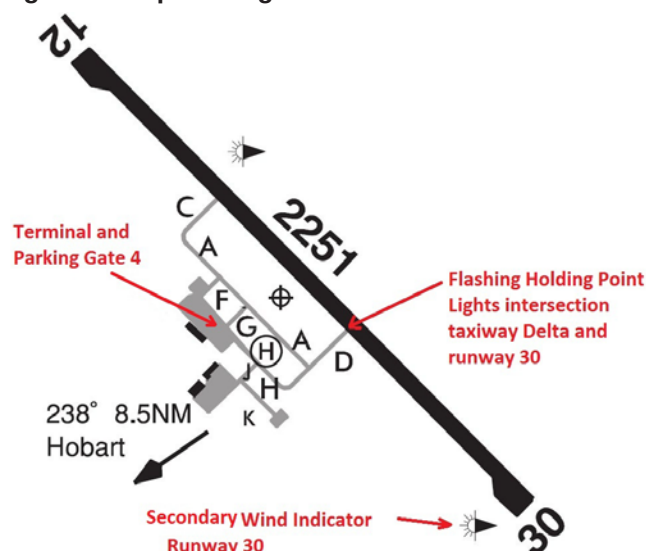
Figure 1: Airport Diagram

On departure, the crew taxied via taxiways Golf (G), Alpha (A) and Delta (D) for runway 30 (Figure 1). At the intersection of taxiway Delta (D) and runway 30 there were alternating flashing holding point lights. The Captain reported that the flashing holding point lights confirmed in his mind that the runway lights were on.
