Collision with terrain involving Cessna 150, VH-UWR

55 km north-east of Bourke, New South Wales | 29 April 2012

ATSB Transport Safety Report

AO-2012-059

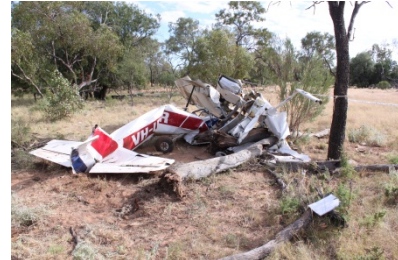
VH-UWR accident site

While manoeuvring at low level the pilot inadvertently allowed the aircraft to aerodynamically stall, resulting in a high rate of descent and collision with terrain. There was insufficient information about pilot control inputs to establish the factors that precipitated the stall.

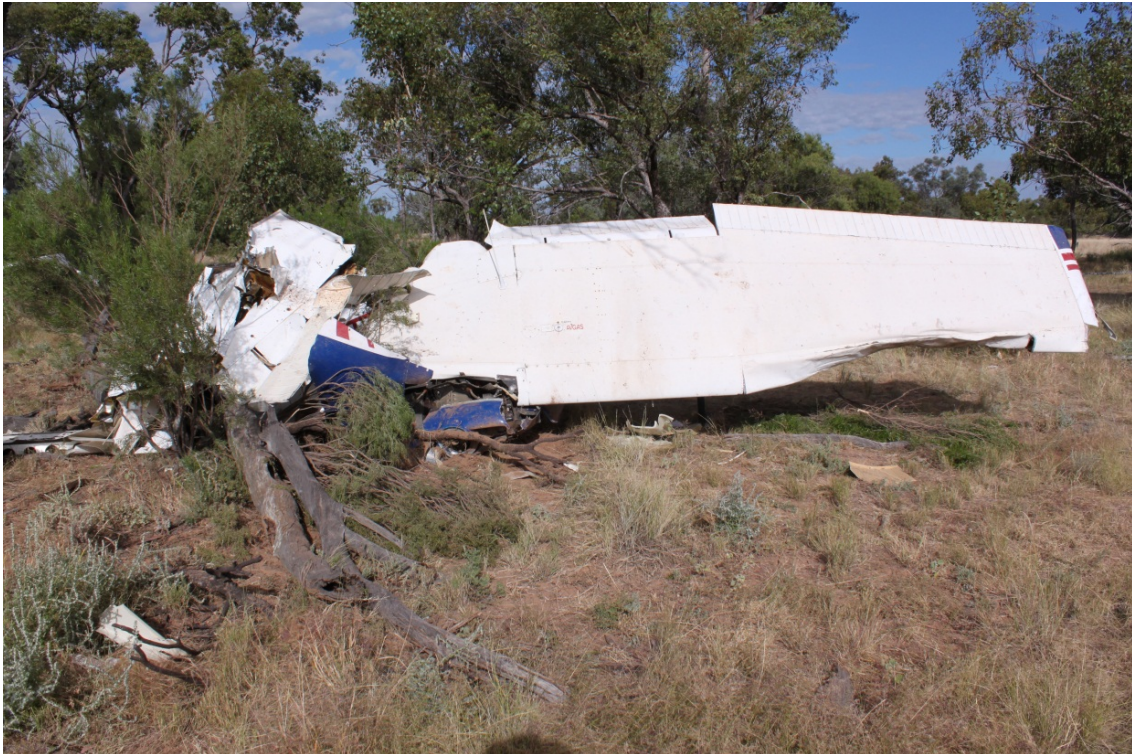
Figure 2: Aircraft wreckage from the front (after some disturbance)

The aircraft was seriously damaged and the pilot sustained fatal injuries.

Prior to impacting the ground, the aircraft's left wing tip made contact with a small tree about 3.5 m above the ground followed by the right wing impacting and becoming severely disrupted by a large tree a short distance later. Damage to the leading edge of the left wing and the propeller spinner were consistent with the aircraft impacting the ground at a very steep, nose-down attitude.

Examination of the wreckage, including the aircraft structure, flight controls, engine and propeller did not detect any pre-impact defects or anomalies. Damage to the propeller was consistent with engine power being applied at impact. The stall warning device was checked and it responded appropriately with an audible tone.

The wing flap actuating mechanism was in the flap-retracted position and the elevator trim was in the neutral position. The carburettor heat control was found in the fully-forward, OFF position.
