Wheels up landing involving Cessna 210M, VH-PBV

Broome Airport, Western Australia, 23 February 2013

ATSB Transport Safety Report
Aviation Occurrence Investigation
AO-2013-039
Final – 28 June 2013

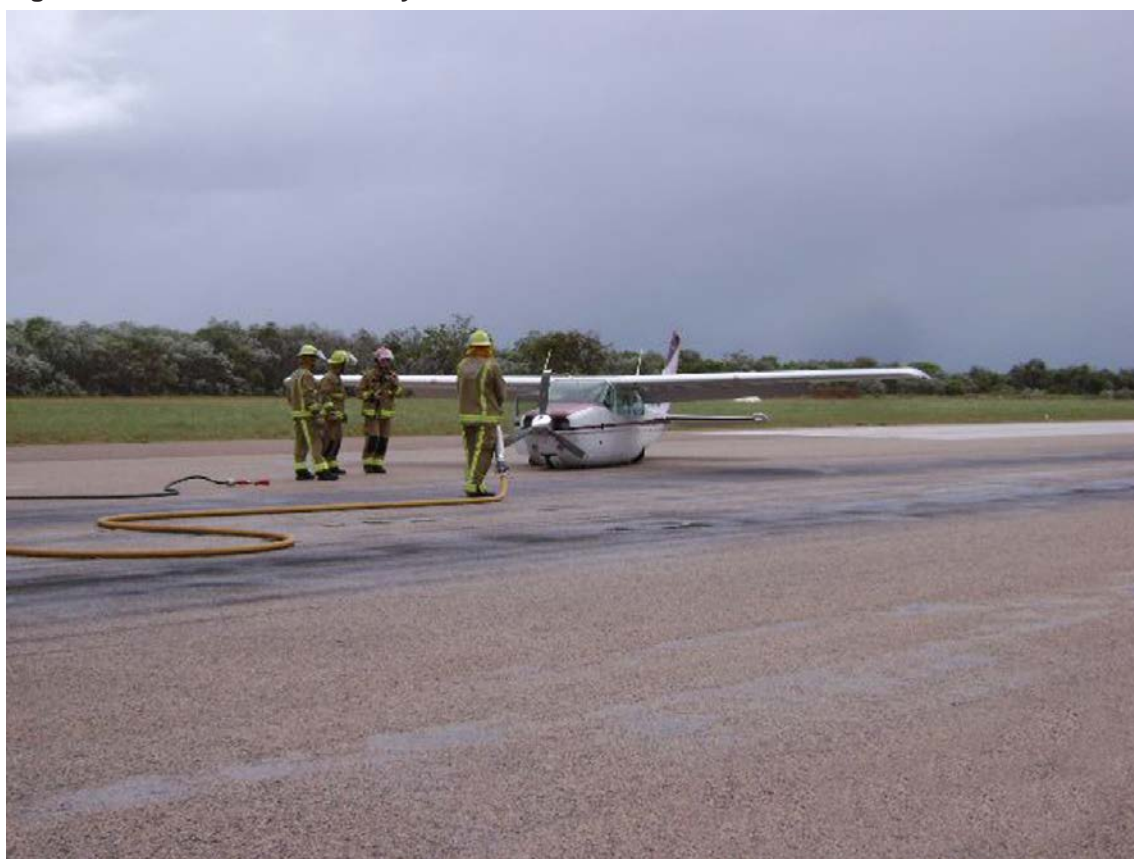
Figure 1: VH-PBV on the runway

Shortly before landing, at about 1410 Western Standard Time,¹ the pilot completed his final checks, but did not look out the window to visually check that the landing gear was down. However, he reported he did observe a green light, indicating that the landing gear was down and locked. To compensate for the crosswind, the pilot operated the aircraft at a slightly higher throttle setting, until flaring to land. PBV then landed on the runway with the landing gear retracted and skidded about 300 to 350 m down the runway on the underbelly (Figure 1). The controller activated the airfield emergency response.

Following the accident, an assessment conducted by an insurance assessor found that the pilot did not extend the landing gear prior to landing. The assessor noted that the micro switch that activated the landing gear warning horn was set for a throttle setting lower than that used by the pilot during the landing.

Bad weather and changed plans can distract attention away from a pilot's primary function – to safely fly the aircraft. However, the failure of the gear warning horn to activate removed a defence against landing with the landing gear retracted.
