# Collision with terrain involving Grob G-115, VH-ZTM

Jandakot Airport, 15 March 2013

**ATSB Transport Safety Report**  
Aviation Occurrence Investigation  
AO-2013-052  
Final – 28 June 2013

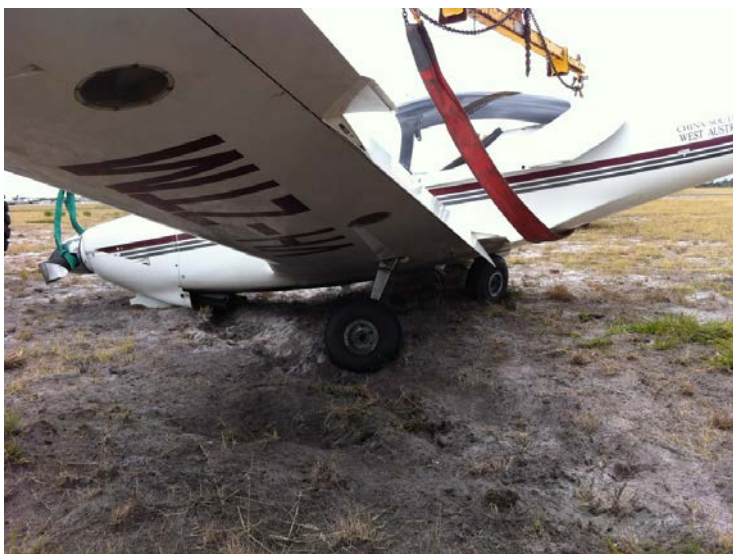
Figure 1: Aircraft damage

At 1135 Western Standard Time,<sup>1</sup> on the student's third solo circuit to runway 06R, ZTM began to drift to the left of the runway centreline. The student elected to go-around and applied full power. Following the application of power, the nose pitched up abruptly and the aircraft then rolled to the left before pitching nose down. The left wing tip contacted the ground and the nose gear and right main gear collapsed before the aircraft came to a stop. The student pilot was able to exit the aircraft without injury, however the aircraft sustained substantial damage.

The aircraft was reported to be in the landing configuration, with landing trim selected together with full flaps which is consistent with photographs taken shortly after the accident. The pitch up together with the reported roll and yaw is consistent with the application of full power, without adequate corrective control inputs being made to correct for the change in power setting. The rapid pitch down is consistent with one or both wings stalling.<sup>2</sup>

- Increased emphasis on Stabilised Approach Criteria to be made during pre-flight briefings.
- Instructor training and standardisation to include more emphasis on the essential use of rudder.
- Inclusion on the training syllabus of an upper air exercise prior to first solo, to check student use of rudder and go-around procedures.
- A more detailed brief on landing technique, for the G115C, to be included in the standard operating procedures.
