# Landing gear separation involving Piper PA28, VH-JXR

Mangalore Airport, Victoria, 7 January 2013

**ATSB Transport Safety Report**

AO-2013-007

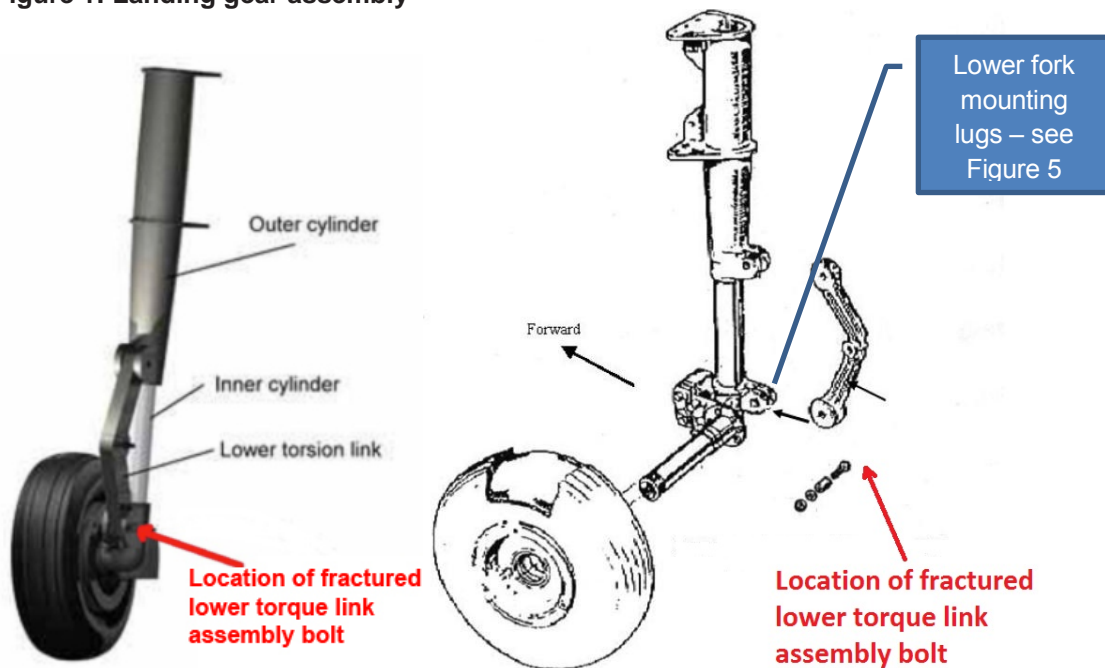
Figure 1: Landing gear assembly

An instructor on the ground watched the aircraft depart and observed an object trailing behind the aircraft. The instructor advised the student via the radio and instructed the student to return and perform a low-level pass so that they could ascertain what the object was. Following the low-level pass, the right main wheel and inner cylinder of the landing gear assembly were observed to have detached from the upper cylinder and to be hanging off the brake line (Figure 1). After a second low-level pass, it was observed that the wheel had completely detached.

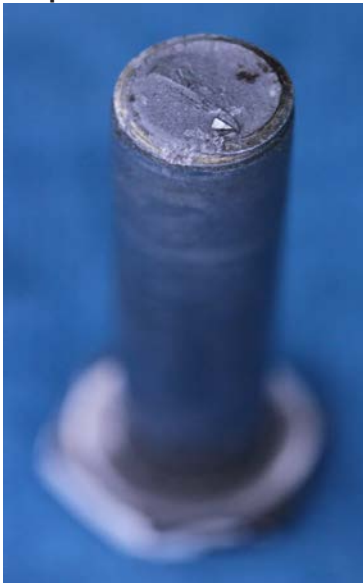
**Figure 2: Failed lower torque link attachment bolt**

The right landing gear assembly and lower torque link bolt were subsequently located and forwarded to the ATSB for examination. The examination of the right landing gear assembly revealed that the lower torque link attachment bolt (Figure 2) had fractured through the final thread. This fracture had allowed the inner cylinder to become detached from the torque link<sup>2</sup> and to fall from the outer cylinder when the aircraft became airborne.

Since this incident, the aircraft operator has undertaken to replace all torque link attachment bolts during the next scheduled maintenance on any Piper PA-28 aircraft they operate.

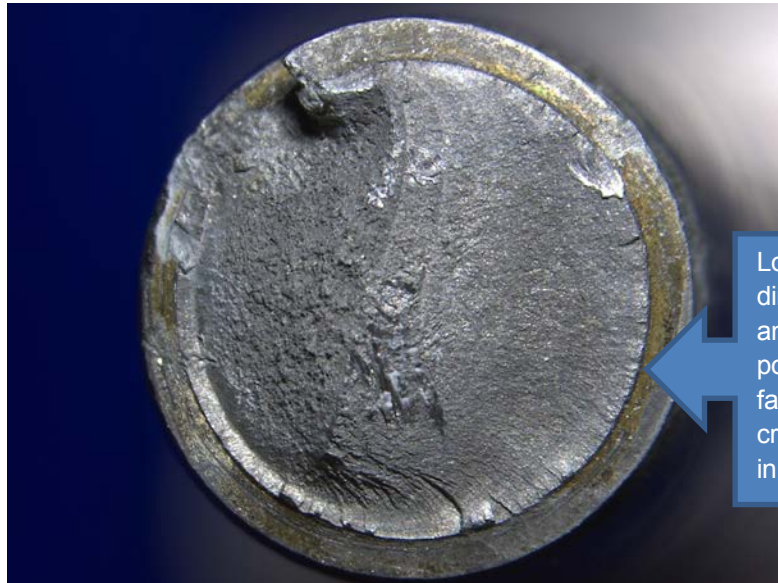
**Figure 3: Bolt fracture surface**

The examination indicated that the failure of the bolt was due to single-point bending fatigue due to asymmetrical loading (bending from one side) (Figure 3).

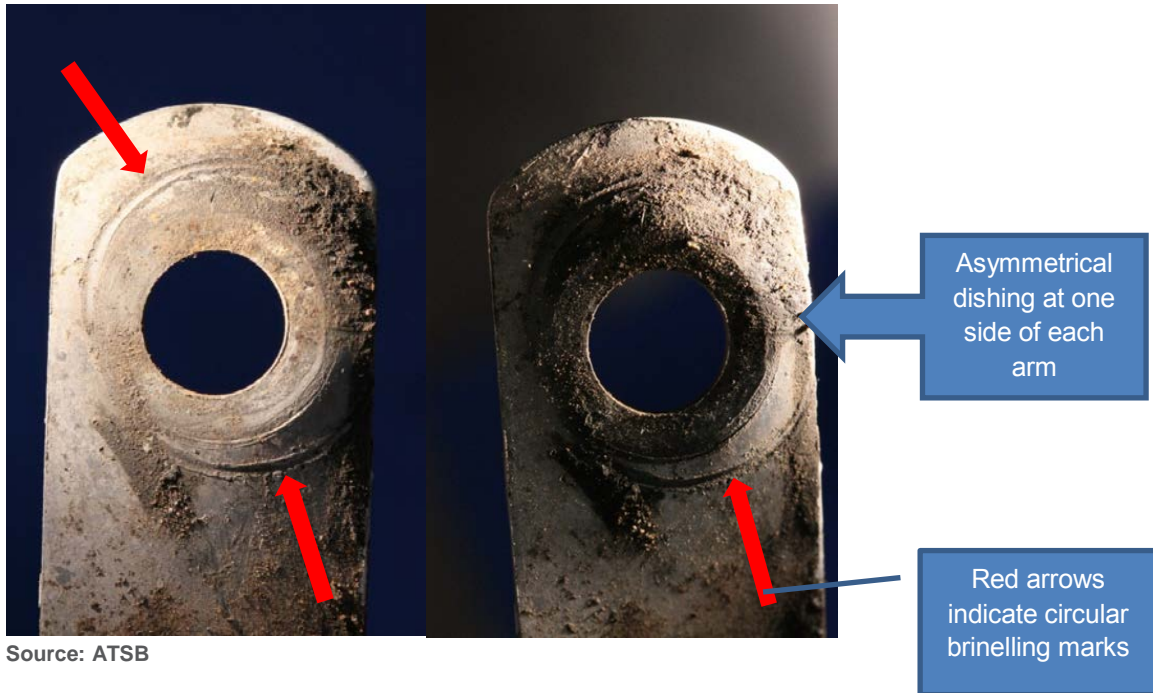
**Figure 4: Inside surfaces at each end of brake hose support bracket**

The mating, U-shaped, brake hose support bracket was mounted on to the lower fork lugs. There were circular brinelling<sup>3</sup> marks and flat-bottomed dishing<sup>4</sup> of both arms of the bracket. However, the dishing depth of the arms was not uniform, being deeper on the forward side of each bracket arm. This indicated an asymmetric loading state (Figure 4). Examination of the lower-fork mounting lugs showed that they were tapered and had been spot faced to accommodate the square faces of the torque link bolt and mating nut. The tapering of the mounting lugs resulted in a variable depth of the spot-faced area and was a source of asymmetry if the bracket was directly attached to them (Figure 5). The circular brinelling marks resulted from heavy contact with the corner shoulder of these spot-faced areas.

There was a witness mark on the bracket, indicating the presence of a washer-like component at some point in time. However, the examination concluded that the specified washer thicknesses were insufficient to prevent an asymmetrical loading state being present.
