Descent below minimum safe altitude involving Boeing 737, VH-TJS

21 km south of Canberra Airport, Australian Capital Territory | 12 February 2012

ATSB Transport Safety Report
Aviation Occurrence Investigation
AO-2012-040
Final – 5 July 2013

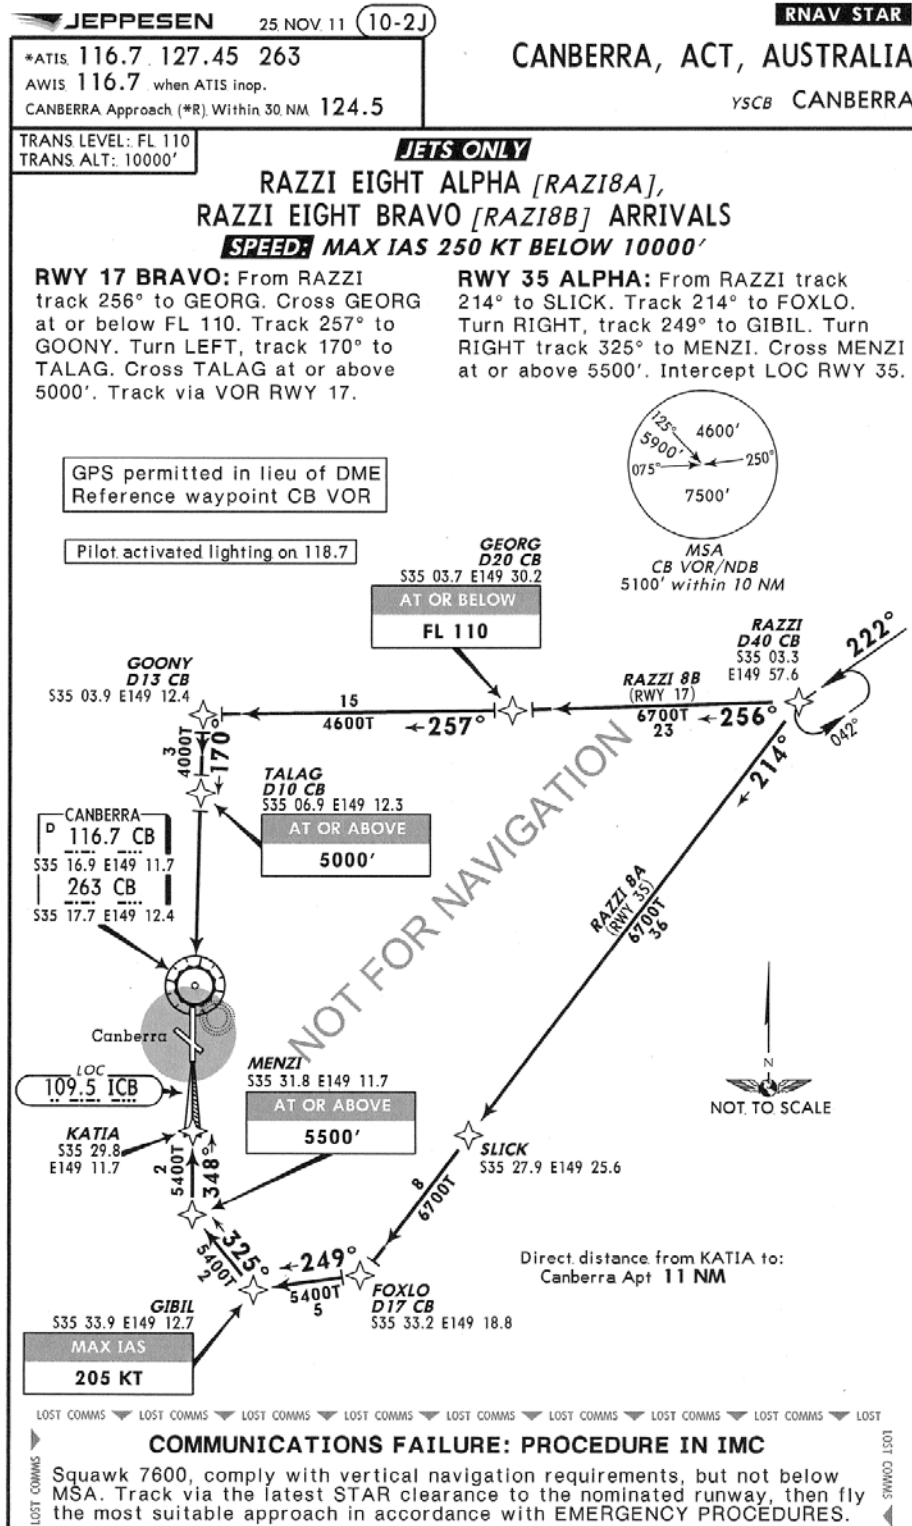
Appendix A – Canberra RAZZI EIGHT ALPHA arrival

While en route, air traffic control cleared the crew to conduct the Razzi Eight Alpha arrival procedure (Appendix A), with the expectation of a VOR Runway 35 approach. The captain reported that he and the first officer were tired after the busy day and that the possible implications for the approach were discussed as part of the approach brief.

The Canberra Airport weather information available to the crew reported wind from the east at 15 kt (28 km/h), rain showers in the area, layers of scattered³ cloud at 1,800 ft, 2,500 ft and 3,500 ft, and visibility greater than 10 km. The crew reported that visual meteorological conditions existed below layers of cloud and that they were visual with Canberra from about waypoint FOXLO (Appendix A).

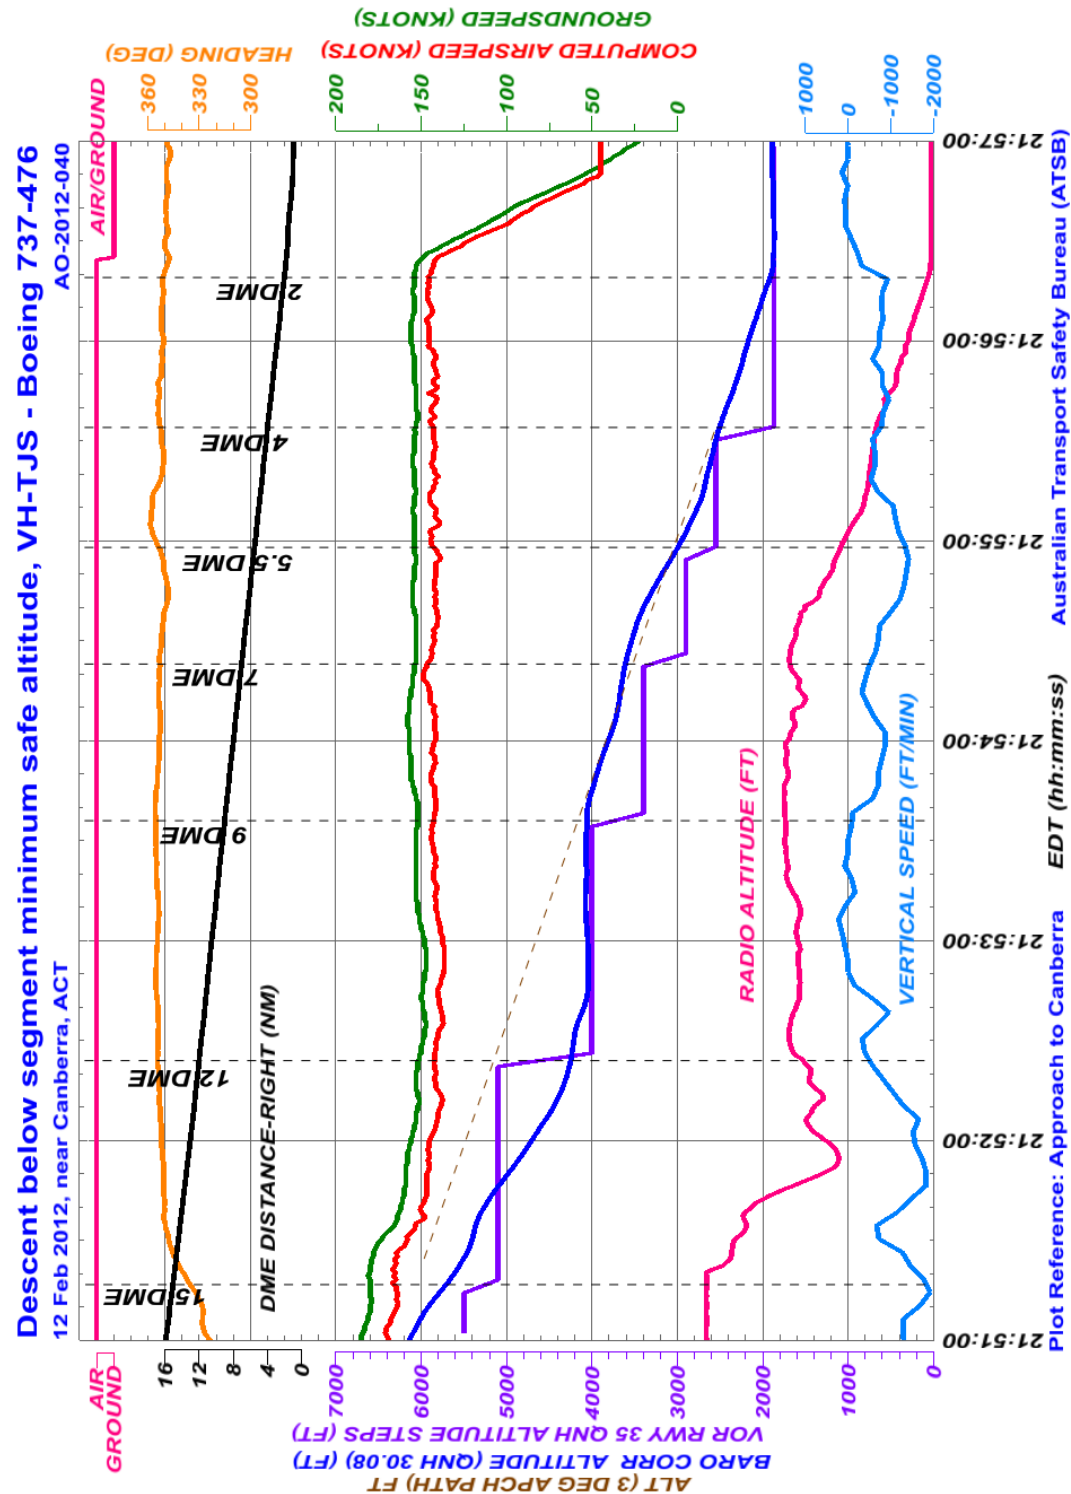
Appendix C – Selected parameters from the quick access recorder

segment toward MENZI, the effect of the tailwind was reduced. Recorded data showed that the rate of descent during that segment increased to about 1,600 ft/min (Appendix C).
