In-flight uncontained engine failure Airbus A380-842, VH-OQA

overhead Batam Island, Indonesia | 4 November 2010

ATSB Transport Safety Report
Aviation Occurrence Investigation
AO-2010-089
Final – 27 June 2013

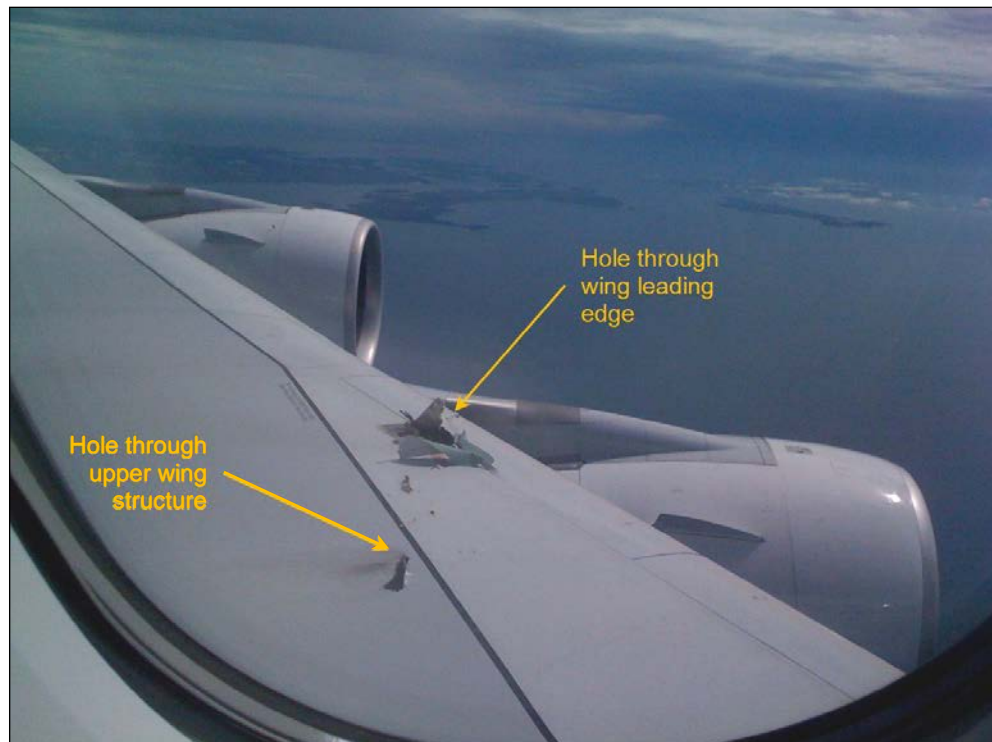
Figure 7: Examples of damage to the left wing

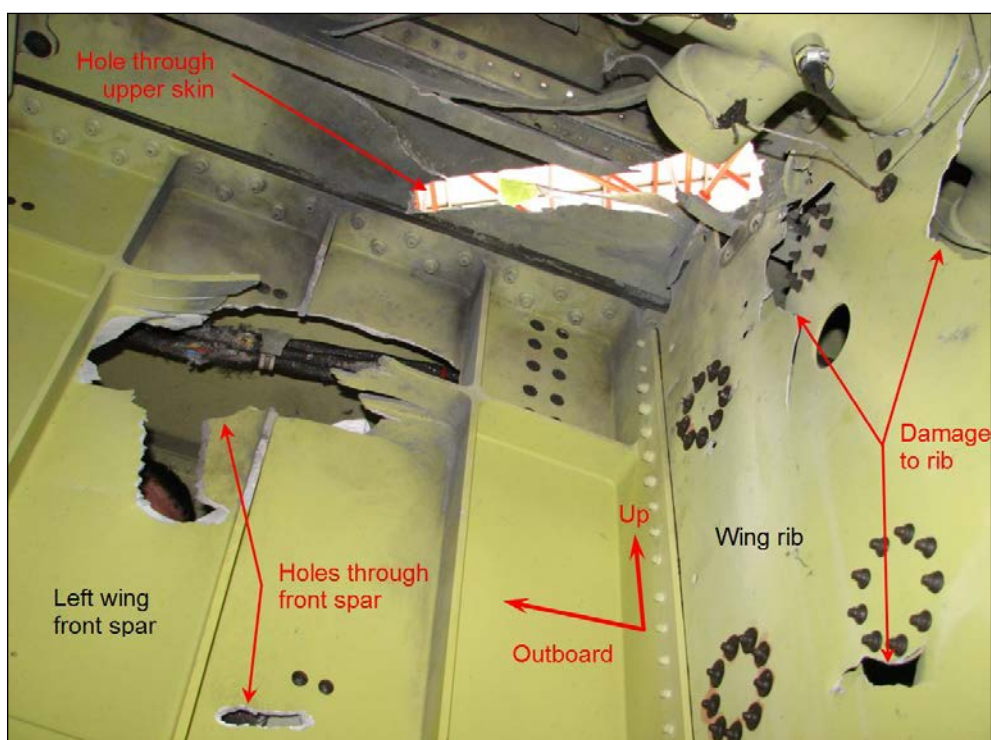
Figure 8: Example of internal damage to the left wing (looking forward and up)

In addition to the damage to the primary structure, the left wing lower skin, fuselage skins and vertical and horizontal stabilisers contained numerous indentations and score marks from debris impacts. Further information on the airframe damage is contained in Appendix B.

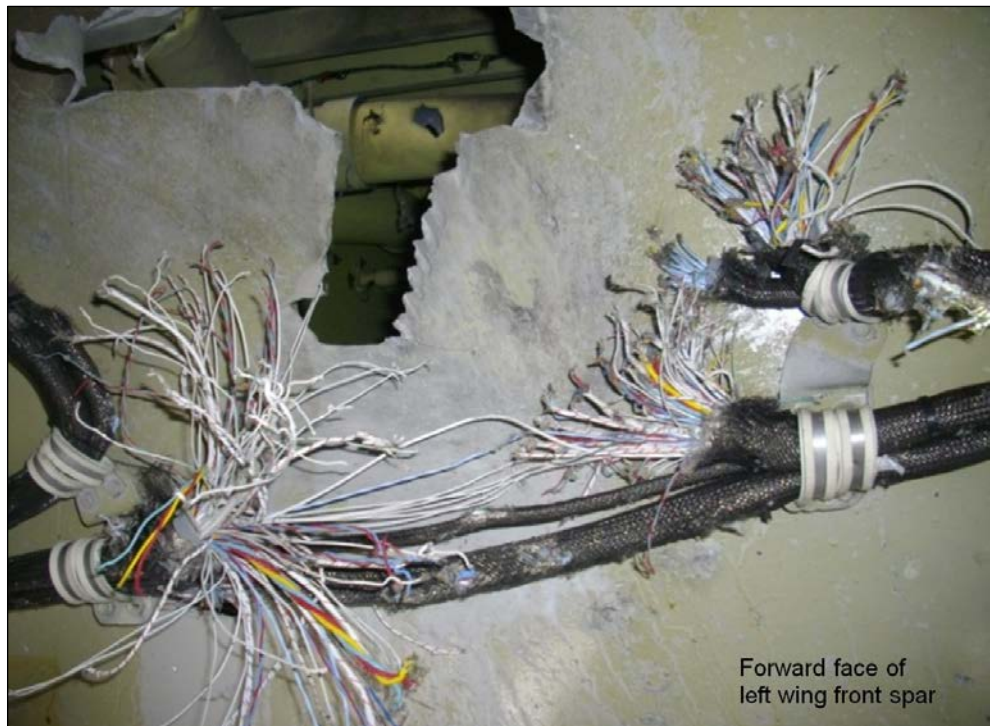
Figure 9: Example of wiring damage in the left wing (looking rearwards)

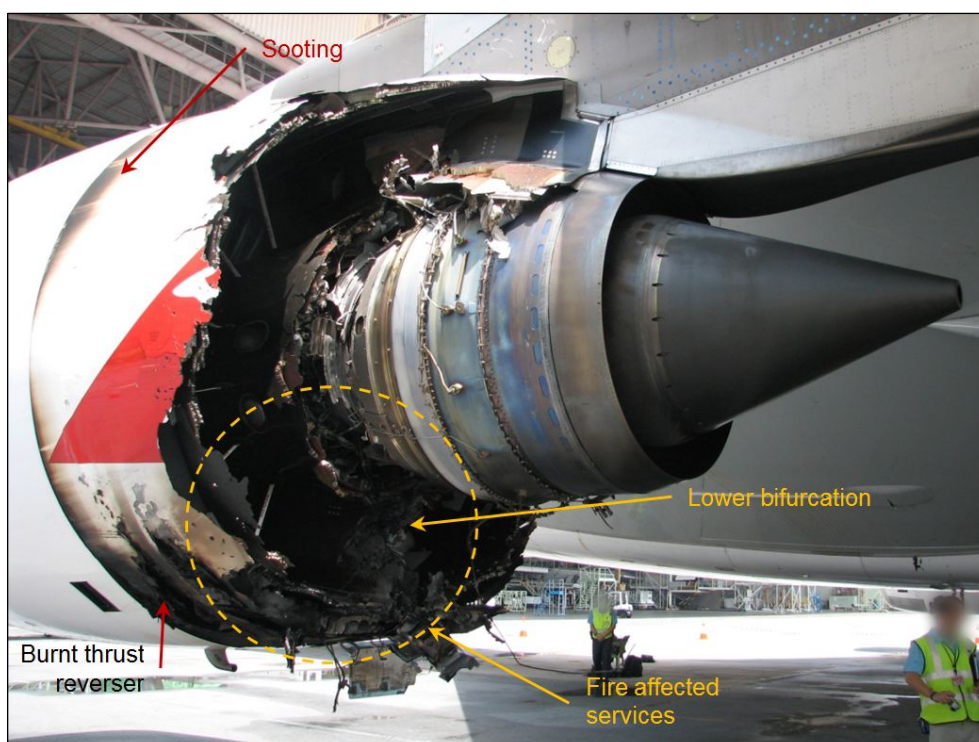
Figure 16: No. 2 engine showing fire damage to the lower left engine nacelle

Initial on-site inspection identified that the fire was most intense in the lower left thrust reverser section and in the lower bifurcation¹³ (Figure 17 and 18). Sooting, glazing and the effects of heat were observed on a number of electrical, air, oil and hydraulic supply lines and the nacelle anti-ice bleed air ducts within the core section, lower bifurcation and accessories section (on the fan casing). A significant amount of oil was smeared on the lower panel of the thrust reverser cowl (Figure 18).

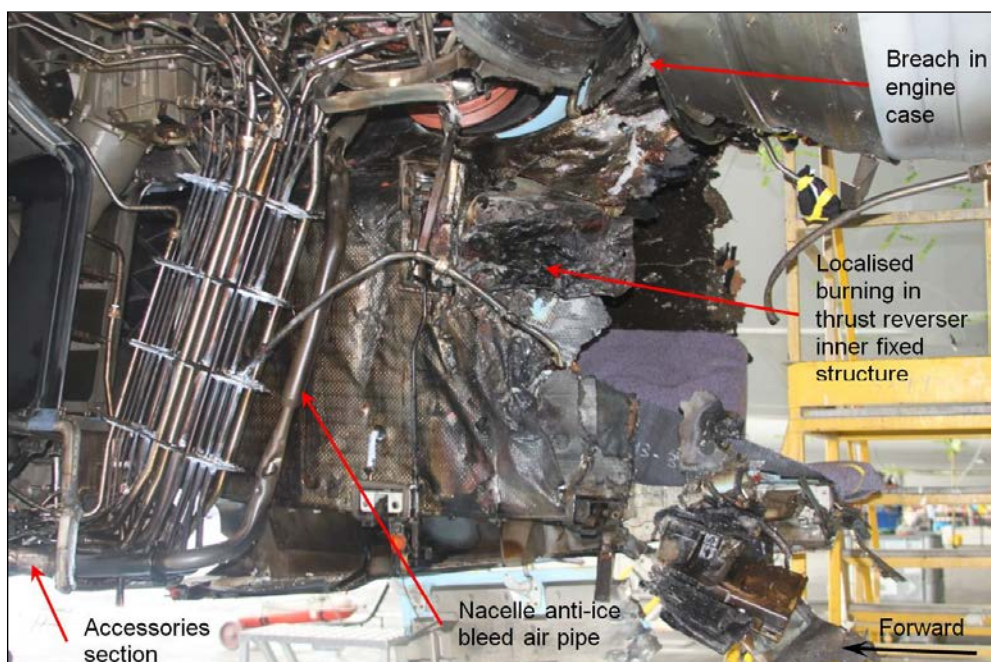
Figure 17: Example of fire damage in lower the bifurcation (looking to the forward and right of the No. 2 engine)

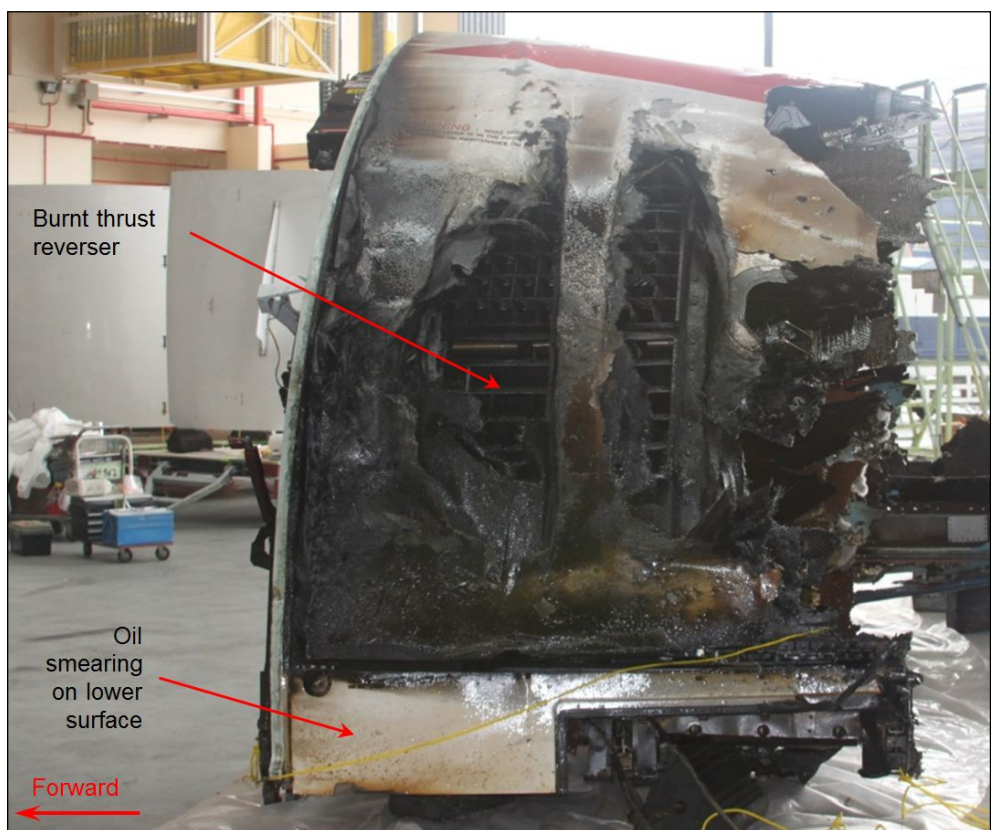
Figure 18: Left thrust reverser section (looking at the lower surface of the engine)

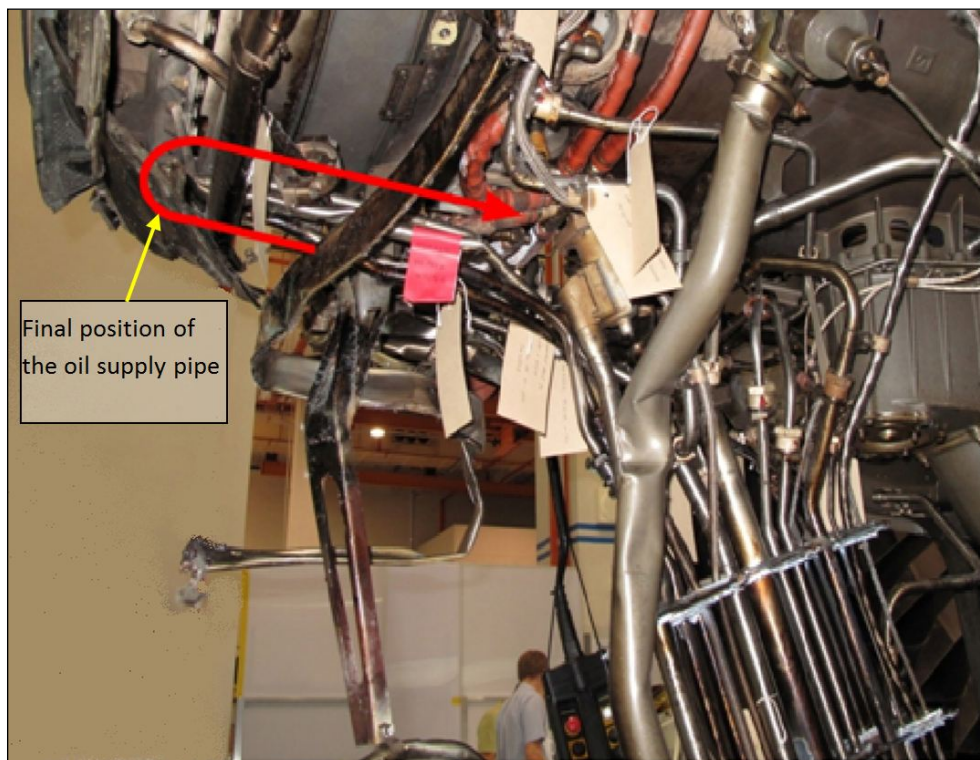
During the subsequent engine inspection, it was noted that an oil supply pipe to the HP/IP and low pressure (LP) turbine bearings that was located within the lower bifurcation had been severed and was kinked forward (Figure 19). That damage was

Figure 19: Representation of the position of the oil supply pipe to the HP/IP and LP turbine bearing chambers (severed and bent forwards during the engine failure sequence)

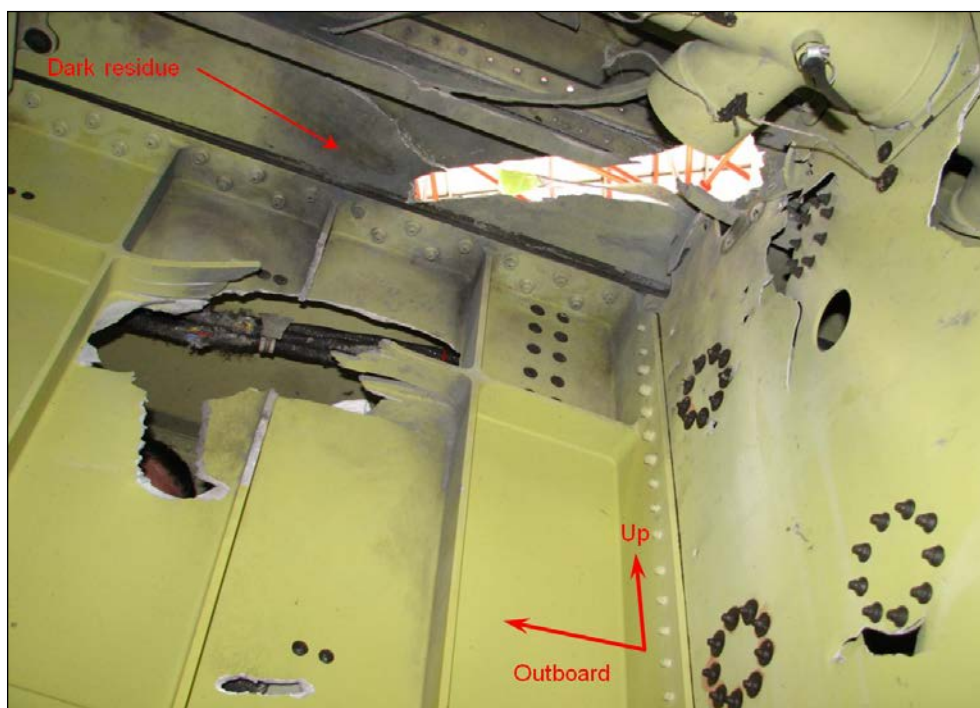
Figure 23: Dark residue in left inner wing fuel tank (looking up and forward)

The ATSB conducted a detailed inspection of the left inner fuel tank region to identify potential sources of ignition. The surface temperature of the turbine disc fragment and the frictional effects associated with the passage of the fragment would have been sufficient to ignite the fuel vapour within the tank volume. No other potential sources of ignition were identified as being sufficient to have initiated the fire.

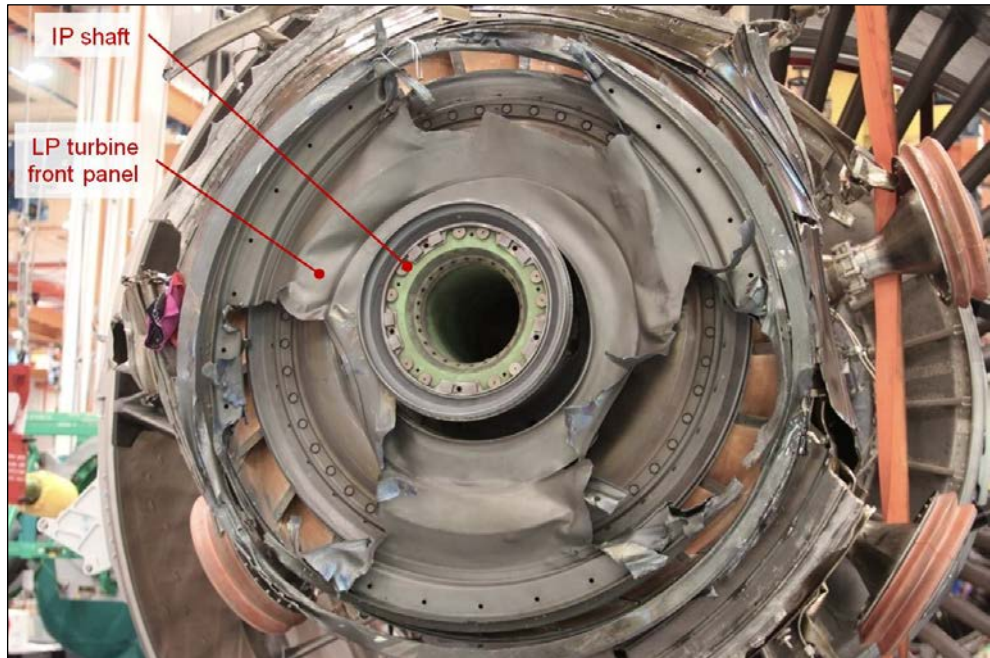
Figure 33: LP turbine front panel damage

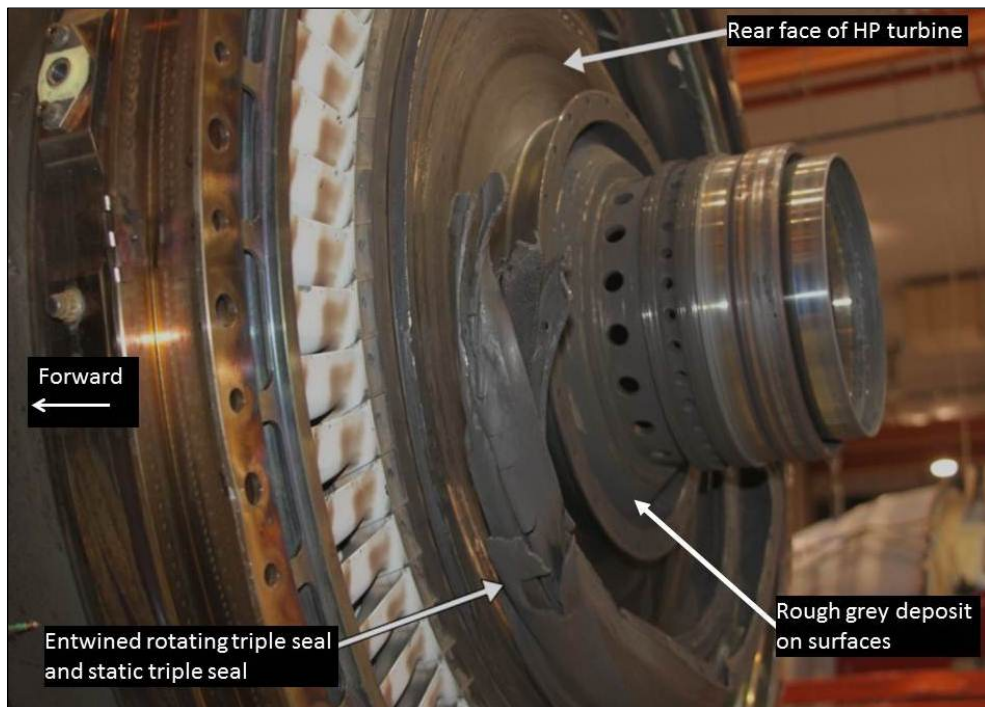
Figure 35: Damage between the HP/IP structure and HP turbine

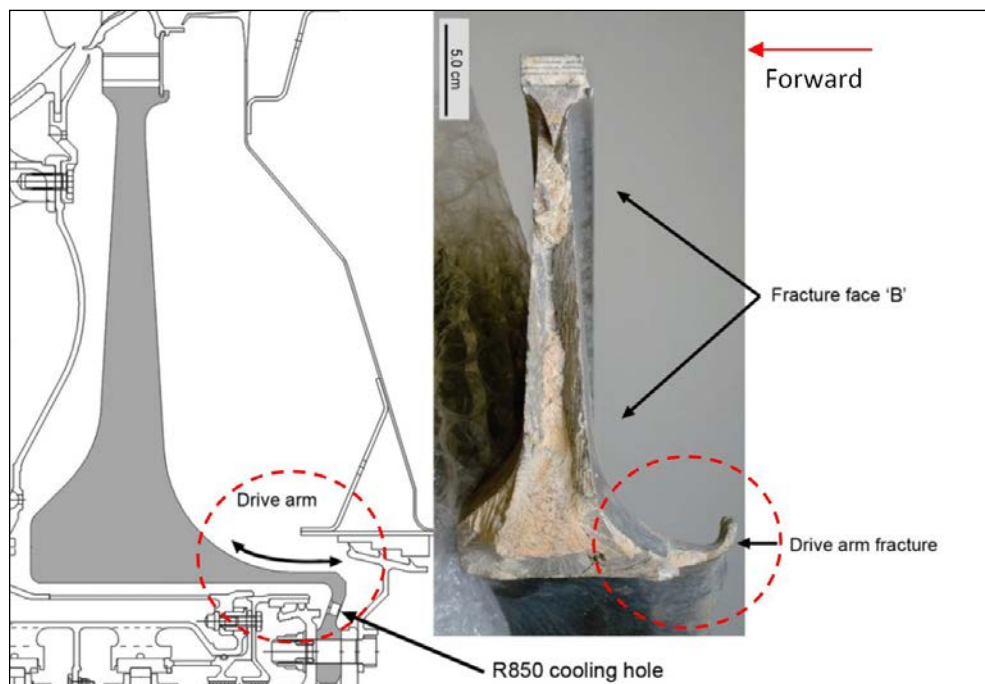
Figure 39: Comparison of a diagrammatic representation of the IP turbine disc with the recovered segment of the disc

The disc segment exhibited a significant amount of overall deformation. There was an average radial growth of about 19 mm and the blade restraint (firtree) slots had opened by 0.3 to 0.4 mm when compared to the manufacturer's specifications.

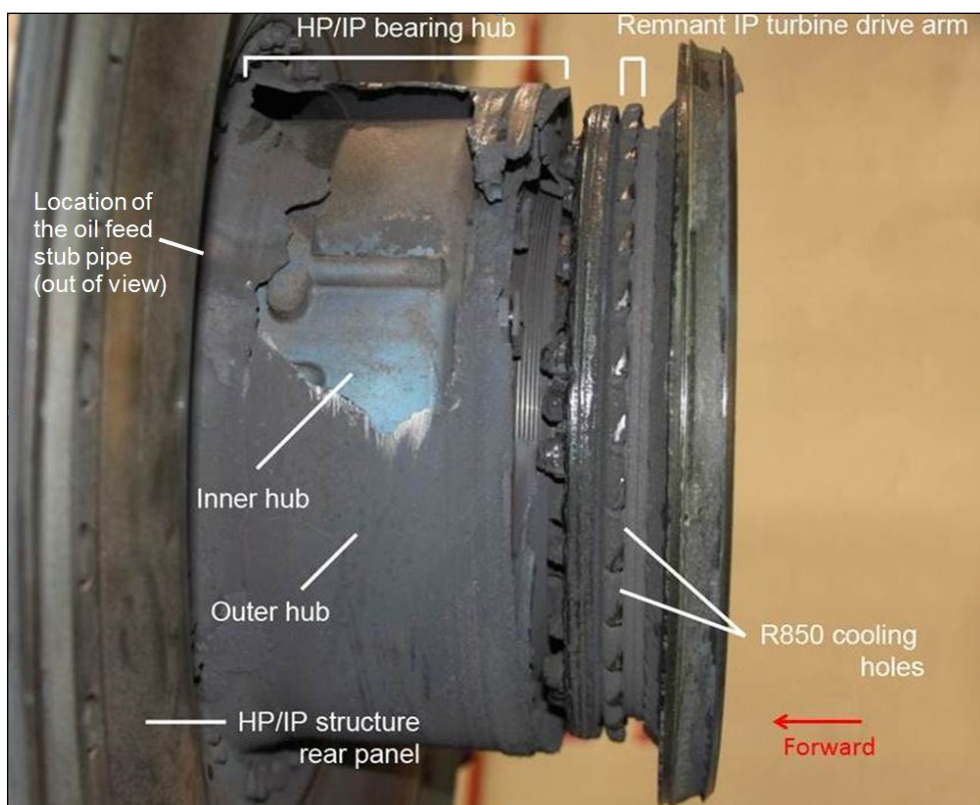
Figure 40: Damage to the HP/IP hub structure

The oil feed stub pipe had detached and displaced outwards about 30 mm from the inner hub. A remnant of the oil feed stub pipe remained in the inner hub (Figure 41).

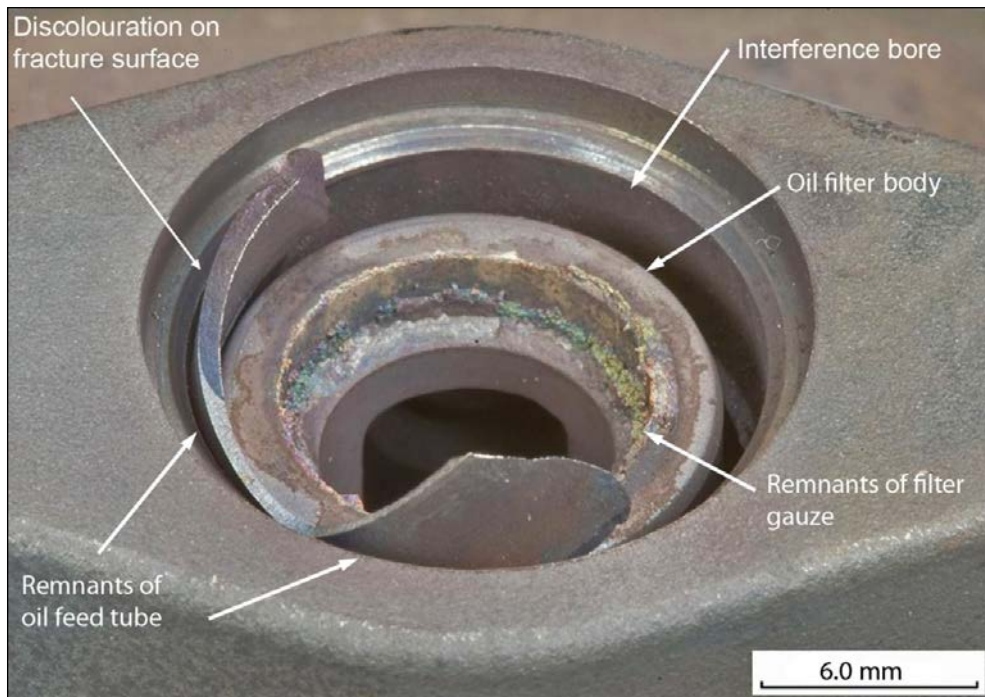
Figure 42: HP/IP inner hub oil feed pipe

The oil feed stub pipe was fractured in two planes, one around the weld that attaches the pipe to the inner hub, and the other further outboard, close to the shoulder where the pipe presses into the inner hub. Three distinct fracture regions were identified on the oil feed stub pipe:

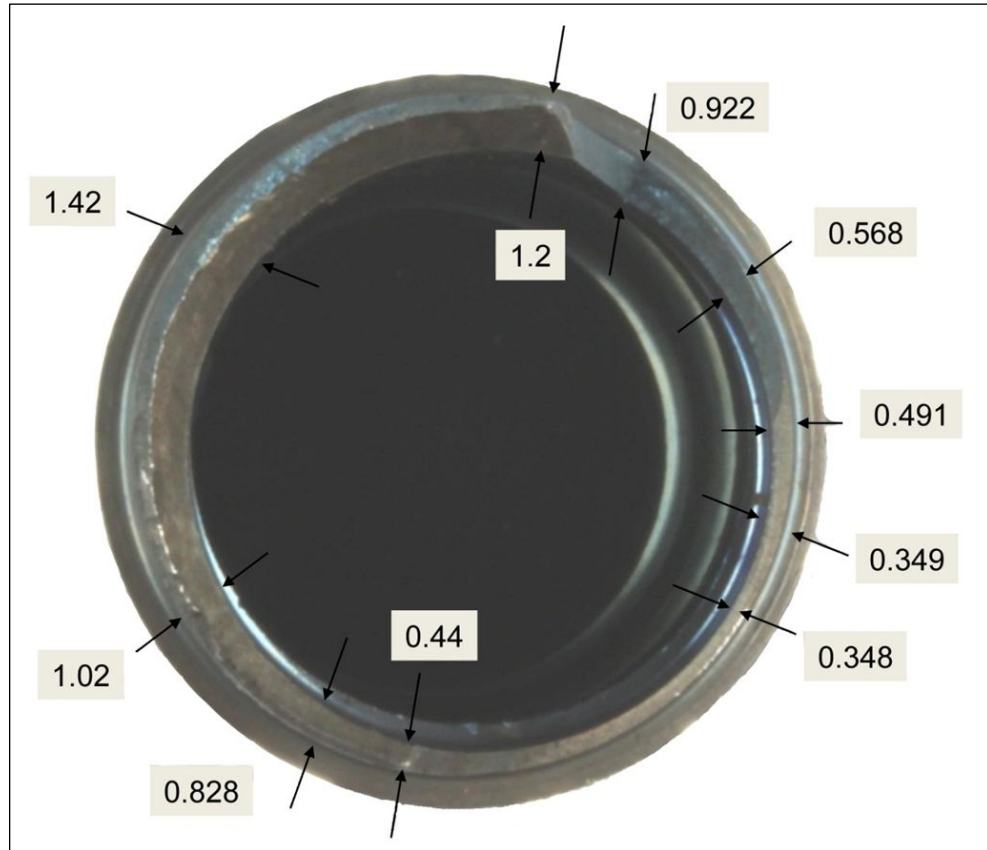
Figure 45: Fractured oil feed stub pipe wall measurements

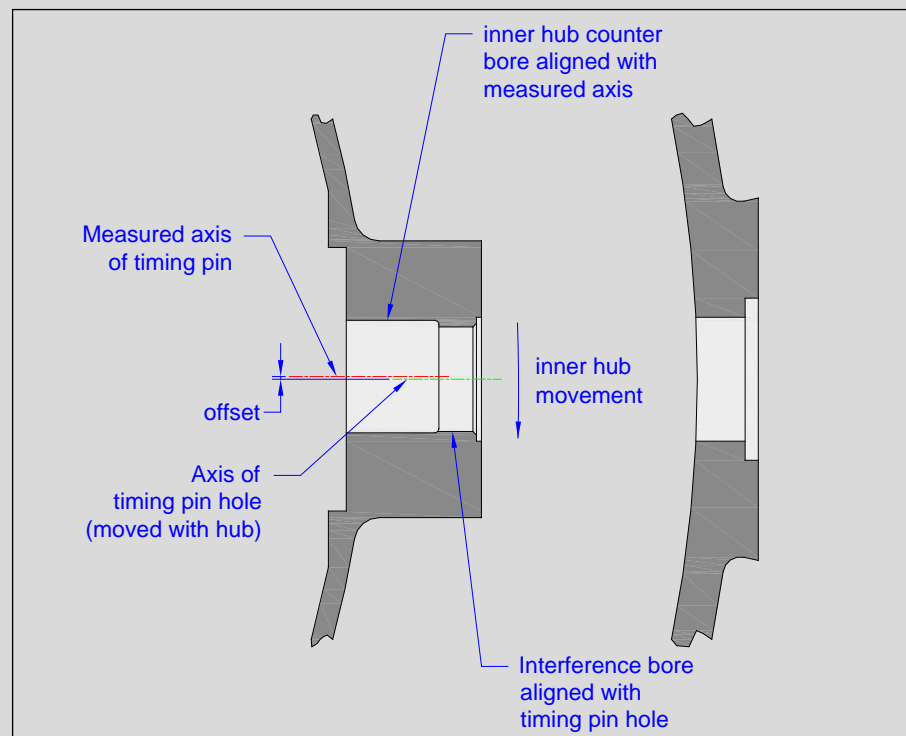
Figure 74: Example of inner hub counter bore/interference bore offset

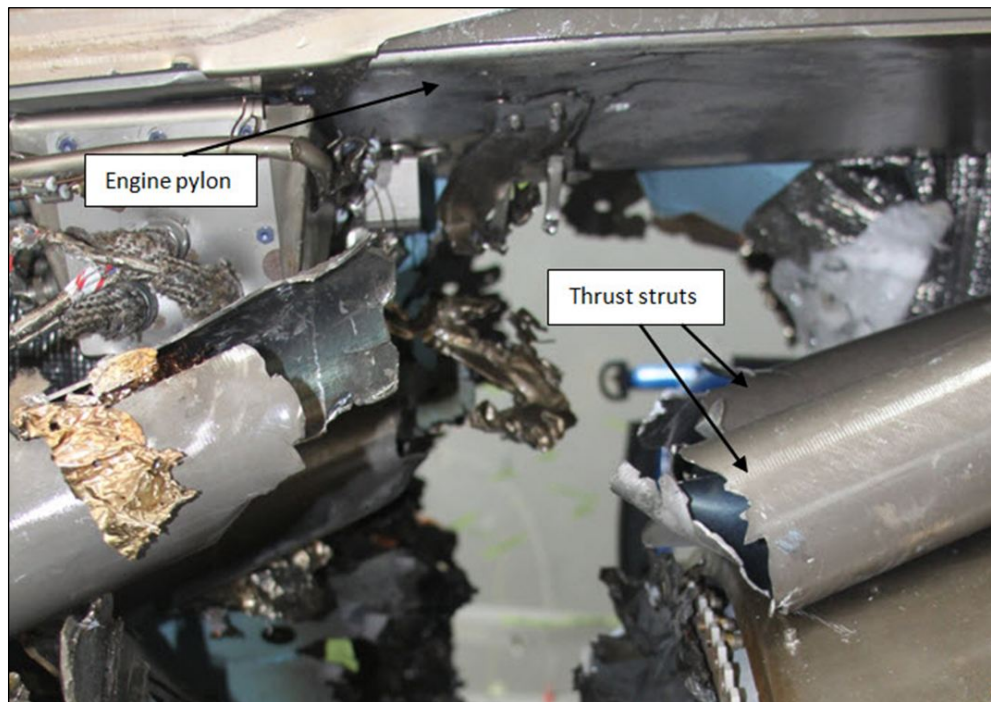
Figure B4: Fractured tubular thrust struts

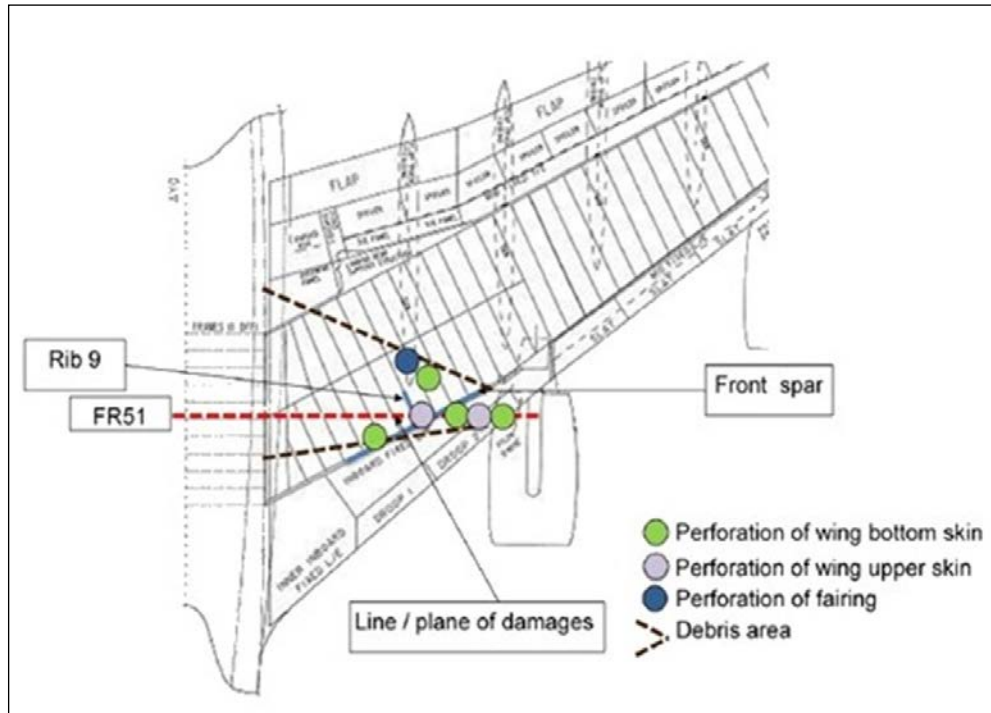
Figure B6: Left wing schematic showing the locations of significant wing skin damage and distribution of debris path

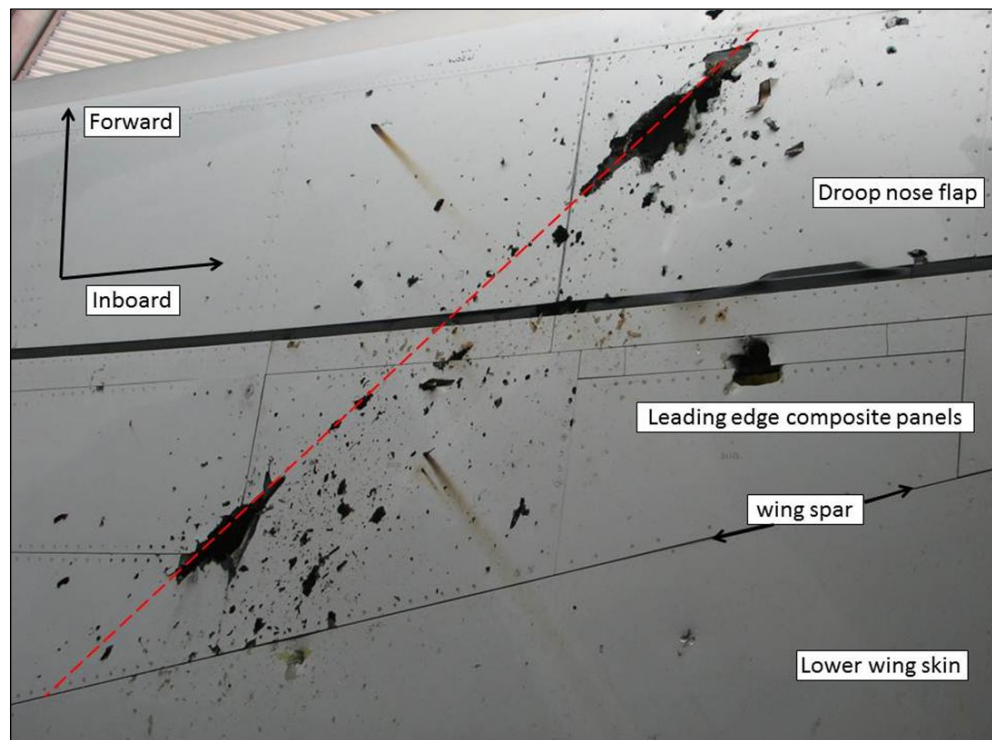
Figure B10: Penetration damage to the lower wing skin and droop nose flap from major IP turbine disc fragments and other engine debris that were ejected after the burst

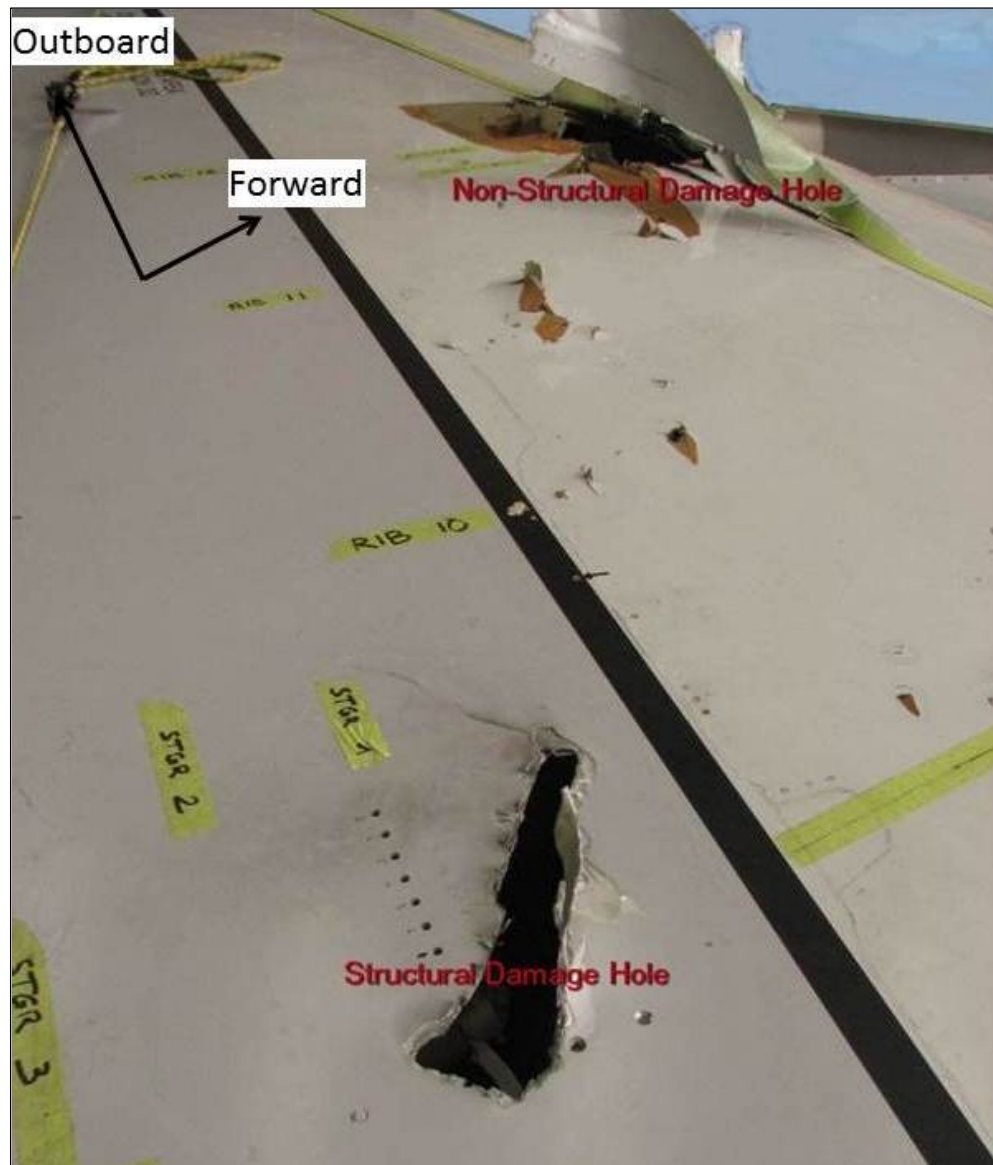
Figure B15: Upper wing damage showing structural and non-structural damage

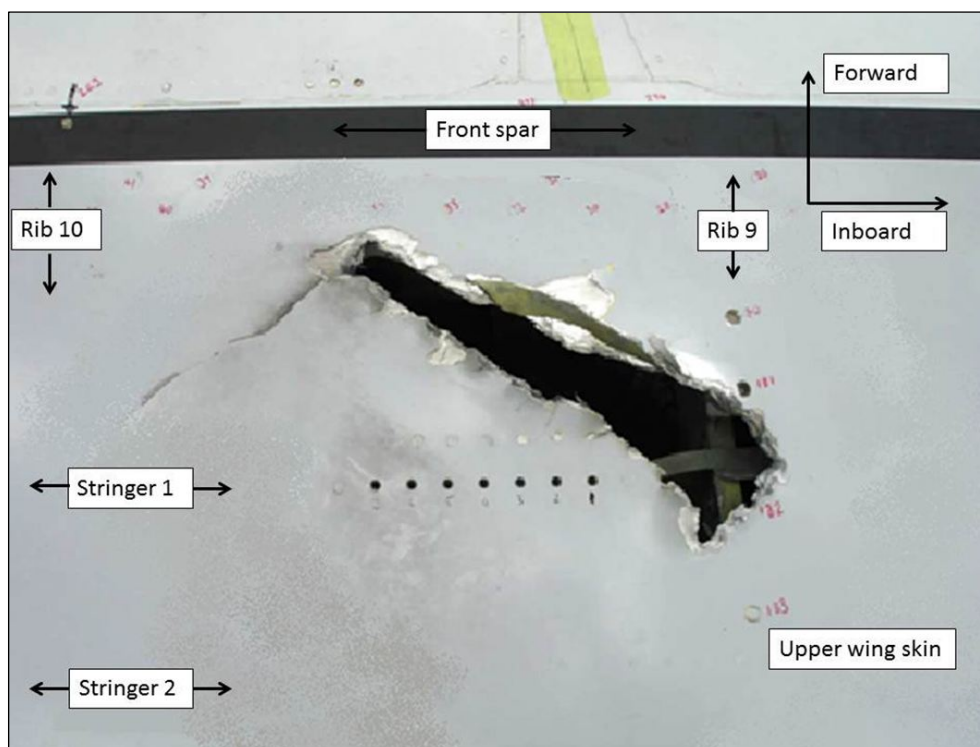
Figure B16: Damage to the upper wing skin from a significant disc fragment, panel No. 1 between Ribs 9 and 10

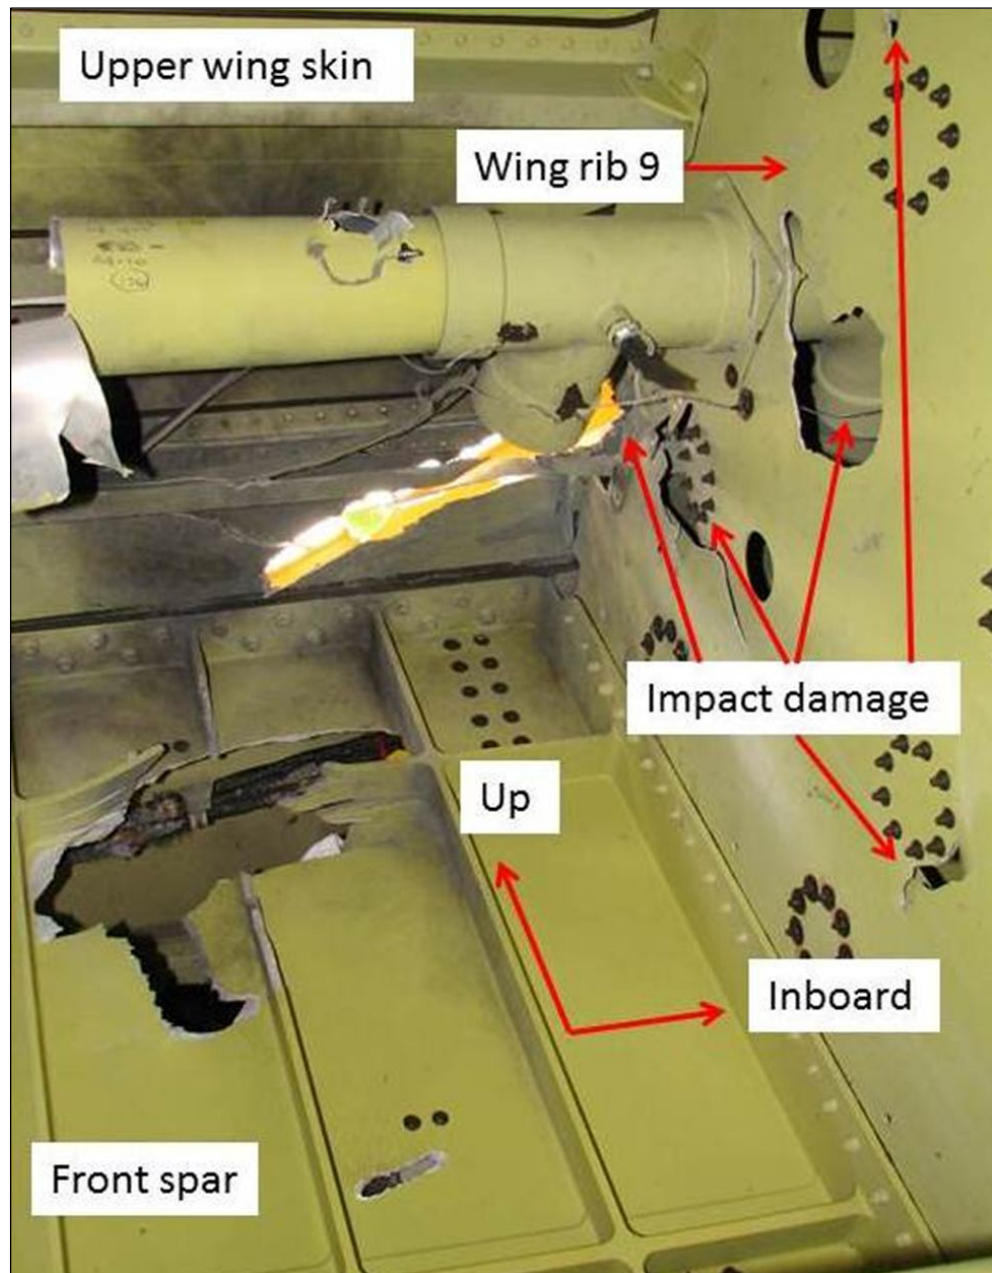
Figure B19: Internal wing rib damage showing damage in 5 locations. Viewed from lower wing skin access panel

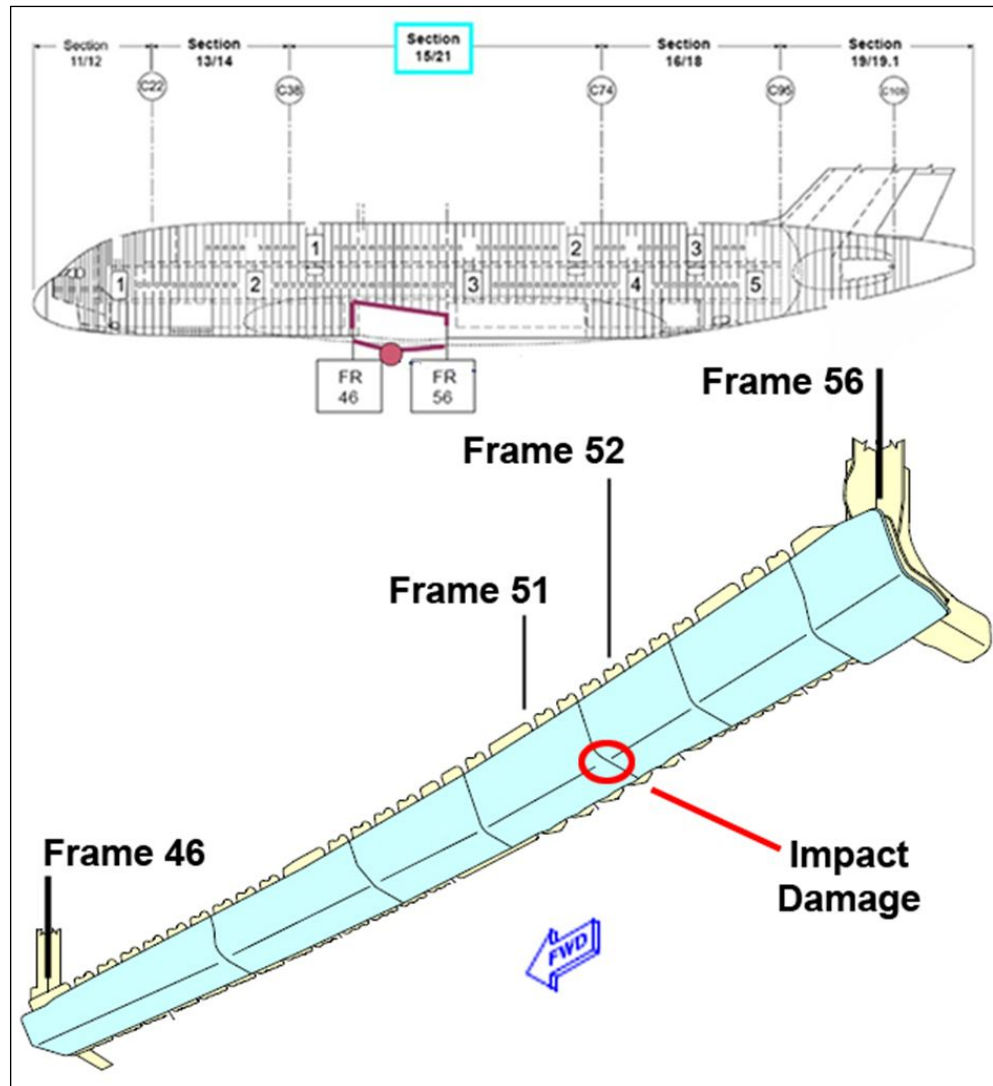
Figure B22: Left butt-straps and damage location between Frame 52 and 51

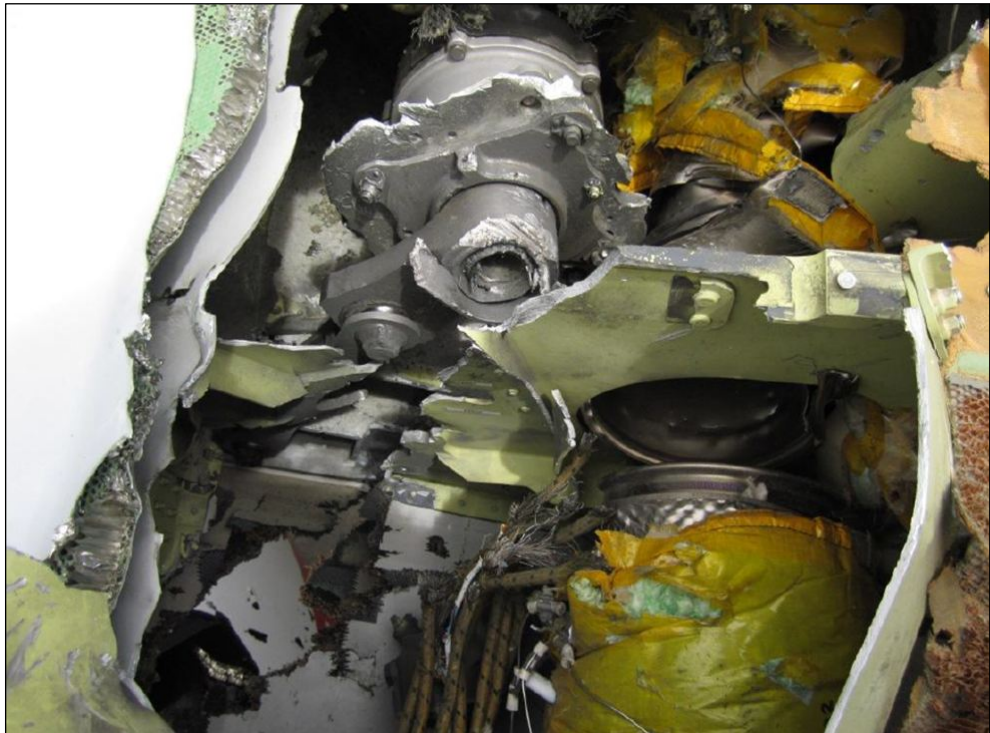
Figure B29: Engine debris impacted the wing droop nose slat, wing structure and components within the leading edge—viewed from the upper wing surface

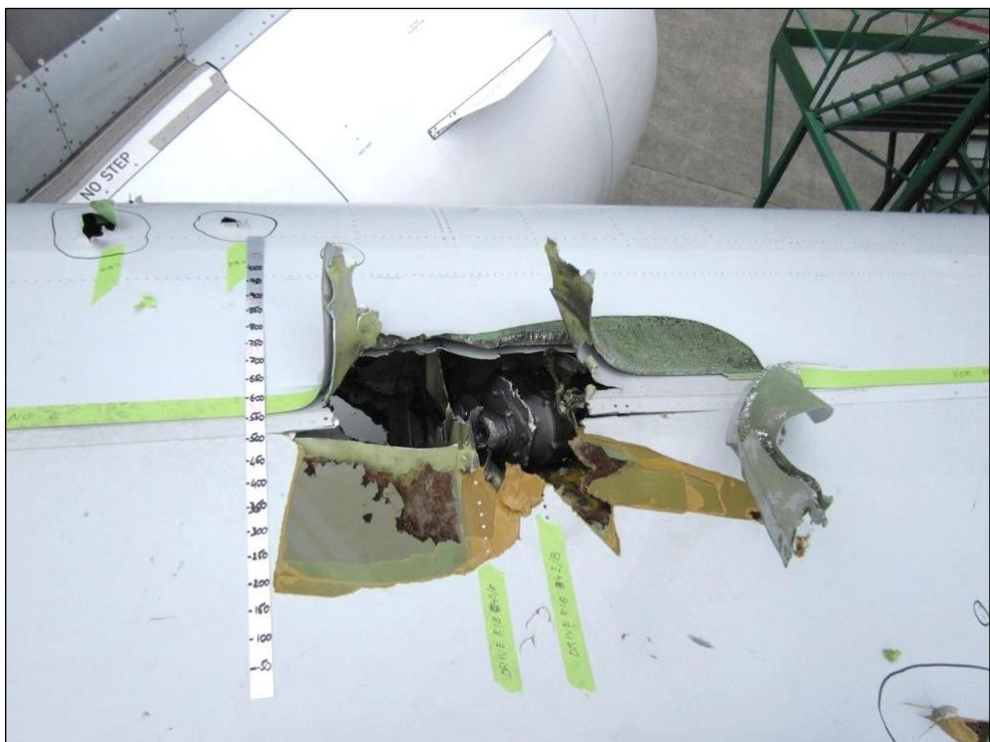
Figure B30: Damage to the drive motor located at leading edge Drive Rib No. 4

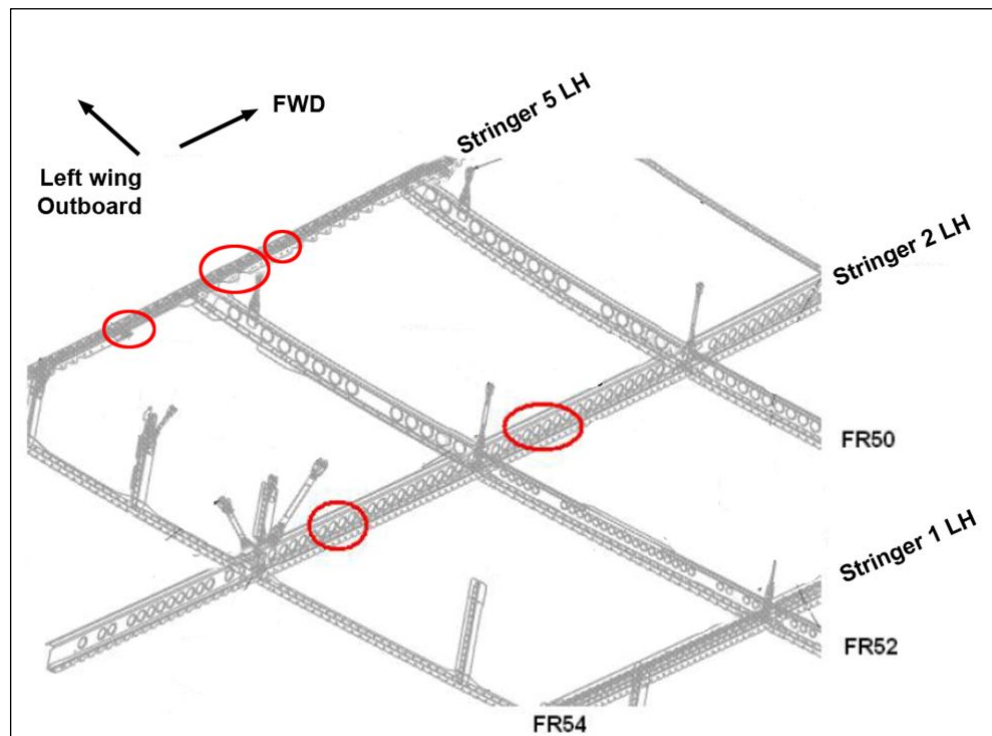
Figure B33: Structural arrangement of the fuselage between frames 50 and 54 showing the damage points from engine debris that penetrated the belly fairing

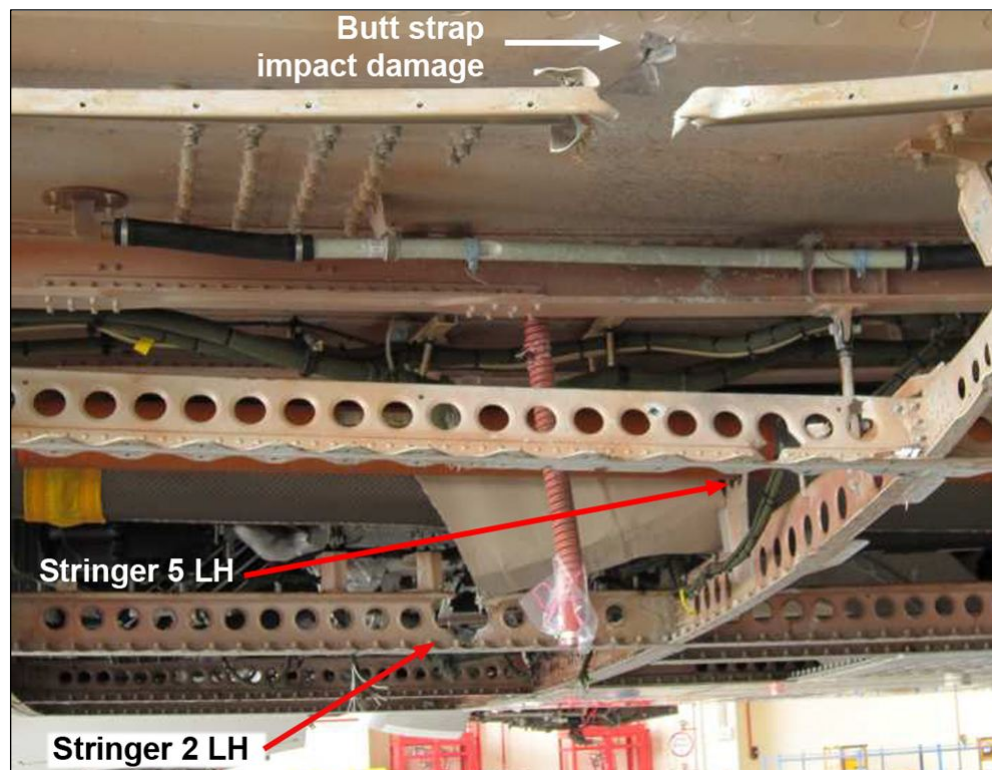
Figure B34: Impact and penetration damage to the fuselage structure between airframe locations FR50 and FR54 from a high-energy fragment of the IP turbine disc

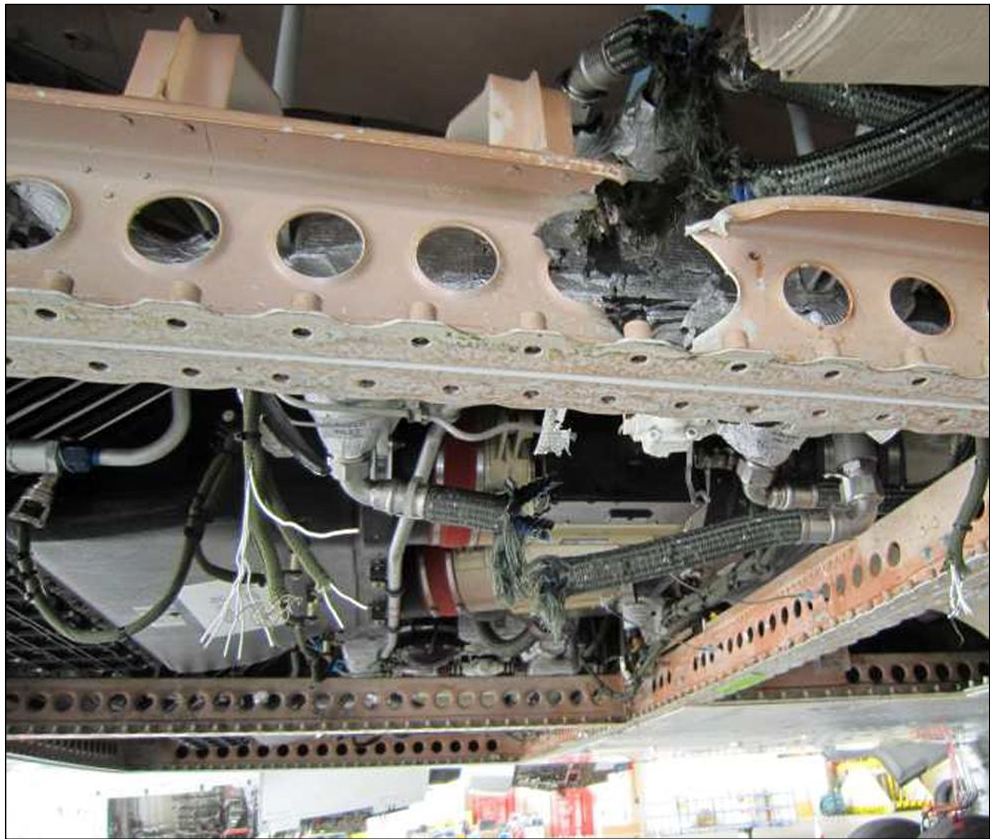
Figure B35: Stringer 2 LH impact damage

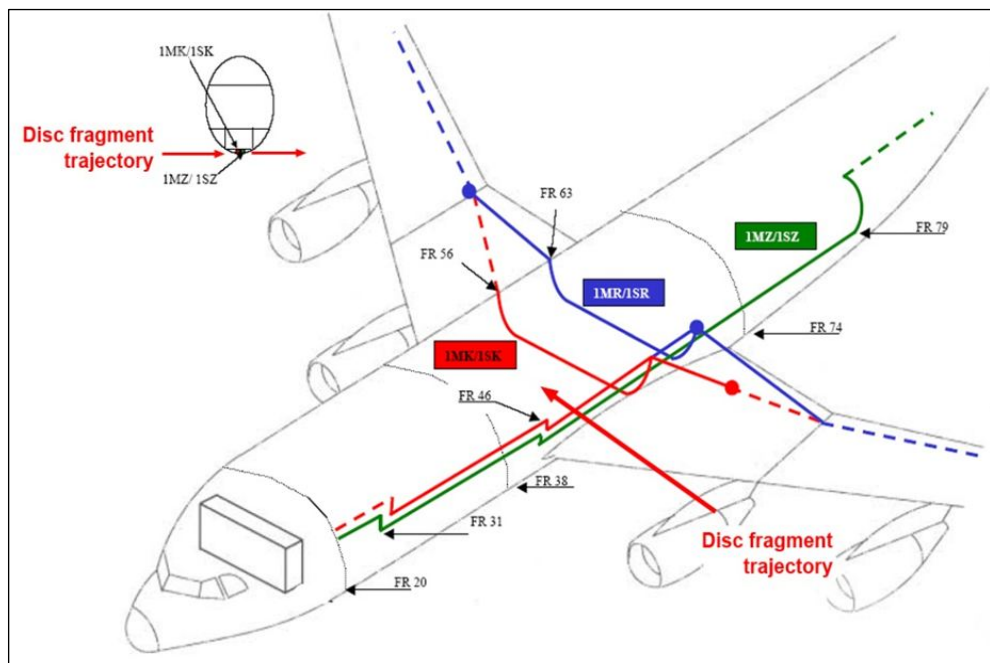
Figure B37: Representation of the smaller, high energy disc fragment's trajectory through the aircraft belly fairing (keel beam) which severed wiring harnesses
