In-flight uncontained engine failure Airbus A380-842, VH-OQA

overhead Batam Island, Indonesia | 4 November 2010

ATSB Transport Safety Report
Aviation Occurrence Investigation
AO-2010-089
Final – 27 June 2013

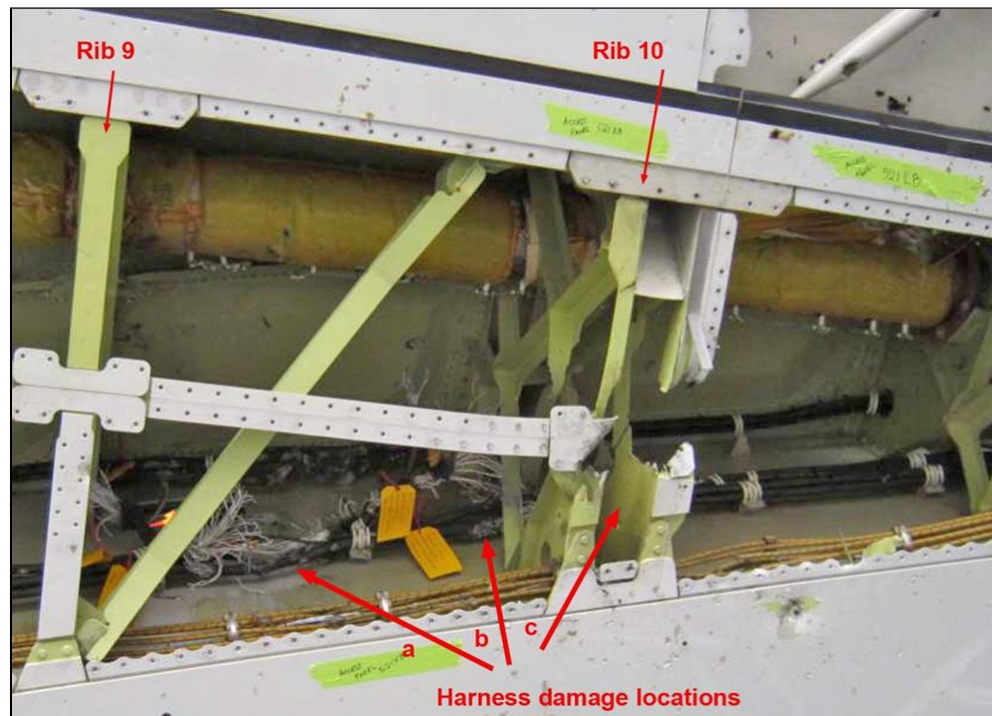
Figure B40: Wiring harness damage at three main locations within the leading edge of the Rib 9 and Rib 10 area

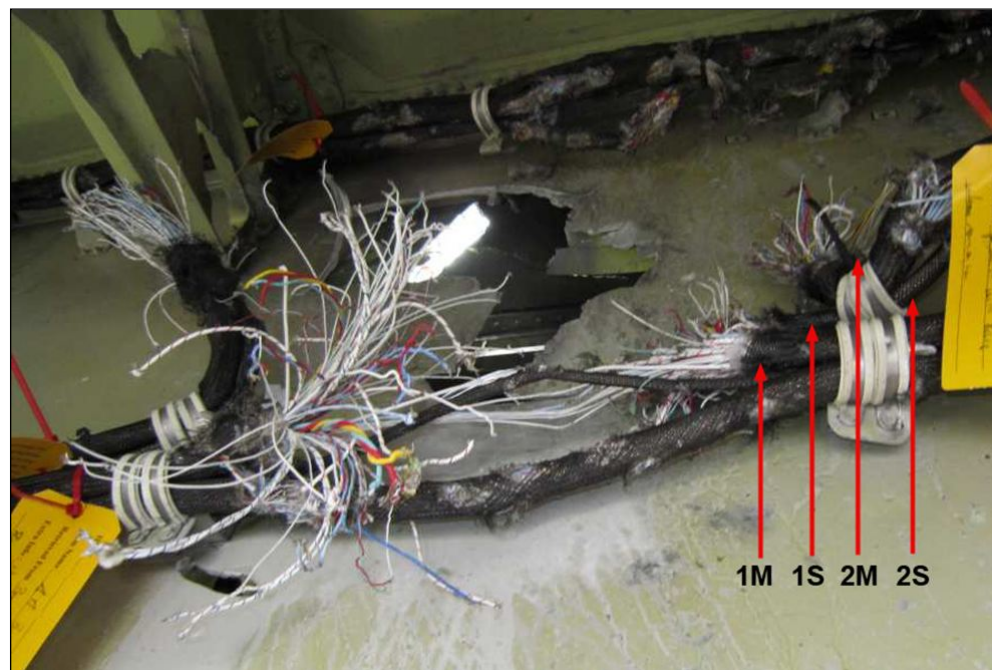
Figure B41: Damage location (a) from Figure B40 showing complete severing of the route 1M, 1S, 2S and 2M wiring harnesses—the entry/exit hole through the front spar and upper wing skin from a high-energy disc fragment is also apparent

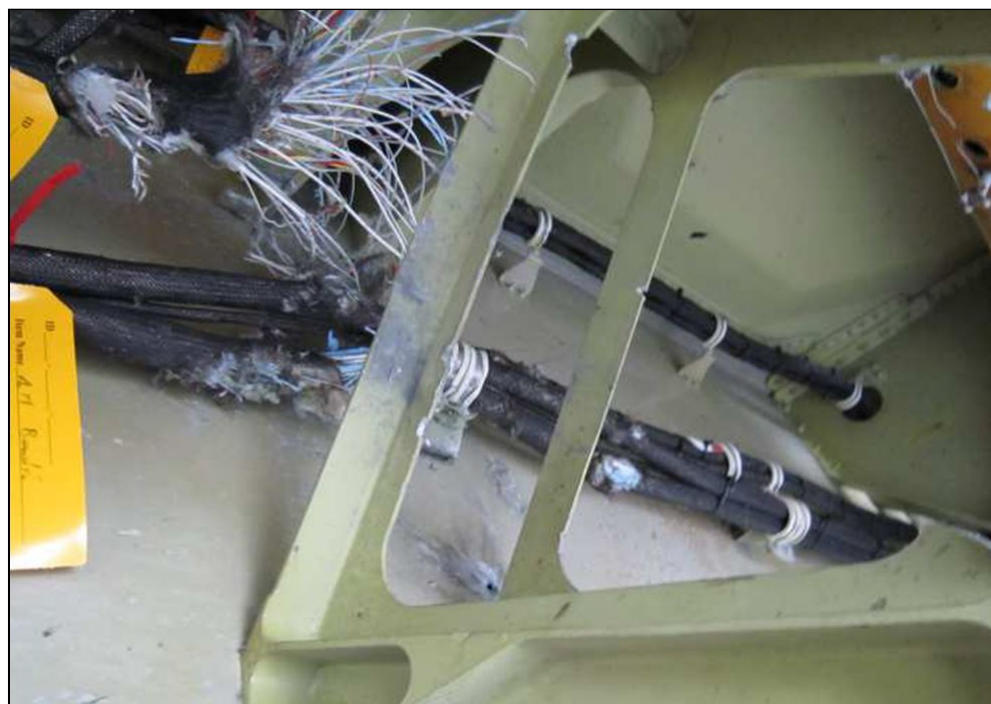
Figure B43: Damage location (c) from Figure B40

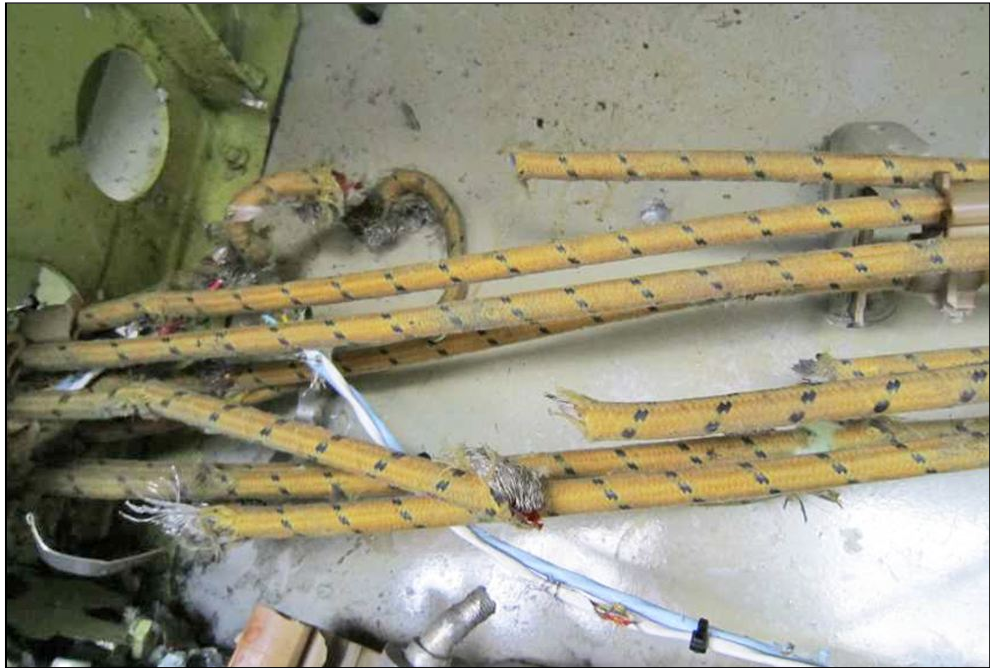
Figure B46: Close detail of damage to route 1G, 3029VB harness, between Rib 10 and Rib 11

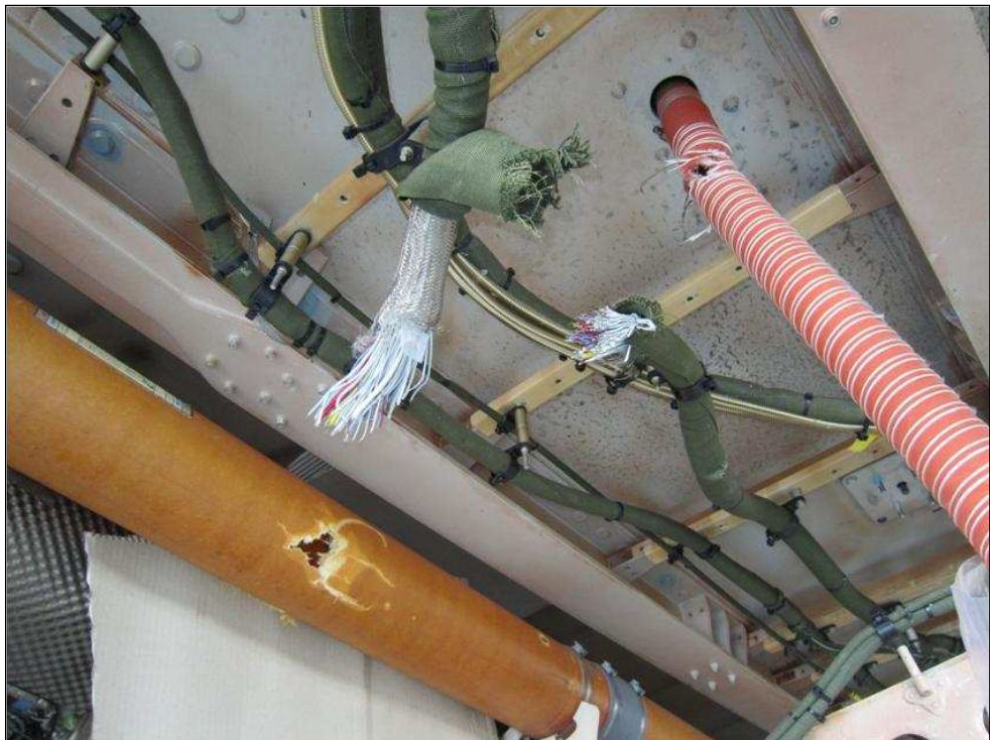
Figure B47: Wiring harnesses within the belly region of the aircraft structure were damaged from the liberated engine debris. Shown is harness 1525VB (route 1MK). All wires were severed

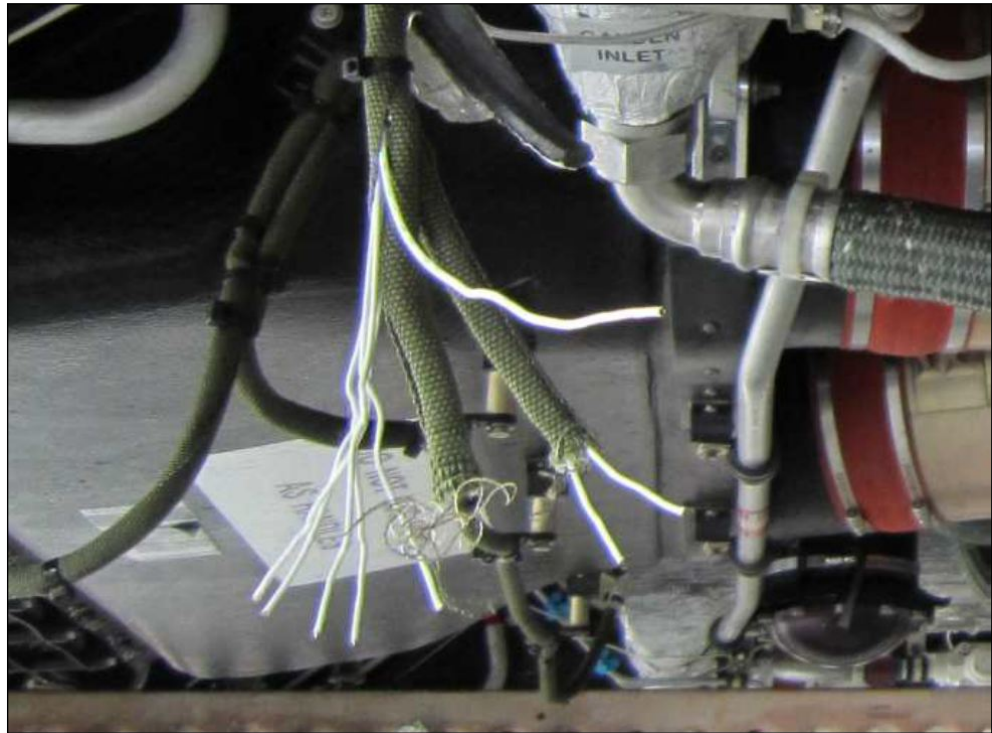
Figure B48: Wiring harnesses within the belly region of the aircraft structure were damaged from the liberated engine debris. Shown is harness 1532VB (route 4M and 2MZ). All wires were severed

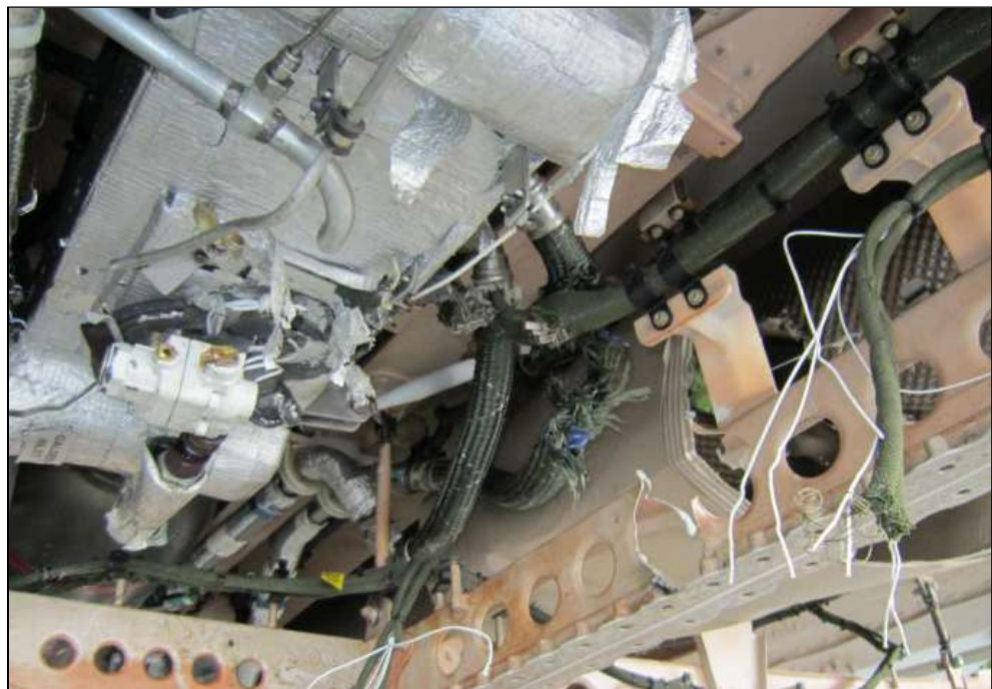
Figure B49: Wiring harnesses within the belly region of the aircraft structure were damaged from the liberated engine debris. Shown is harness 500HW1 (route 1PZ). All wires were severed

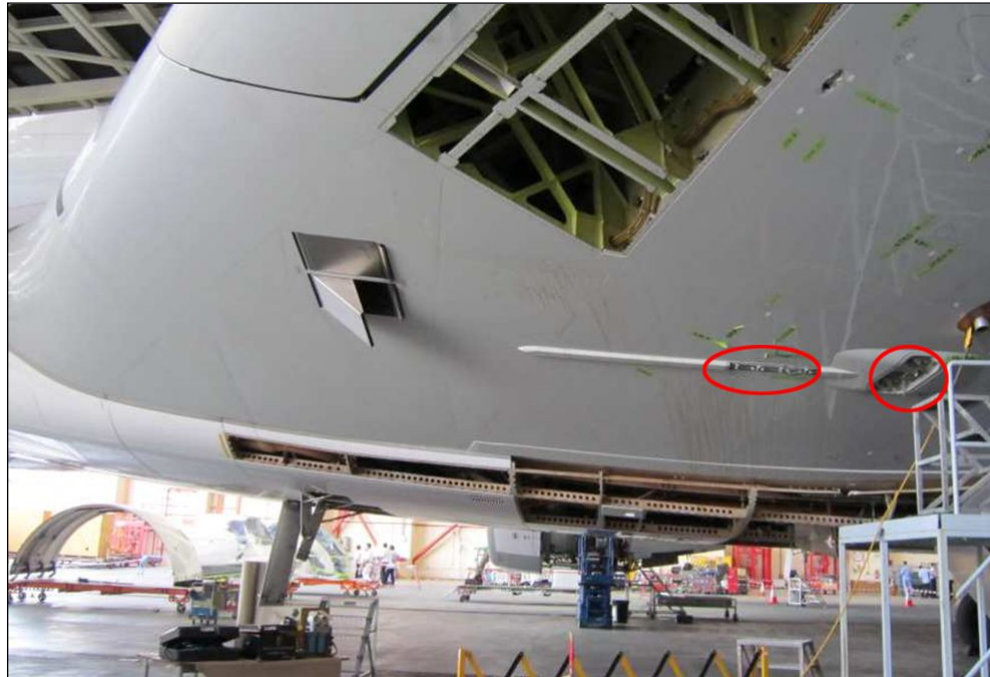
Figure B50: Location of the left wing fuel pump harness damage, routes 1M (fuel pump) and 2M (standby fuel pump) were both severed

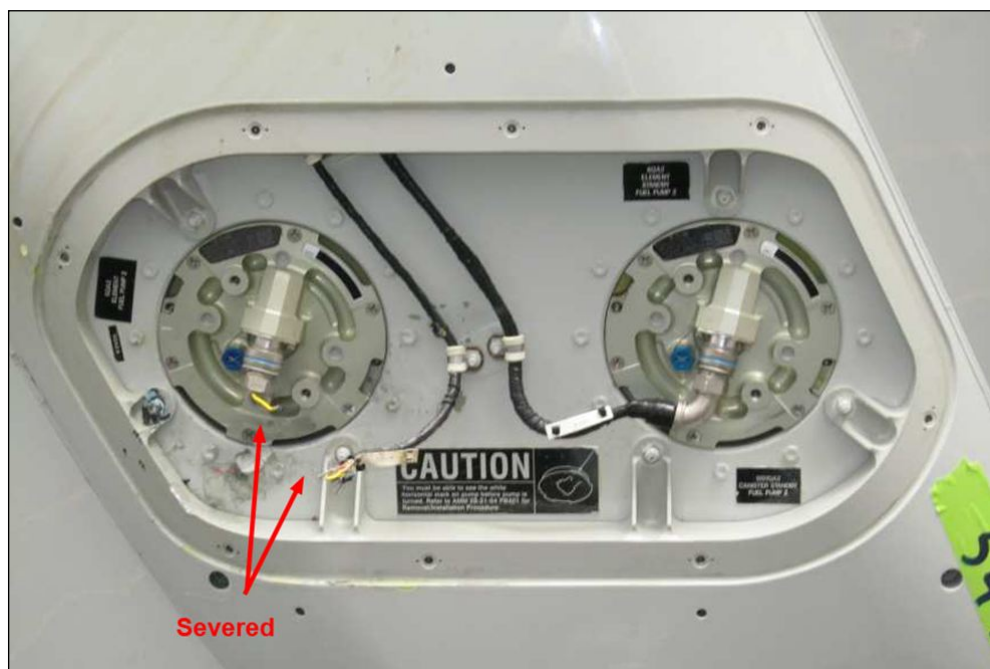
Figure B51: Damage to the 1M harness that supplied to the left wing forward fuel pump

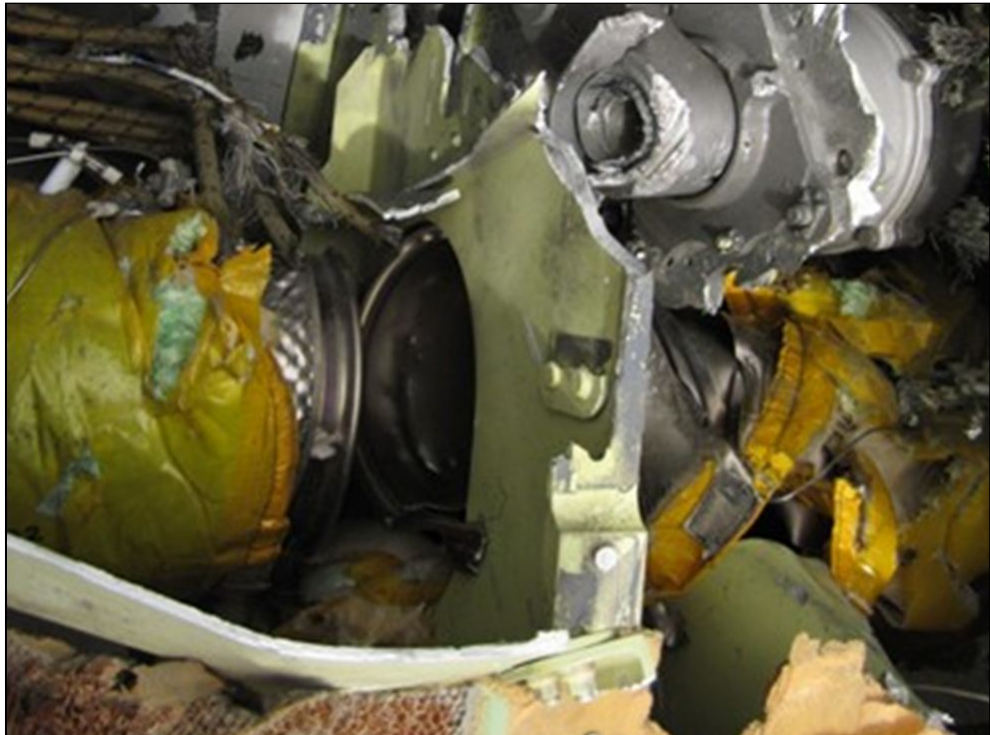
Figure 60: Bleed air duct damage

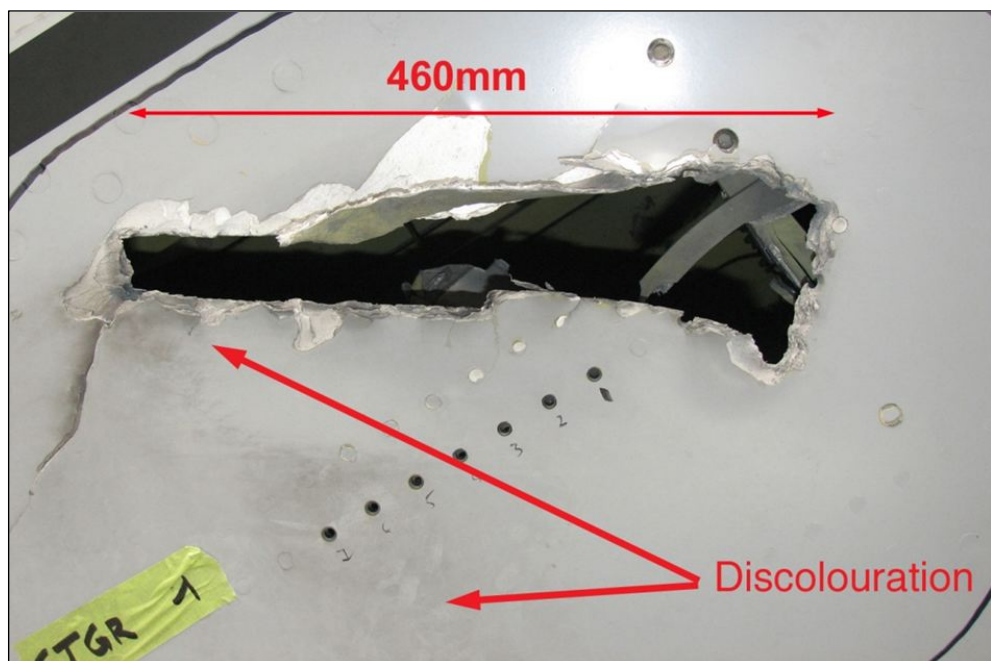
An examination of the internal surfaces of the LIT showed the residue to be principally located on the upper regions of the front spar (above the large hole), and along the underside of the top skin on the surfaces of the stringers (Figure D5 and Figure D6). The residue was also observed within the vent pipe shown in Figure D6. No evidence of dark residue was observed on either the wing underside, or on the front droop-nose structure.

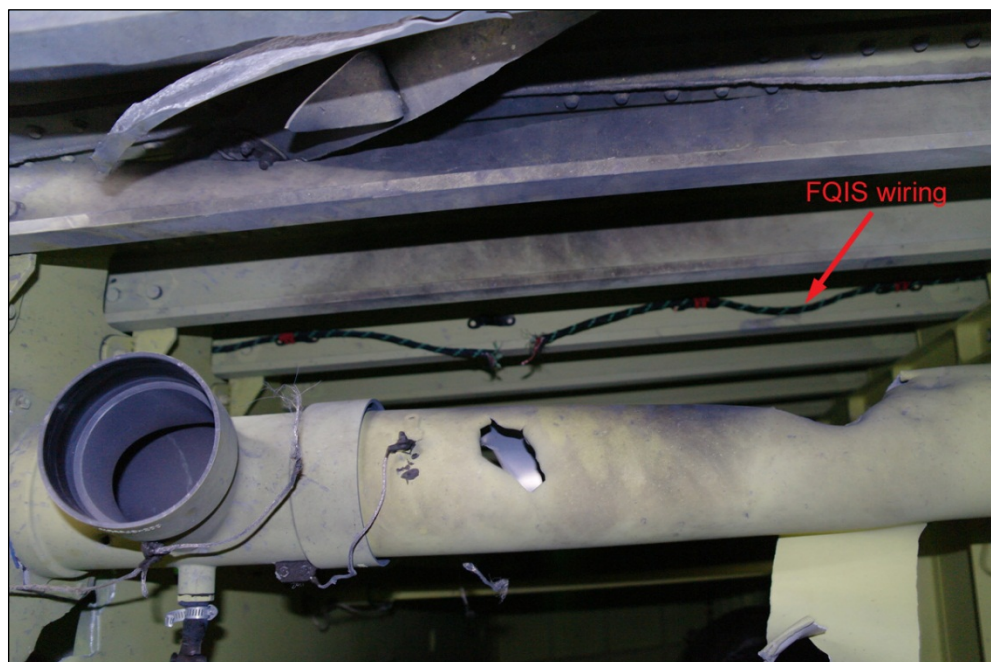
Figure D6: Residue observed along the top of the LIT
