# Nose landing gear malfunction involving a Hawker Beechcraft G58, VH-OMS

Hervey Bay, Queensland, 3 April 2013

**ATSB Transport Safety Report**  
Aviation Occurrence Investigation  
AO-2013-065  
Final – 7 August 2013

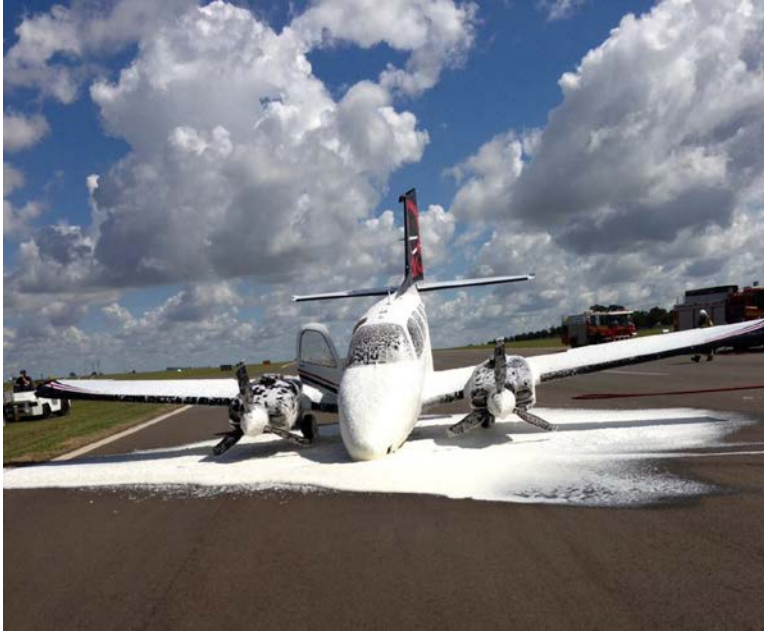
**Figure 1: VH-OMS after landing**

The aircraft arrived at Toowoomba and a pass over the runway was conducted at 500 ft. Ground personnel confirmed that the NLG had extended, but was not in the locked position.

As the aircraft's main landing gear touched down, the copilot selected the fuel and mixture controls to off, while the PIC concurrently reduced the throttle settings to idle and turned the electrical system off. The aircraft's nose then lowered and slid along the runway. The aircraft came to a stop and the crew exited. As a precaution, the aircraft was covered with fire retardant foam, but no fire resulted. A video of the landing can be viewed at:

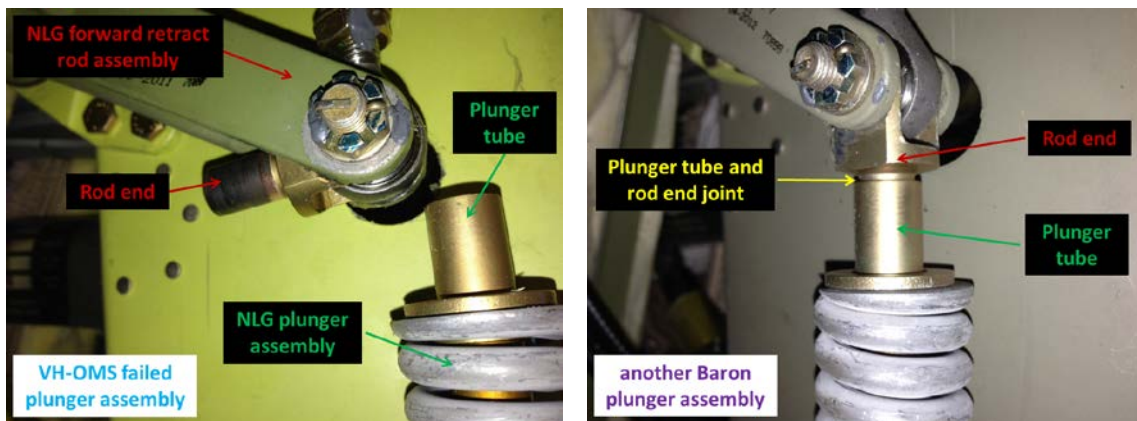
**Figure 2: VH-OMS and another Baron rod plunger assembly in situ**

The maintenance provider conducted an examination of the aircraft and determined that the rod end on the NLG forward retract rod assembly had separated from the plunger tube on the NLG plunger assembly (Figure 2). The initial examination suggested that there may have been a manufacturing issue that resulted in a defective joint between the rod end and plunger tube.

After the accident involving OMS, the NLG of a second Baron aircraft was inspected and it also showed signs of a similar defect (Figure 2). That aircraft was built in 2012 and had 127 hours total time in service.

- **Mandatory Service Bulletin (MSB):** was released by the aircraft manufacturer on 6 May 2013 as a result of this accident: <http://csobeech.com/files/HBC-SB32-4125.pdf>. It was issued to inspect for, and if necessary, replace the specified nose landing gear plunger assemblies. This must be accomplished no later than 50 flight hours or 9 months from the issuance of the MSB, whichever occurs first.

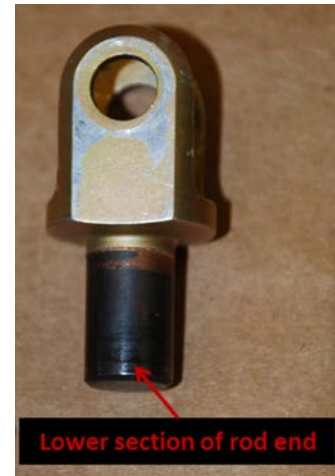
**Figure 3: VH-OMS rod end**

The affected components were examined by the aircraft manufacturer in the United States, who identified that there was no copper brazing visible on the lower section of the rod end (Figure 3) and inside the plunger tube.

It was determined that the copper braze had not been placed inside the plunger tube before the rod end had been inserted. This subsequently resulted in the rod end separating from the plunger tube.

All new assemblies were required to be 'pull tested' to a 2,200 lb. test load. For the assemblies fitted to OMS, the aircraft manufacturer reported that a pull test had been conducted by the supplier; however, it could not be determined why that test did not reveal the lack of brazing. Two other assemblies manufactured by the supplier were pull tested and failed at about 6,000 lbs; the braze joint did not separate.

- **Assembly manufacture:** manufacture of the plunger assembly will now be conducted in-house.
- **Braze specifications:** they are reviewing all braze process specifications and other brazed components manufactured by the supplier.
