**Departmental investigation into the
grounding of the Singapore flag
container ship
NOL AMBER
on Larpent Bank, Torres Strait
on 1 November 1997**

Navigation Act 1912
Navigation (Marine Casualty) Regulations
investigation into the
grounding of the Singapore flag
container ship
NOL AMBER
on Larpent Bank, Torres Strait
on 1 November 1997

Published: April 1998

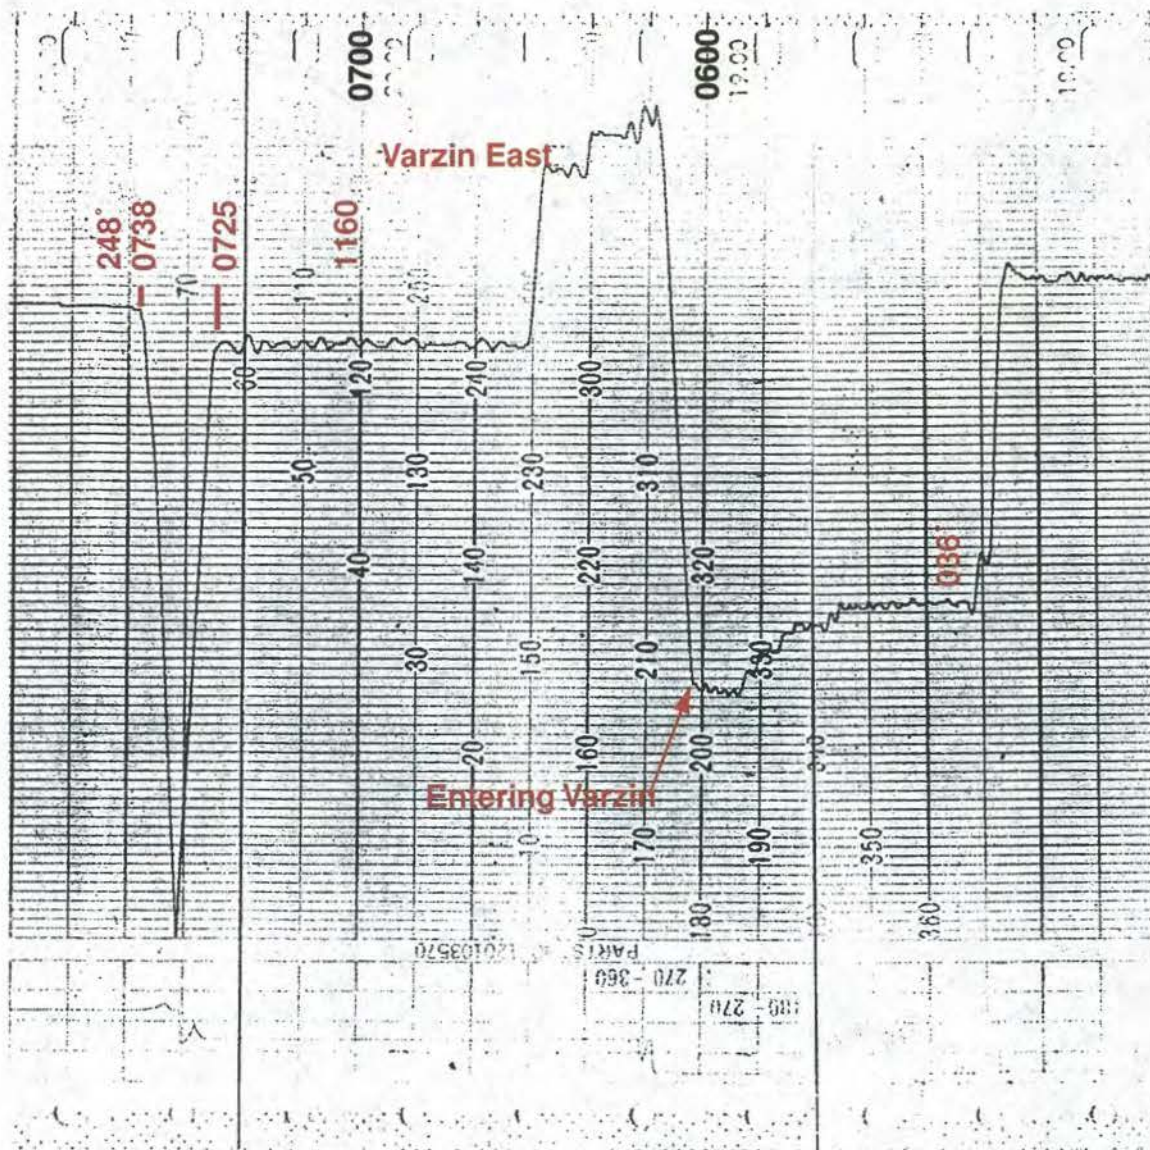
Portion of NOL Amber's course recorder chart

The vessel is equipped with a course recorder and examination of the chart indicates that the recorder was set up reasonably accurately for time, but was one degree high on the gyro compass steering repeater. In common with the majority of course recorders, there is no rudder angle recorder, so there is no record to confirm helm orders.

The course recorder chart shows that the turn to starboard, to lose time, commenced at 0725 and *NOL Amber* turned at a uniform rate of 11°/min until 0736, passing through a heading of 180° gyro at 0731½. When called by REEFCENTRE, at 0735, the vessel was passing through a heading of 225° gyro. At 0736, when the heading was 236° gyro, there was a reduction in rate of turn to 8°/min, followed by a much greater reduction in rate of turn, to 2½°/min at 0737. At 0738, the vessel stopped turning, on a heading of 246½° gyro, but there was a another, slight movement of the heading, to 247° gyro, at 0739½.

The reduction in the rate of turn at 0736 probably coincides with the decrease in under-keel clearance as reported by the Third Mate, while the cessation of turn at 0738 provides the time of the vessel being hard aground. Initial contact with the bank was probably at 0737, when the rate of turn dropped to 2½°/min.

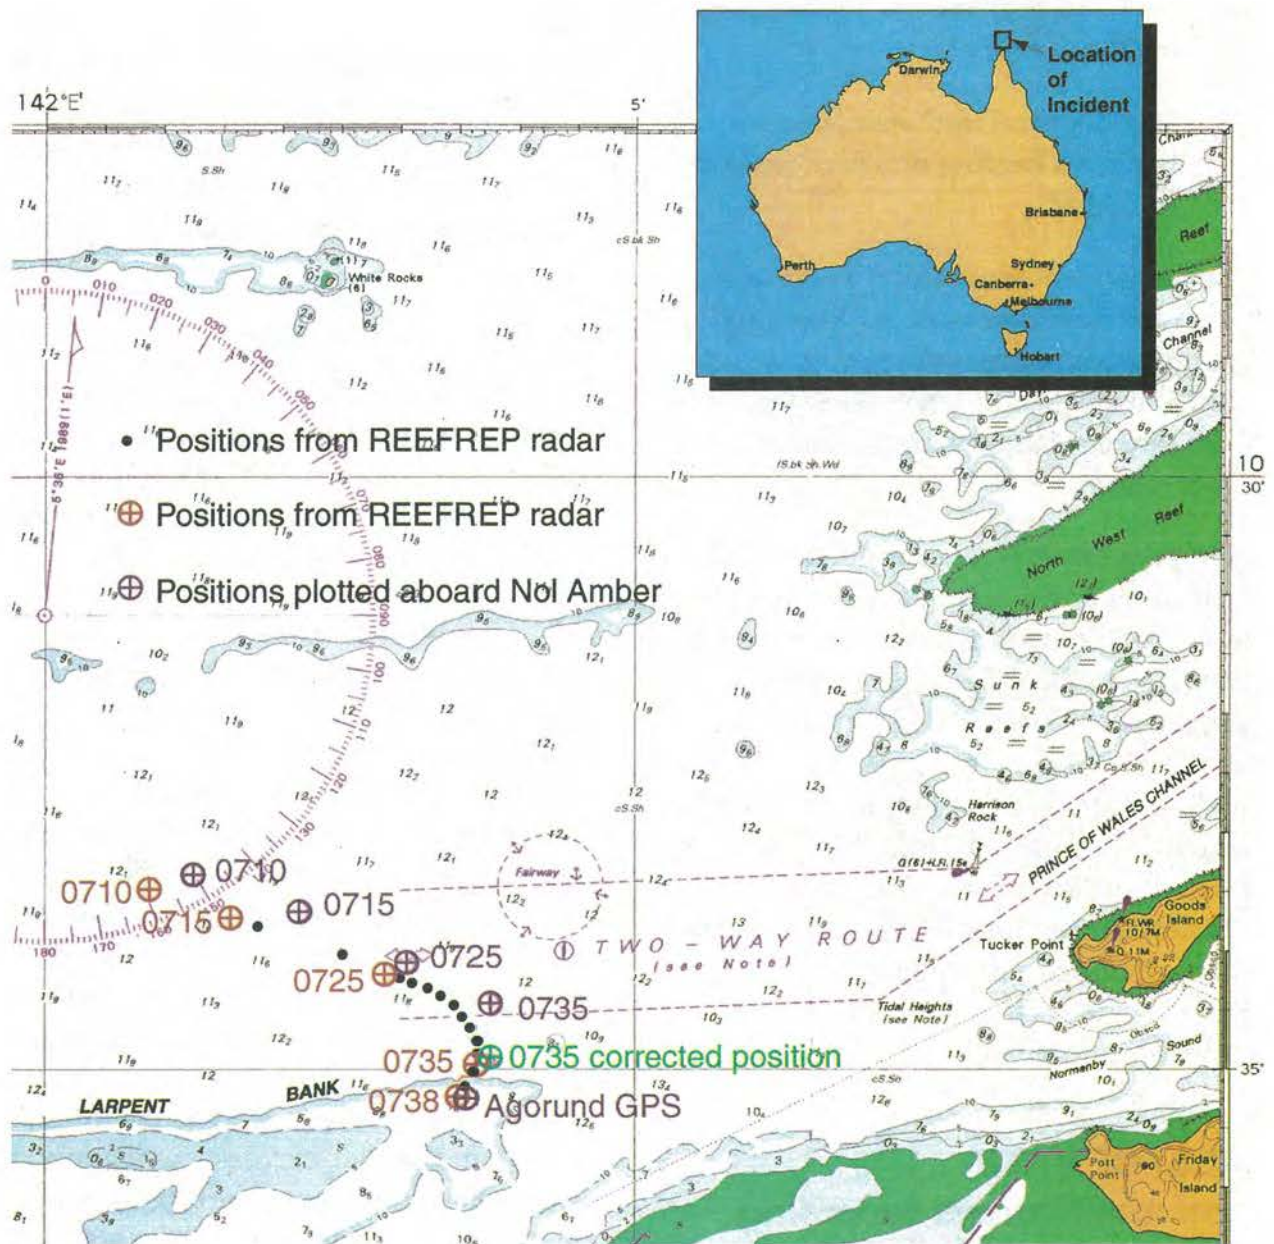
Portion of chart Aus 296 showing track of NOL Amber

Plotting the radar derived positions against the positions plotted on *NOL Amber's* navigation chart reveals a number of differences. Using Tucker Point (Goods Island) as the point of reference, the following differences are obtained:

- the Third Mate was not applying the gyro error ($1\frac{1}{4}^{\circ}$ - $1\frac{1}{2}^{\circ}$ high) to the bearings he obtained by radar;
- the 0715 position was probably obtained at 0717;
- at 0735, the Third Mate, in error, laid off a bearing of $085\frac{1}{2}^{\circ}$ instead of $080\frac{1}{2}^{\circ}$.

Applying the 0.09 miles difference in the grounding positions to the other positions, as a possible error in the calibration of the shore radar, the differences in the distances at 0725 and 0735 become negligible. However, the differences at 0710 and 0717, are still in the region of a quarter of a mile (460 m). While on passage between ports, the Master checked the variable range marker against the range rings and reported no errors, therefore, the differences are most probably attributable to operator error.
