Collision with terrain, VH-ROU

67 km west of Sydney Airport, New South Wales

10 October 2010

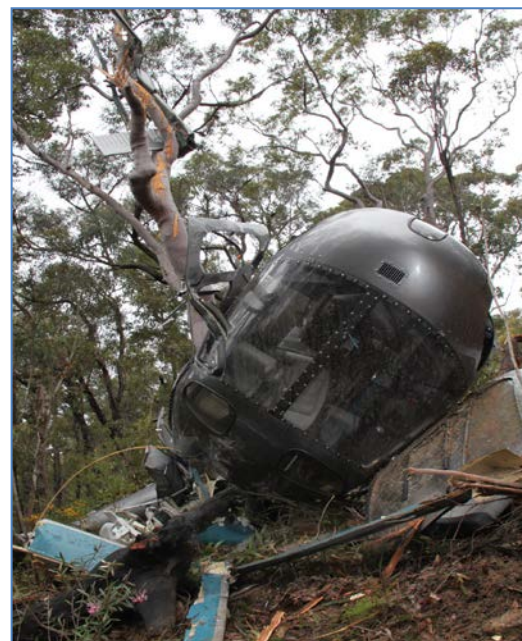
Figure 1: Wreckage of VH-ROU

The helicopter came to rest inverted, about 85 m from the first tree that was hit during the accident sequence. The helicopter was seriously damaged³ (Figure 1). Two passengers sustained minor injuries and were airlifted to Westmead Hospital from the accident site by emergency services as a precaution.

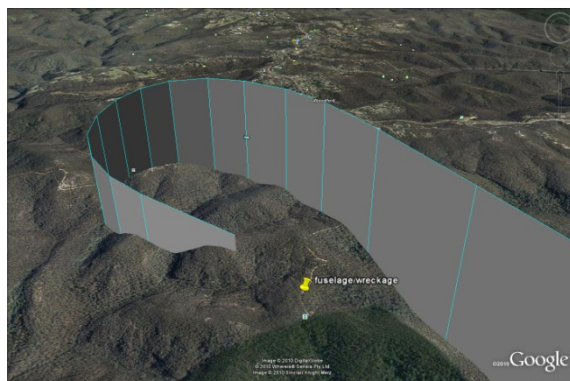
Figure 2: Turnback and track during the descent out of cloud⁶

The aircraft exited the base of the cloud at about 118 kts groundspeed, with about 41° left wing-low and 4,300 ft/min rate of descent (ROD). The pilot saw the Oaks Fire Trail below and had

Figure 2 shows a representation of the last few minutes of the flight, including the turnback following the decision to abort the flight and the descent out of the cloud. The yellow marker identifies the location of the accident site.
