ATSB TRANSPORT SAFETY REPORT  
Aviation Occurrence Investigation A0-2012-021  
Preliminary

# Collision with terrain Jaspers Brush Aerodrome, New South Wales 4 February 2012

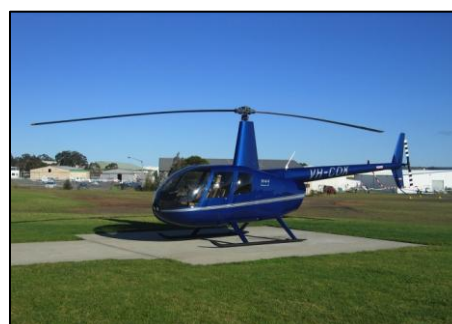
Figure 1: VH-COK

On 4 February 2012, a Robinson Helicopter Company R44 Raven II helicopter, registered VH-COK, was flown to Jaspers Brush Aerodrome, New South Wales (NSW) in preparation for an aerial filming flight (Figure 1). The right rear door and some non-essential equipment were removed from the helicopter in preparation for the filming task. The pilot and camera operator then conducted a short flight at Jaspers Brush to prepare for the filming later that day.

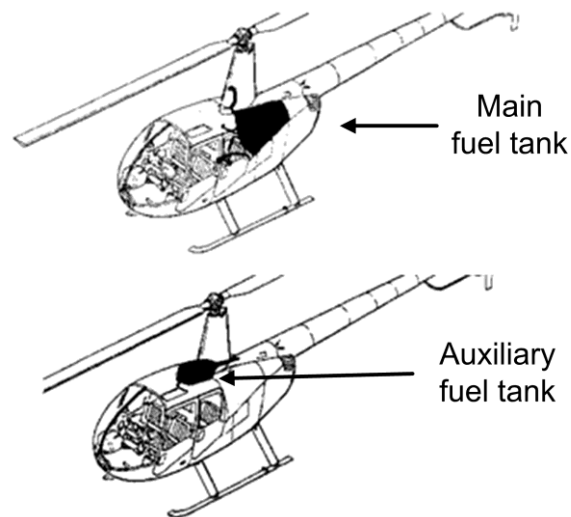
**Figure 2: Fuel tanks**

The R44 was originally manufactured with two all-aluminium fuel tanks that were installed above the engine firewall, either side of the main transmission (Figure 2). That was the case with VH-COK at the time of the accident.

On 20 December 2010, the manufacturer issued R44 Service Bulletin 78 (SB 78) requiring that R44 helicopters with all-aluminium fuel tanks be retrofitted with bladder-type tanks as soon as practical, but no later than 31 December 2014. The background information to the service bulletin stated:

The manufacturer advised that the bladder-type fuel tanks provided improved resistance to post-accident fuel leaks. That improvement was due to their improved cut and tear resistance and the ability of the bladders to sustain large deformations without rupture. SB 78 also incorporated the fitment of:

The Australian Transport Safety Bureau encourages all operators and owners of R44 helicopters that are fitted with all-aluminium fuel tanks to note the circumstances of this accident as detailed in this preliminary report. It is suggested that those operators and owners actively consider replacing these tanks with bladder-type fuel tanks as detailed in the manufacturer's Service Bulletin (SB) 78A as soon as possible.

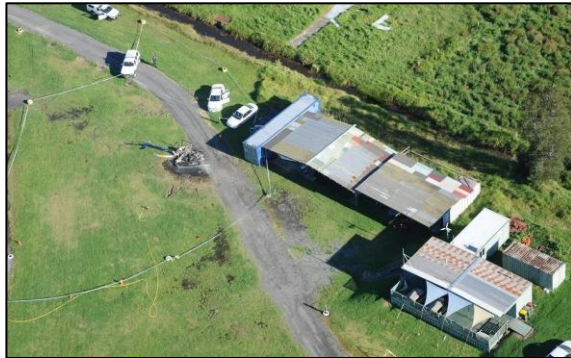
Figure 3: Accident site

The wreckage was located on a grassed area of the aerodrome about 12 m from the nearest structure (Figure 3). All of the helicopter's major components were identified at the accident site (Figure 4).

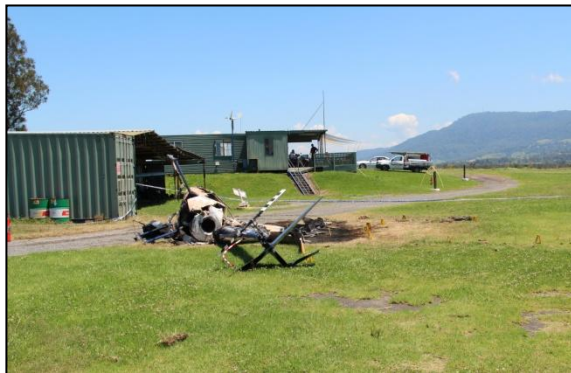
Figure 4: Helicopter wreckage

Much of the wreckage was consumed by a post-impact, fuel-fed fire. There was no evidence of an in-flight fire.

The main fuel tank was destroyed by the fire and the main rotor gearbox, which was located adjacent to the main fuel tank at manufacture, was displaced from three of its four mounting points. There were holes in the side of auxiliary

fuel tank closest to the main rotor gearbox (inboard tank wall) that appeared to have been a result of the fire. There was superficial damage only to the corresponding outer wall of the tank. About 20 L of fuel was recovered from the auxiliary tank.

Most of the alloy flight control tubes had been burned away during the post-impact fire, precluding a full examination of the flight control system. Examination of the helicopter's main and tailrotor flight control connections, engine control connections, main and tailrotor drive and its fuselage structure revealed no evidence of any pre-existing anomalies.
