Aviation Short Investigation Bulletin

Issue 20

AB-2013-088

Final – 28 June 2013

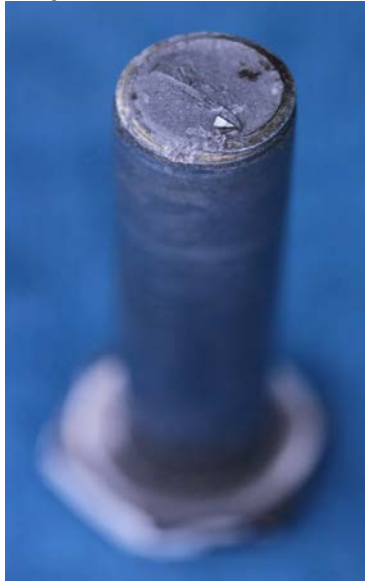
Figure 2: Failed lower torque link attachment bolt

The right landing gear assembly and lower torque link bolt were subsequently located and forwarded to the ATSB for examination. The examination of the right landing gear assembly revealed that the lower torque link attachment bolt (Figure 2) had fractured through the final thread. This fracture had allowed the inner cylinder to become detached from the torque link² and to fall from the outer cylinder when the aircraft became airborne.

Since this incident, the aircraft operator has undertaken to replace all torque link attachment bolts during the next scheduled maintenance on any Piper PA-28 aircraft they operate.

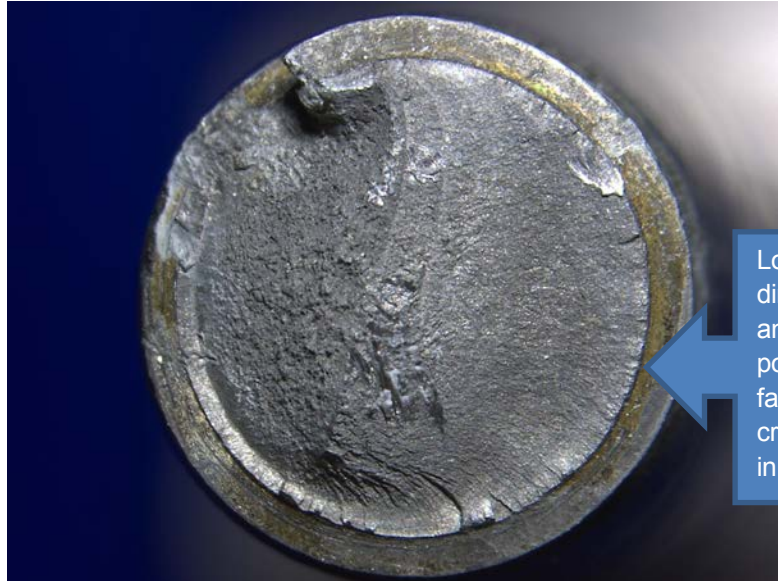
Figure 3: Bolt fracture surface

The examination indicated that the failure of the bolt was due to single-point bending fatigue due to asymmetrical loading (bending from one side) (Figure 3).

Loading direction and point of fatigue crack initiation

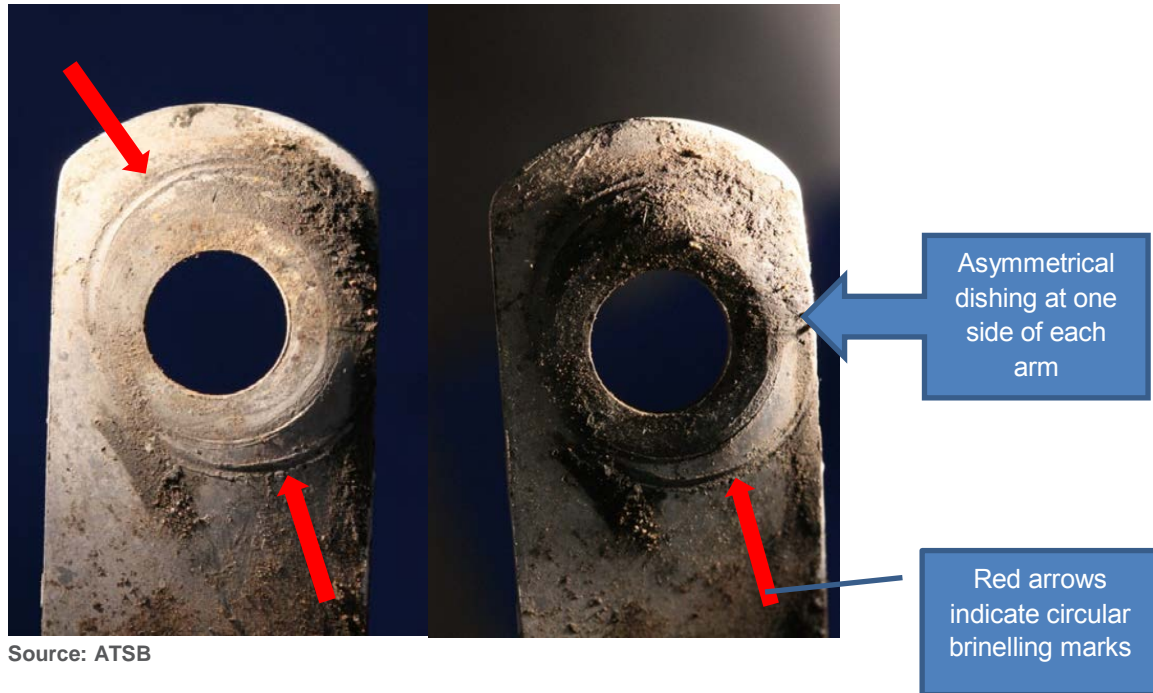
Figure 4: Inside surfaces at each end of brake hose support bracket

The bending failure mode of the lower torque link attachment bolt differed from its function of transferring bearing loads from the lower torque link onto the fork's lugs and so further investigation of the source of this asymmetric loading was carried out.

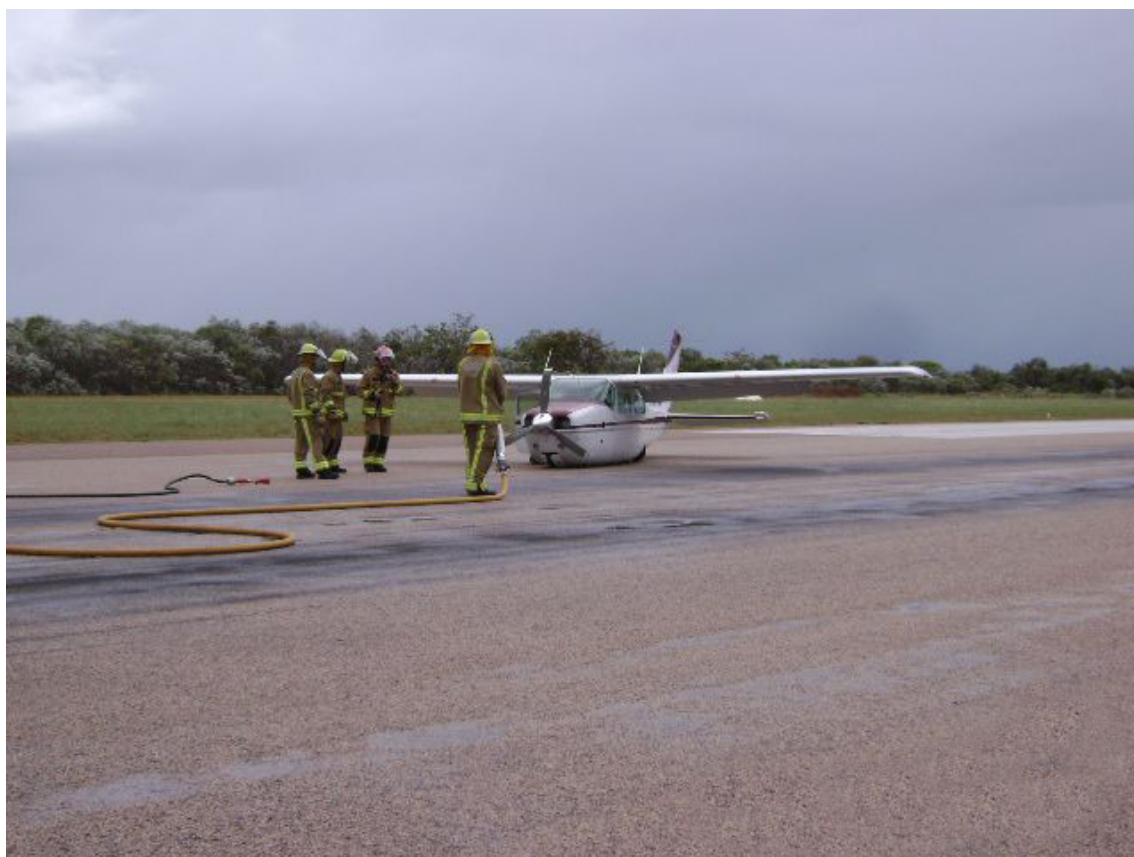
Figure 1: VH-PBV on the runway

Following the accident, an assessment conducted by an insurance assessor found that the pilot did not extend the landing gear prior to landing. The assessor noted that the micro switch that activated the landing gear warning horn was set for a throttle setting lower than that used by the pilot during the landing.

Bad weather and changed plans can distract attention away from a pilot's primary function – to safely fly the aircraft. However, the failure of the gear warning horn to activate removed a defence against landing with the landing gear retracted.

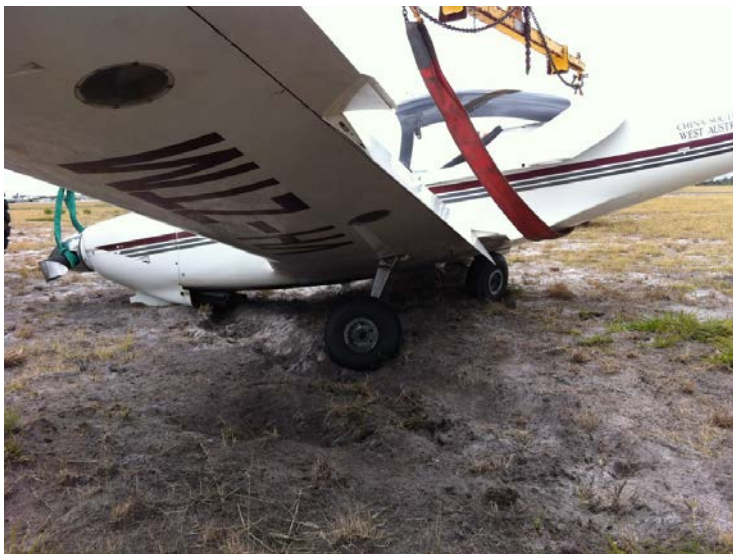
Figure 1: Aircraft damage

At 1135 Western Standard Time,¹ on the student's third solo circuit to runway 06R, ZTM began to drift to the left of the runway centreline. The student elected to go-around and applied full power. Following the application of power, the nose pitched up abruptly and the aircraft then rolled to the left before pitching nose down. The left wing tip contacted the ground and the nose gear and right main gear collapsed before the aircraft came to a stop. The student pilot was able to exit the aircraft without injury, however the aircraft sustained substantial damage.

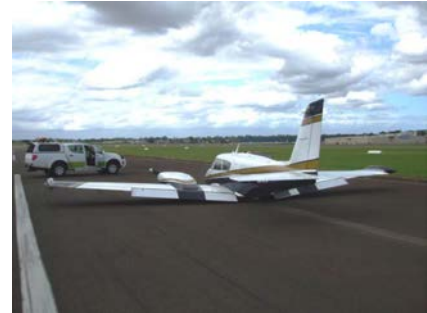
VH-HPR

HPR touched down on the main wheels followed by the nose wheel, which collapsed when it contacted the ground, followed by the left main wheel and right main wheel. HPR then slid on its belly between 300 and 400 m, before coming to rest to the right of the runway centreline. The pilot and passengers exited the aircraft without injury and the aircraft sustained substantial damage.

Inspection of the aircraft by a licenced maintenance organisation was arranged by the insurer. The landing gear mechanism was visually inspected and the worm drive was almost to the full retraction position, indicating the gear was retracted electrically. A number of partial retractions were able to be performed within the limits permitted by the damage and the system operated normally.

The reason for this electrical retraction despite the gear selector being in the down position was not determined. However, it was considered that an electrical fault within the squat switch³ system may have been a factor in the failure of the gear to retract.

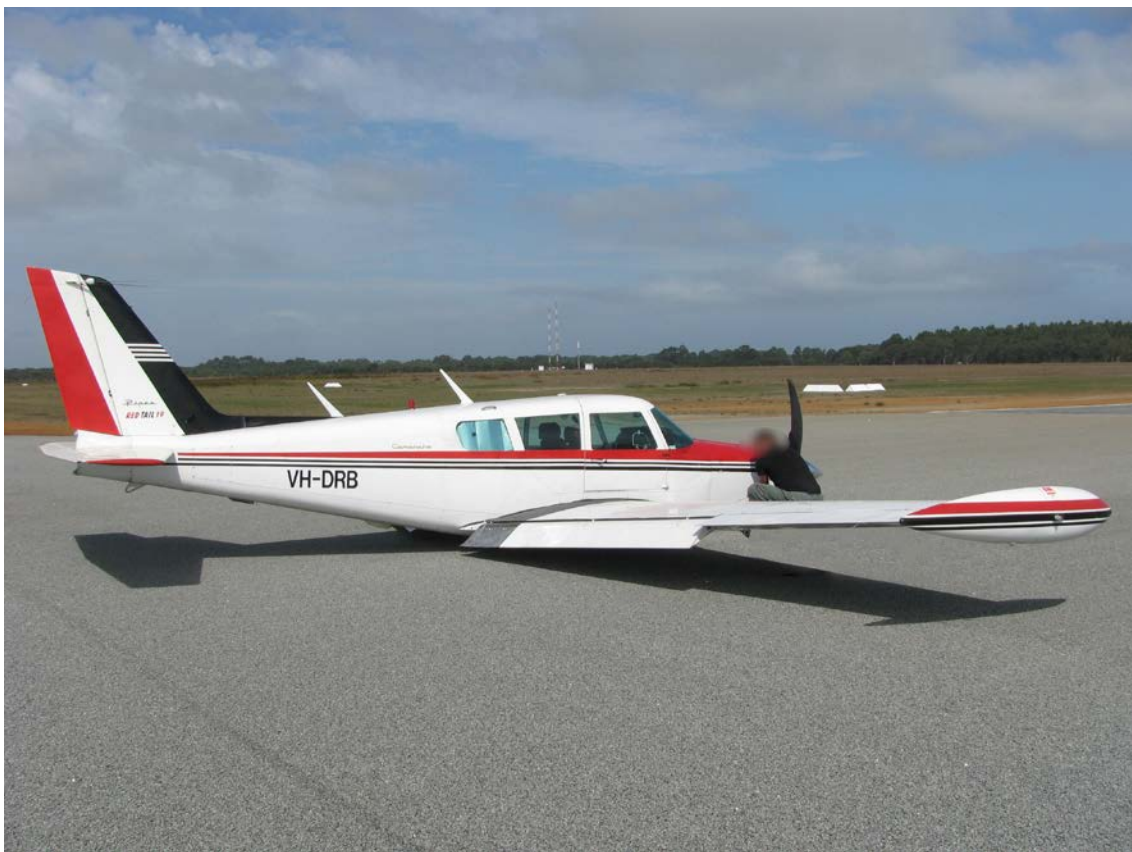
Figure 1: VH-DRB

After conducting the aerial work component of the flight review, DRB returned to the circuit for a touch and go, followed by a flapless touch and go, on runway 14. On take-off after the flapless touch and go, the testing officer informed the pilot that the circuit would be at low-level for a full stop landing. On early downwind, the testing officer asked the pilot if a glide approach could be made for runway 23 and the decision was made to conduct a practice forced landing on runway 23. The pilot moved the throttle lever to reduce engine power and extended the flaps to slow the aircraft. On final, the testing officer thought she saw the pilot move his hand to the landing gear selector. The aircraft subsequently landed with the landing gear retracted just past the intersection with runway 14/32, skidded and then came to a stop (Figure 1). The pilot and testing officer were not injured and the aircraft sustained minor damage.

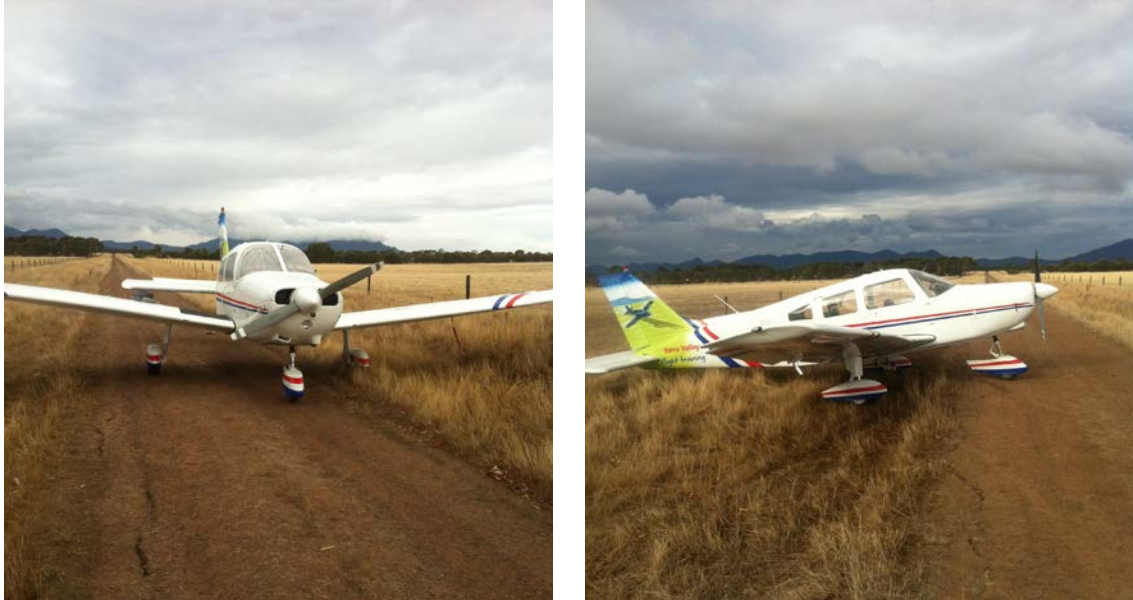
Figure 3: VH-MSG after landing (left) and moved off the road shortly after (right)

The pilot reported that the actual headwinds experienced on the flight were stronger than that forecast, which resulted in a reduced ground speed and increased flight time. He estimated that his actual arrival time at Hamilton was 1 hour or more after his planned arrival time. It was likely that the forecast trough was passing through the area at that time.

As a result of this occurrence, the aircraft operator has advised the ATSB that they are considering incorporating into their operations manual, minimum weather criteria for student pilots conducting solo navigation flights. These criteria would exceed the visual meteorological conditions (VMC) minima and the VFR alternate aerodrome requirements stipulated in the Aeronautical Information Publication (AIP)⁶, and also include a minimum time buffer on forecast changes to non-VMC.

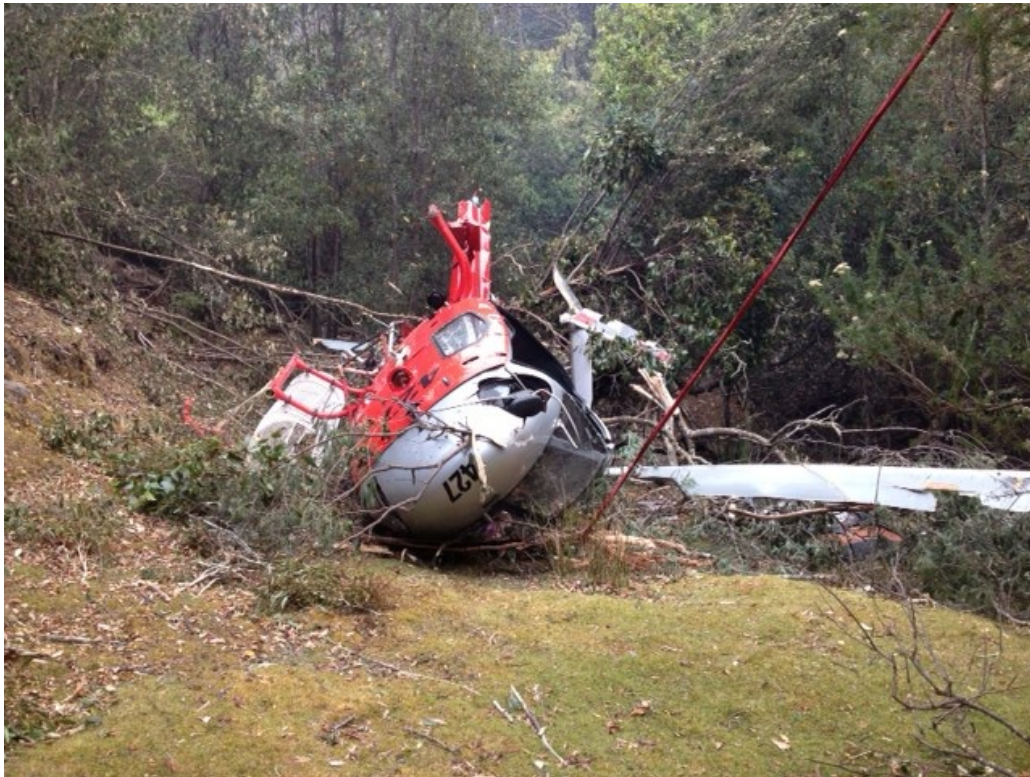
Figure 2: VH-EWM at the accident site

On 7 February, 2013 at about 1655 Eastern Daylight-saving Time¹ a Eurocopter AS350 B2 helicopter², registered VH-EWM (EWM) was conducting water-bombing operations near Hobart, Tasmania, when it collided with terrain (Figures 1 and 2). The pilot, the sole person on board, suffered minor injuries and the helicopter sustained substantial damage.

The operator completed an investigation of the crash site, and interviewed the pilot in command. After collating this information, coupled with the environmental and flying conditions both prior to and during the accident sequence, they suggested the helicopter may have experienced settling with power.

BEA noted that if the uncommanded descent could be associated with vortex ring phenomenon or a loss of power, the left yaw could not have been triggered by one of them. They added that the left yaw could be explained by a loss of the tail rotor effectiveness (LTE).
