Operation below minimum safe altitude involving Aero Commander, VH-TQA

7 km south of Townsville Airport, Queensland, 11 April 2013

ATSB Transport Safety Report
Aviation Occurrence Investigation
AO-2013-078
Final – 17 September 2013

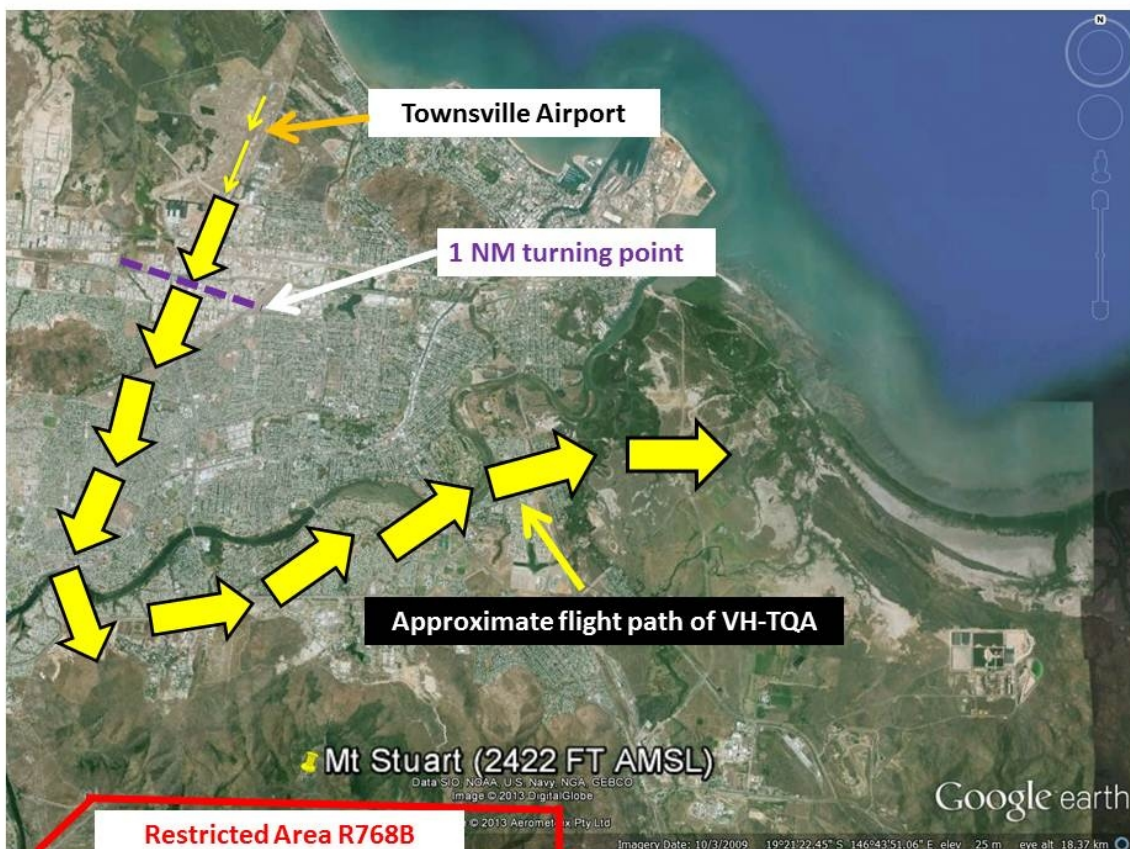
Figure 1: Approximate flight path of VH-TQA

Prior to taxiing, the pilot received a clearance from Townsville air traffic control (ATC)² to depart via the runway 19 TOWNSVILLE SOUTH THREE standard instrument departure (SID). Due to the proximity of Mount Stuart³ and Restricted Areas 'R768A' and 'R768B'⁴ (Figure 1), the SID required the pilot to turn left onto a track of 105° when at 1 NM; ATC will then issue radar vectors according to the flight planned track and other traffic at the time.

The pilot misunderstood this comment to be a radar vector, read back 'left 105°' and commenced a turn onto that heading. The aircraft was now in instrument meteorological conditions (IMC)⁷ and approaching 4 NM south of the airport. At that time, the aircraft was 1,500 ft below the radar terrain clearance chart (RTCC) step.

Shortly after, the Tower controller suggested to the Approach controller that a safety alert be issued. The Approach controller then issued a restricted airspace alert to the pilot. He also reminded the pilot that the lowest safe altitude (LSALT)⁸ for the area was 3,500 ft, which the pilot acknowledged, advising TQA was now climbing through 2,500 ft.
