Australian Transport Safety Bureau

Total power loss involving a Mooney M20J, VH-NFP

Canberra Airport, Australian Capital Territory, 2 June 2013

ATSB Transport Safety Report
Aviation Occurrence Investigation
AO-2013-092
Final – 17 September 2013

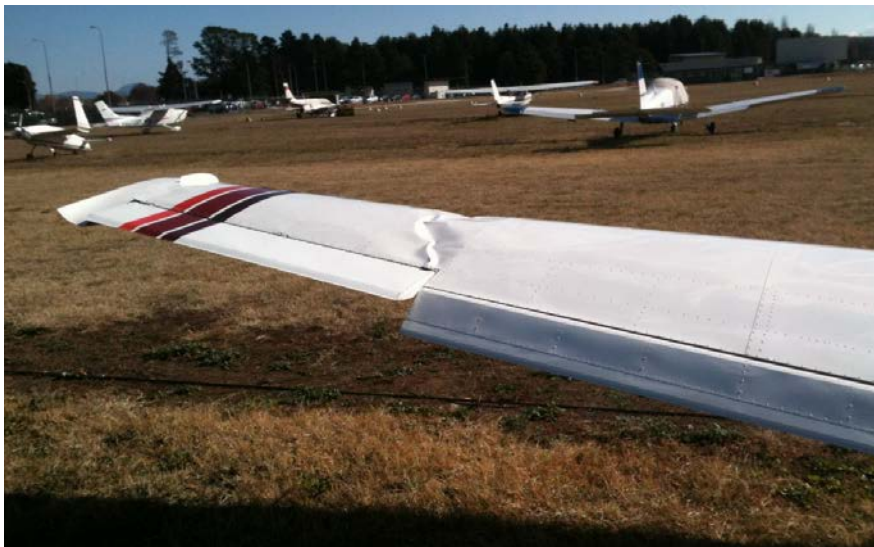
The pilot retracted the landing gear at about 100 ft above ground level. Within seconds of retracting the gear, the engine stopped. The pilot lowered the landing gear, switched fuel tanks and lowered the aircraft nose to increase airspeed. While he was conducting emergency checks, the aircraft descended and landed on the runway heavily on the left wing and landing gear, with the propeller striking the ground (Figure 1).

An inspection of the aircraft and engine after the accident revealed water in the left wing fuel tank, fuel system and fuel injector lines. The pilot reported that he contacted the Mooney Service Centre and was advised that incorrect re-sealing of the M20 series aircraft fuel tanks could allow 1 to 2 litres of water to be retained in the wing, which could not be drained.

Figure 1: Left wing damage to VH-NFP
