Collision with terrain involving a Bell 412, VH-EMZ

12 km WSW Horn Island Airport, Queensland, 13 June 2013

ATSB Transport Safety Report
Aviation Occurrence Investigation
AO-2013-099
Final – 17 September 2013

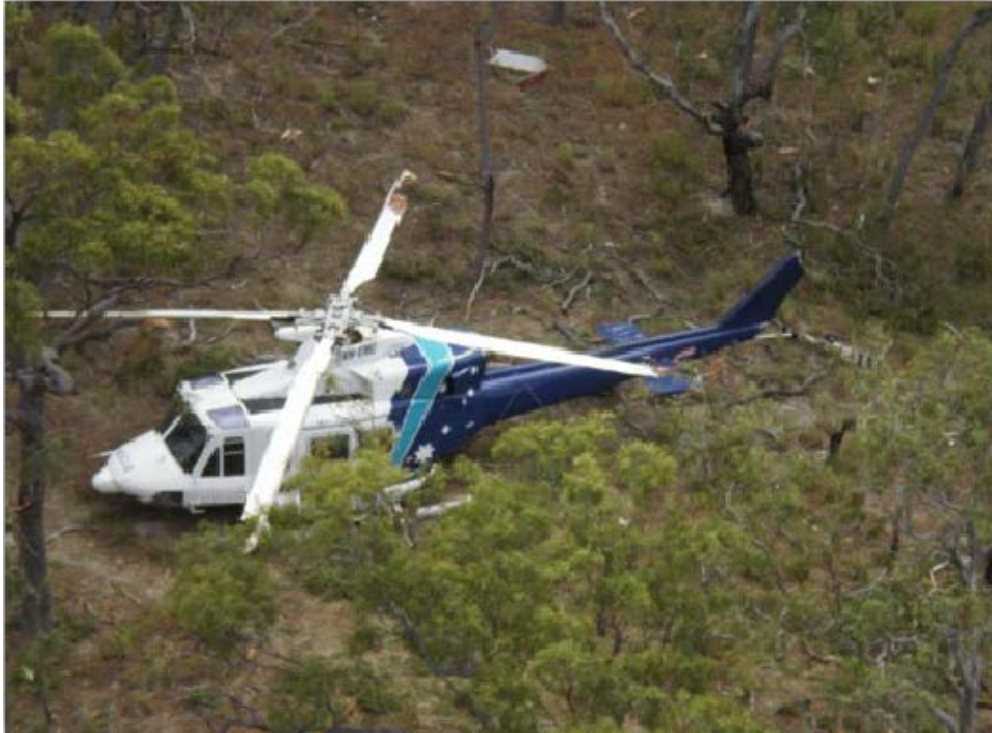
Figure 1: Helicopter at accident site

The training pilot reported that he took the controls to assist with the go-around and then became aware of the trees in his peripheral vision. The training pilot called 'brace, brace, brace' as the helicopter descended into the trees. The helicopter impacted the ground heavily and remained upright. The crew shut down the helicopter. To assist the rescuers in locating the helicopter, the crew discharged flares from the accident site. The crew were uninjured and the helicopter was substantially damaged.

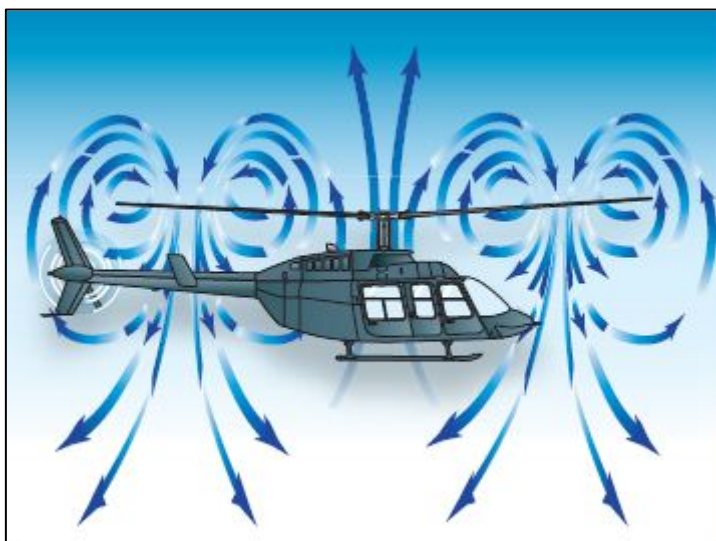
Figure 2: Vortex ring state

- The high rate of descent and decreasing airspeed is hypothesised to have resulted in the onset of an incipient vortex ring state (VRS) in the final stages of flight.

A fully developed vortex ring state is characterized by an unstable condition in which the helicopter has uncommanded pitch and roll oscillations, little or no collective authority, and a descent rate that may approach 6,000 feet per minute (fpm), if allowed to develop (Figure 2).
