Australian Government Australian Transport Safety Bureau

Aircraft proximity event between a Janus glider, VH-IZI and a McDonnell Douglas 500N, VH-KXS

Bacchus Marsh (ALA), Victoria, 29 June 2013

ATSB Transport Safety Report Aviation Occurrence Investigation AO-2013-108 Final – 17 September 2013 Released in accordance with section 25 of the Transport Safety Investigation Act 2003

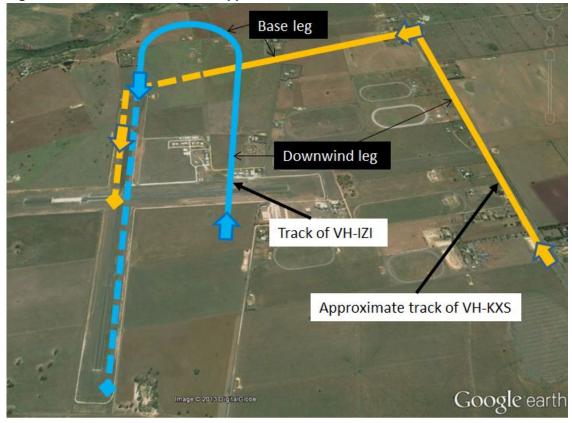
Figure 2: GPS track of VH-IZI and approximate track of VH-KXS

At about 1430 Eastern Standard Time,² IZI joined the downwind leg of the circuit for runway 19. After ensuring the radio volume was turned up, the pilot reported broadcasting a downwind call on the CTAF. Towards the end of the downwind leg, while descending through about 500 ft, the passenger in the front seat of IZI observed a helicopter (KXS) in his 12 o'clock³ position. The pilot then observed KXS below him, on a diagonal track for runway 19 (Figure 2). The pilot estimated that KXS passed about 100 ft below IZI. He further reported that he did not hear any calls from the pilot of KXS on the CTAF.

When established on late base, at 500 ft, the pilot of KXS reported sighting IZI on downwind, in his 10 o'clock position, about 100 ft above and 100 m away. The pilot stated that he did not believe there was any risk of a collision with IZI and continued with the circuit. He reported that he did not hear a downwind call from IZI.⁴
