# Loss of control involving Robinson R44, VH-WOH

20 km south-west of Mudgee, New South Wales | 9 December 2012

**ATSB Transport Safety Report**  
Aviation Occurrence Investigation  
AO-2012-165  
Final – 26 September 2013

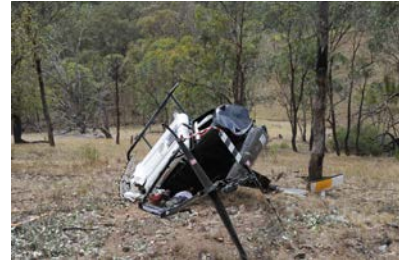
## Helicopter wreckage

On 9 December 2012, the pilot of a Robinson R44 Raven I helicopter, registered VH-WOH, was conducting aerial spraying activities on a property near Mudgee, New South Wales. Following the completion of a number of spray runs, the helicopter failed to return to the refilling station, and a search was commenced. The helicopter was found about 450 m up a hill from the refilling station, having collided steeply with terrain. The pilot was fatally injured.

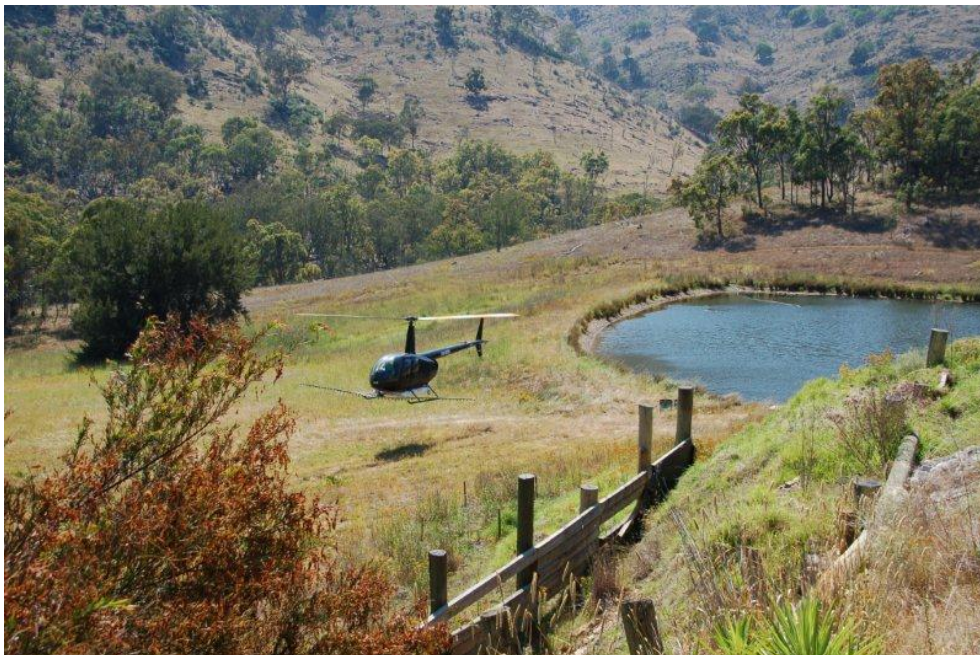
**Figure 1: Helicopter landing at the refilling station**

The pilot completed seven spray runs around the property, reloading with 240 L of chemical mix each time. At about 0945, having refuelled and reloaded with chemical, the pilot departed on what was reported to be the final run prior to moving operations to the neighbouring property.

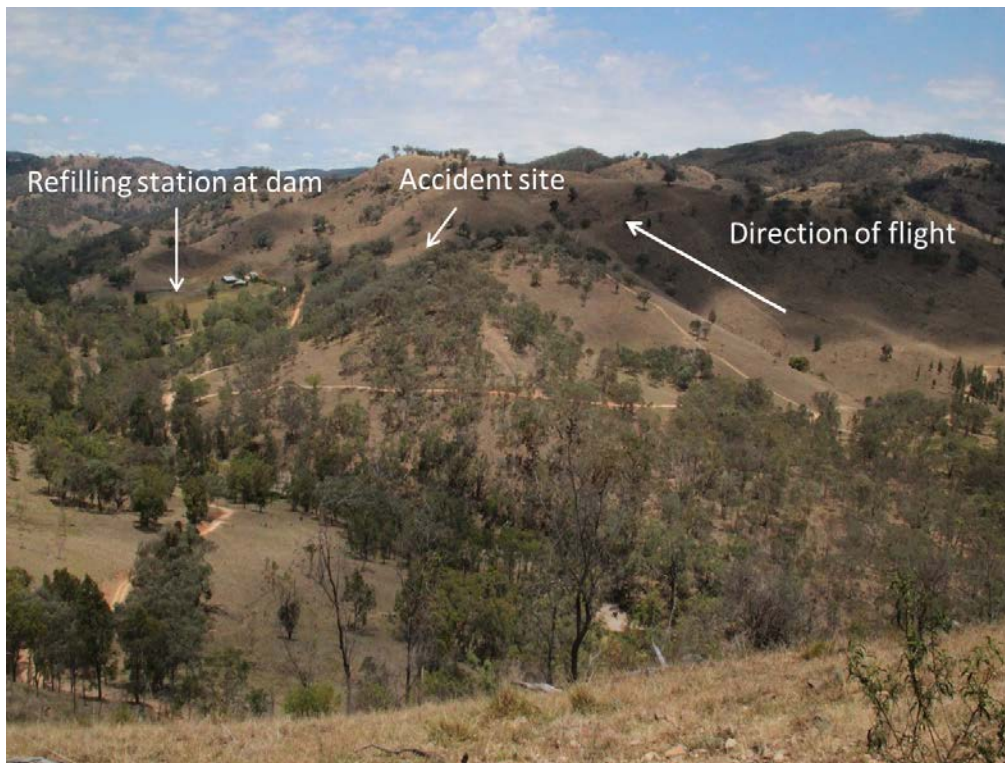
**Figure 2: Overview of the property and accident site**

At about 1015 the loader and neighbouring property owner became concerned that the helicopter had not returned and, along with the property owner, initiated a search. At about 1100, the helicopter was found on steep terrain about 450 m from the refilling station. The damage to the helicopter and disturbance of the surrounding area indicated that the helicopter contacted a tree before impacting the ground in a steep nose-down attitude with the right skid low (Figure 2, 3 and 4). The pilot was fatally injured and the helicopter seriously damaged.<sup>2</sup> There was no fire.

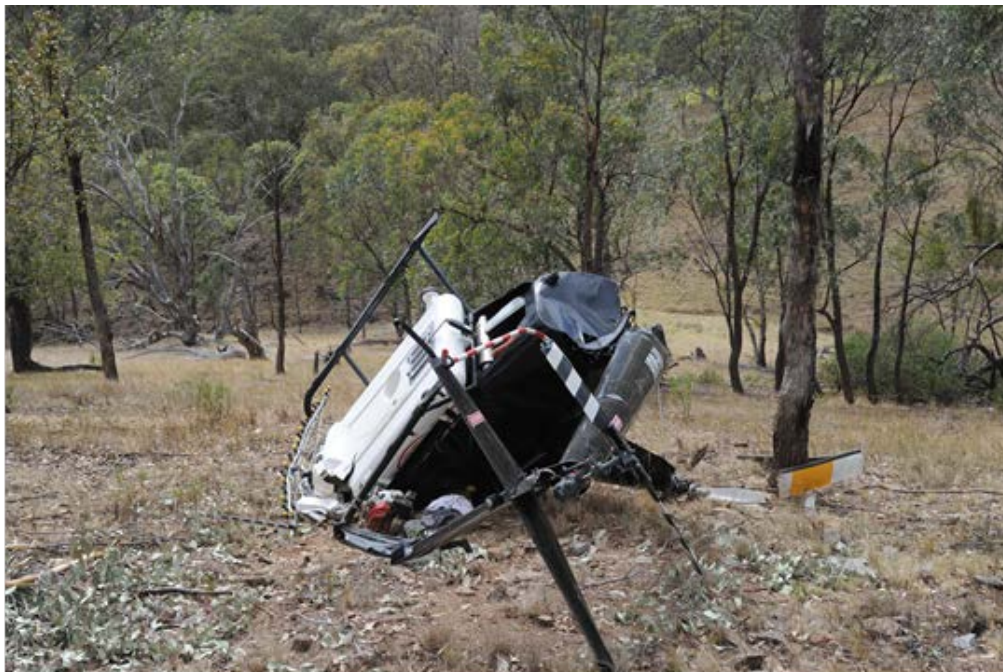
**Figure 3: Accident site showing the helicopter's position at ground impact**

The wreckage of the helicopter was situated on steep terrain that was inclined at a slope of about 23°. The damage to the helicopter and a nearby tree were consistent with the main rotor blades contacting tree branches before the helicopter collided steeply with terrain (Figure 5).

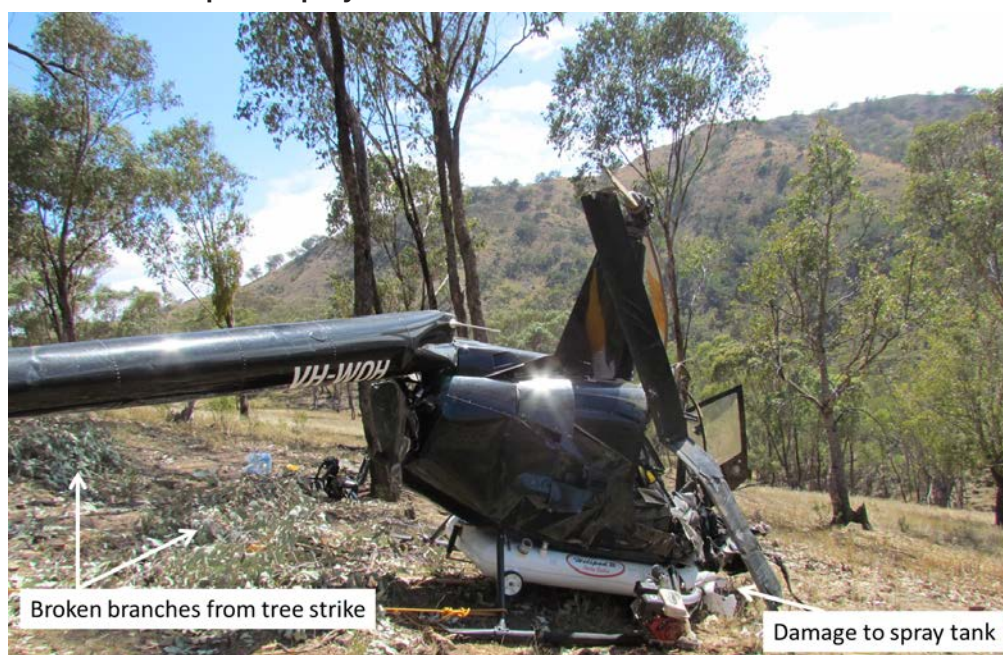
**Figure 5: WOH (uprighted) showing the damage to the surrounding branches and helicopter's spray tank**

The front right corner of the spray tank was ruptured during the impact sequence and the witness reported that on arrival at the accident site, there was no chemical load remaining in the tank and no evidence of chemical in the vicinity. This apparent contrast with the ATSB's assessment that the majority of chemical was on board at the time of the accident (see the previous section titled *Helicopter information*), was probably explained by the combination of the time between the accident occurring and the witness arriving at the scene, the rupture to the spray tank and the nature of the terrain. This would have allowed any chemical to drain from the tank and down the hill.

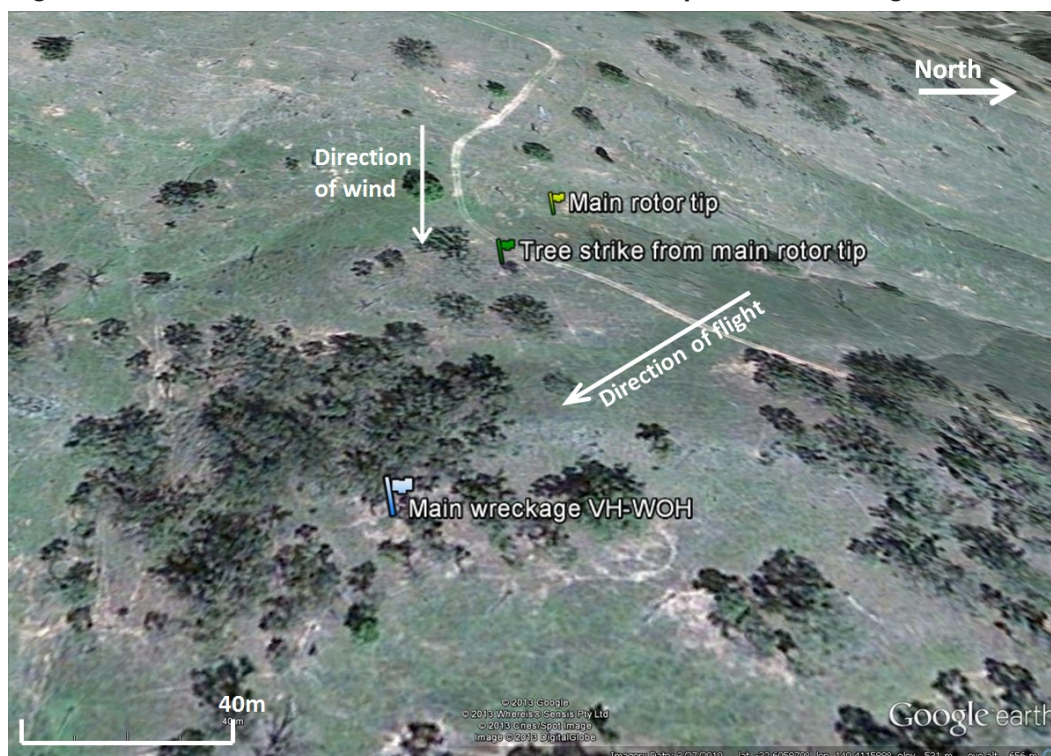
**Figure 6: Location of the detached main rotor blade tip and tree damage**

The fuselage and tail, including the tail rotor assembly, and most of the main rotor blades were contained within the impact site. One main rotor blade tip was found about 162 m from the accident site, on the other side of the hill. Damage to a tree in that area was consistent with the main rotor blade tip detaching from near the accident site and travelling up the hill, before striking the tree. The main rotor tip then came to rest on the other side of the hill (Figure 6).

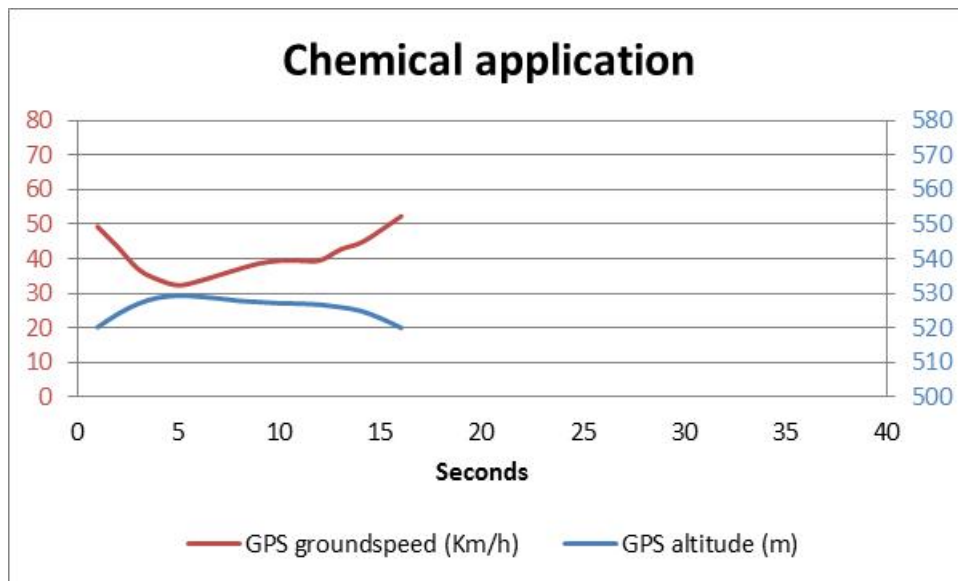
**Figure 7: Speed and height variation during chemical application**

Analysis of the GPS data identified the typical operating profile for the helicopter during aerial spraying activities in the days prior to the accident and the spray runs conducted on the day. These profiles were consistent and showed the pilot operating at speeds as low as 9 kt (17 km/h) in the turns during chemical application. The GPS data also recorded those times when the chemical was dispersed. Examination of this data indicated that on the final spray run the majority of the 240 L of chemical was still on board. The data also showed that while at low speed, the pilot manoeuvred to trade speed for height and vice versa. That is, as the helicopter's speed dropped off in the turn, it was climbing before, at the top of the climb, the pilot would complete the turn and regain speed (Figure 7). Speed is increased in a helicopter by lowering the nose and applying power as required. Of note, during the accident spray run, the speed did not decrease below effective translational lift (ETL)<sup>7</sup> until commencement of the final, sustained, climb (Figure 8).

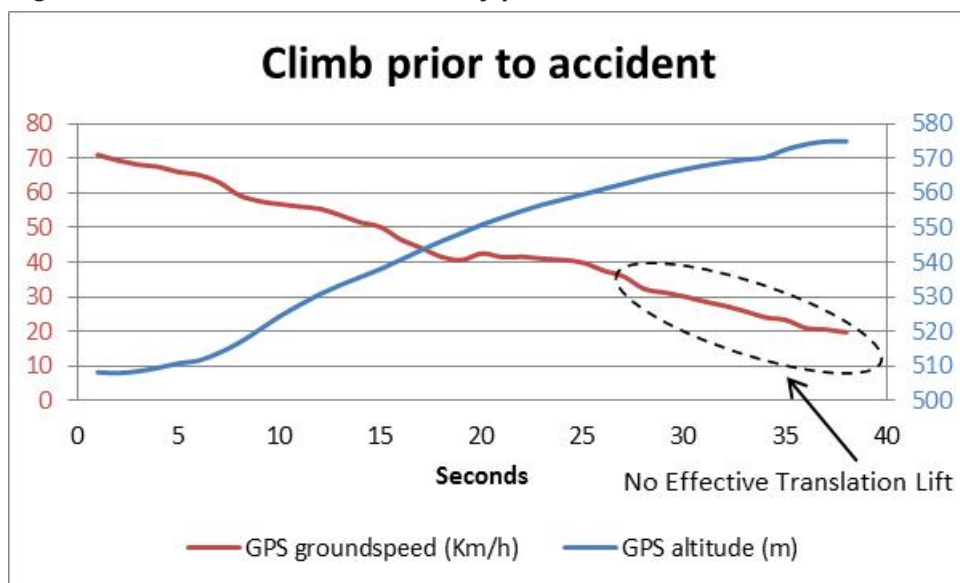
**Figure 8: Sustained climb immediately prior to the accident**

The final segment of GPS data identified that the helicopter was not conducting spray activities at that time. During the final manoeuvring the helicopter climbed for about 35 seconds while the groundspeed reduced to about 10 kt (19 km/h), which, based on the BoM assessment of the likely wind, meant the helicopter's airspeed was probably at or less than the recorded groundspeed. In this case, the helicopter was no longer above ETL, increasing the engine power required for the manoeuvre. Based on the final groundspeed of about 10 kt (19 km/h), the helicopter would have taken about 6 seconds to cover the 33 m from the last recorded GPS position to the accident site.

Consideration of the groundspeed and altitude of the final data point with reference to the underlying sloping terrain identified that the helicopter was effectively in an OGE hover at that time.

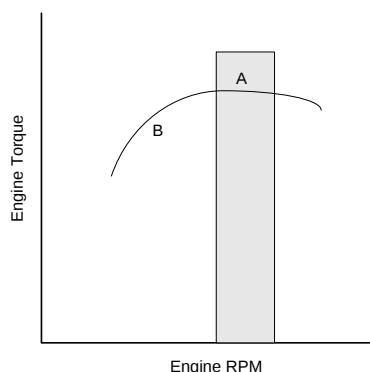
**Figure 9: Typical piston engine torque - RPM characteristics<sup>9</sup>**

The operation of a piston-engine helicopter within the engine's normal RPM range, shaded region 'A' in Figure 9, results in minimal variation in the available engine torque. However, as the engine RPM reduces below that operating range and into region 'B', there is an increasingly significant reduction in the available engine torque and power available to drive the rotor. In consequence, there can be an additional reduction in main rotor RPM.
