Loss of separation involving Boeing 737, VH-VUV and Boeing 737, VH-VXM

near Ceduna, South Australia | 8 November 2011

ATSB Transport Safety Report
Aviation Occurrence Investigation
AO-2011-144
Final – 18 October 2013

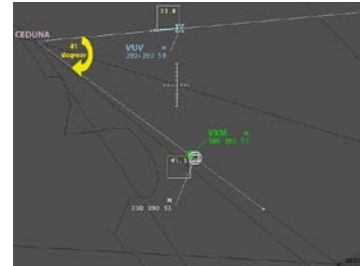
Aircraft positions at 1409:20

On 8 November 2011, a loss of separation occurred between a Boeing Company 737-8FE, registered VH-VUV, and a Boeing Company 737-838, registered VH-VXM, near Ceduna, South Australia. The aircraft were conducting scheduled passenger flights and were under the air traffic control of Airservices Australia (Airservices). The aircraft were operating on converging tracks at 39,000 ft. The procedural longitudinal separation standard of 20 NM (37 km) was infringed. It is likely that there was between 6 NM (11.1 km) and 12 NM (22.2 km) longitudinal separation between the aircraft.

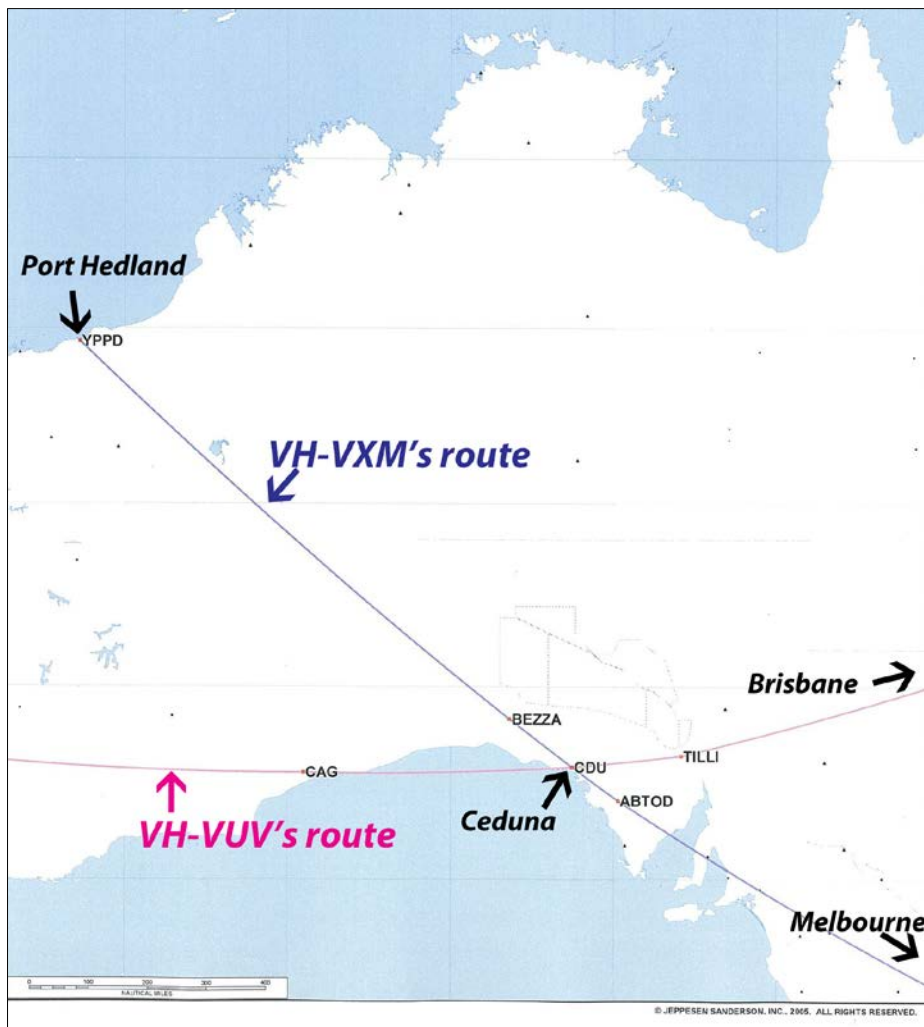
Figure 1: Routes of VH-VUV and VH-VXM

The two aircraft were on different routes, but both were planned to track overhead Ceduna (Figure 1). Both aircraft were also operating at flight level (FL)³ 390. As the magnetic tracks for both aircraft were within the arc from 000° to 179°, the use of the same FL was consistent with relevant requirements.

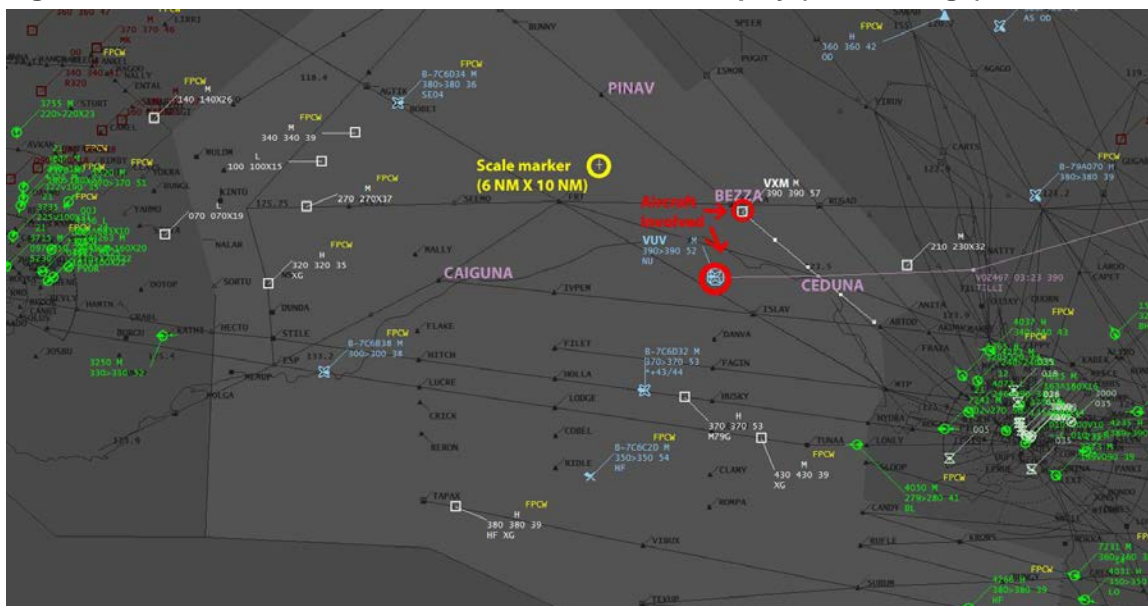
Figure 2: Nullarbor/Nullarbor Low sectors air situation display (default range) at 1352:35

At 1352:35, the crew of VXM reported reaching BEZZA and estimated being overhead Ceduna at 1404, maintaining FL 390. At that time, VUV was 114 NM (211 km) from Ceduna (Figure 2 and Figure 3) and, based on air traffic system data, was estimating to be overhead Ceduna at about 1405.

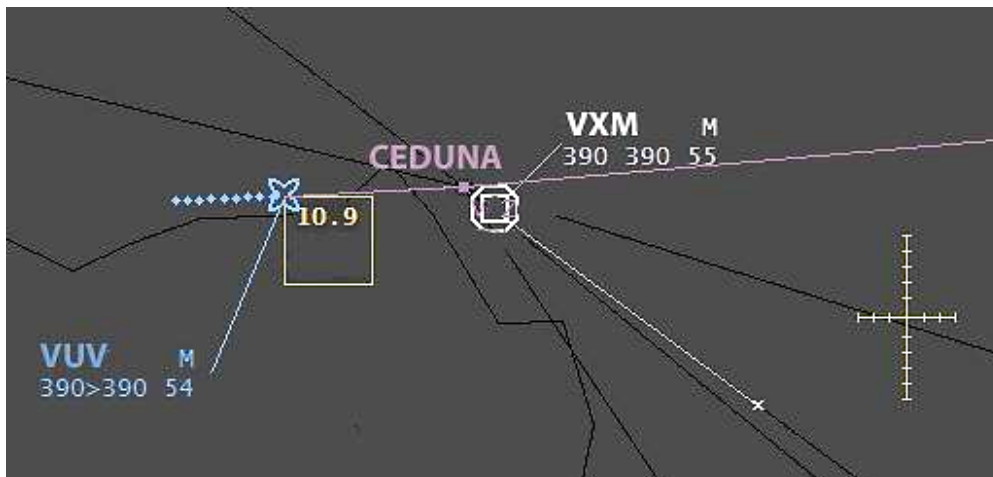
Figure 4: Displayed positions of the aircraft at 1404:19

At 1404:19, over an hour after the aircraft had entered the NUL sector, the loss of separation occurred when VUV was 10.9 NM (20.2 km) from Ceduna and VXM was also within 11 NM of Ceduna (Figure 4). The estimated arrival times for the two aircraft overhead Ceduna indicated that there would be 2 minutes between the aircraft, which was less than the required 10-minute procedural time separation standard.⁴ The separation was also less than the longitudinal separation standard of 20 NM (37 km), or the lateral separation standard of 11 NM (20.4 km), which were also both procedural standards. In the event that longitudinal or lateral separation did not exist, the vertical separation standard required was 1,000 ft.

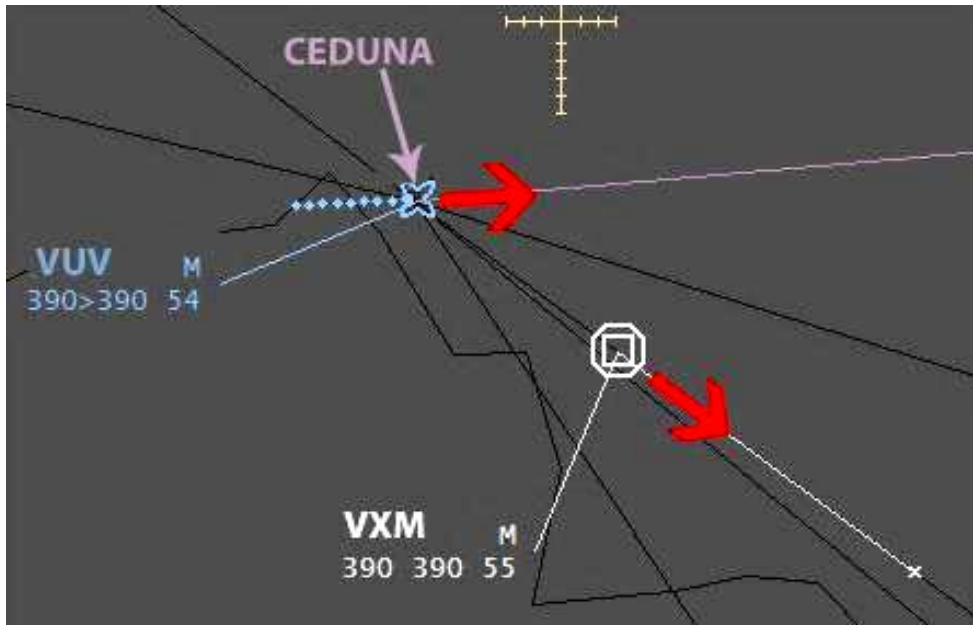
Figure 5: Displayed positions of the aircraft at 1405:33

At 1405:33, ADS-B data indicated that VUV was overhead Ceduna (Figure 5). The crew of VXM subsequently reported (at 1407:22) that they had been overhead Ceduna at 1404. As the times

reported to ATC were to be rounded within a 30-second period, VXM would have been overhead Ceduna sometime between 1403:31 and 1404:29. As VUV was observed on ADS-B to be overhead Ceduna at 1405:33, the time between the two aircraft would have been between 63 seconds and 122 seconds. Based on a groundspeed of about 6 NM per minute for the Boeing 737 aircraft, it was estimated that there was 6 to 12 NM longitudinal separation between the two aircraft when VUV was overhead Ceduna.
