Engine failure involving Airbus A380, A6-EDA

near Sydney Airport, NSW, | 11 November 2012

ATSB Transport Safety Report
Aviation Occurrence Investigation
AO-2012-150
Final – 9 September 2013

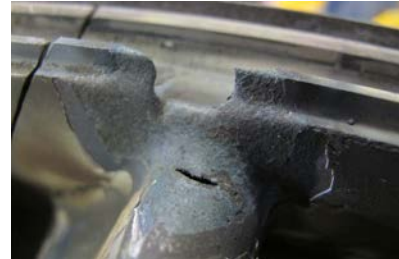
HPT stage-2 nozzle distress

The investigation found that the increase in the exhaust gas temperature and subsequent engine shut down was a result of significant internal damage that had initiated within the high pressure turbine (HPT) module. The damage had resulted from the effects of HPT stage-2 nozzle distress, likely caused by exposure to hotter than expected operating temperatures. The nozzle distress led to eventual failure and separation into the gas flowpath. Over the preceding weeks there were two other engines within the operator's fleet that had experienced a similar problem, and a number of steps had been taken by the manufacturer to address the issue, including the increased monitoring of distress development. During the previous flight, the engine health and trend monitoring program had identified a performance trend shift with this particular engine, and it was due to be inspected upon return to the main base in Dubai.

The engine manufacturer, Engine Alliance, had issued a service bulletin in June 2010 for the replacement of affected HPT stage-2 nozzle segments with new, more durable components during the next workshop visit when the HPT stage-2 was removed from the engine. Following this occurrence, another service bulletin was released on 6 December 2012, requiring the direct inspection of the nozzle segments that had not yet been replaced. The US Federal Aviation Administration also released an Airworthiness Directive which required inspection of the nozzle segments and their removal from service if distress was identified.

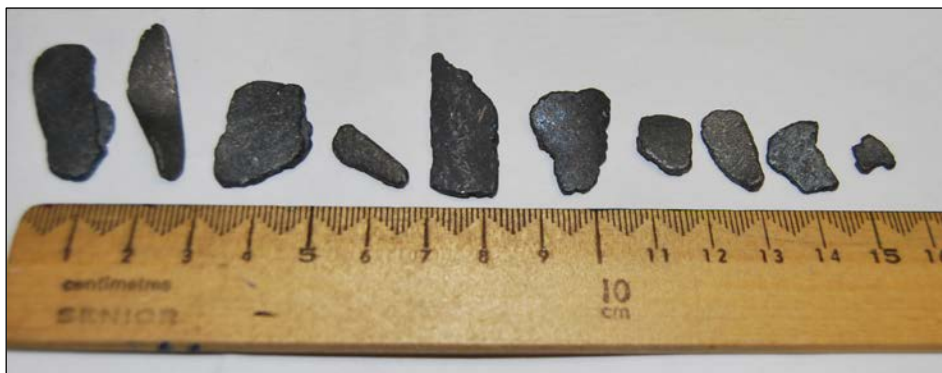
Figure 2: Pieces of engine debris recovered from Riverstone, NSW

A witness to the event reported hearing a distant bang at approximately 2200 on the night of the occurrence, followed by impact noises on the tile roof of their property in Riverstone NSW. Pieces of suspected engine debris (Figure 2) were later collected by the NSW police service.

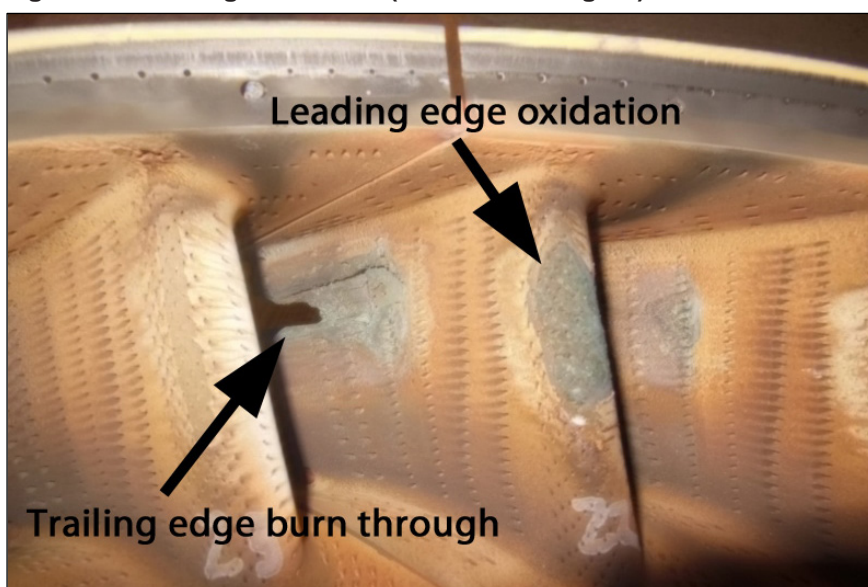
Figure 5: HPT stage-1 nozzles (forward looking aft)

- The fan, LPC and HPC exhibited no significant damage.
- The combustor and fuel nozzles were in good condition with no notable burning or streaking on inner or outer liners.
- The majority of damage sustained by the engine was within the HPT module and downstream.
- Damage to the HPT componentry was most severe in the 6:00 to 9:00 o'clock position (aft looking forward). From the HPT stage-1 shrouds rearward, the nozzles, shrouds and shroud hangers were missing in that quadrant.
- All 40 of the HPT stage-1 nozzles showed varying levels of leading edge distress, including missing thermal barrier coating, oxidation of the base metal and trailing edge burn through (Figure 5). Three nozzles showed distress in the fourth row of cooling holes and two trailing edge inserts showed a white dust accumulation.

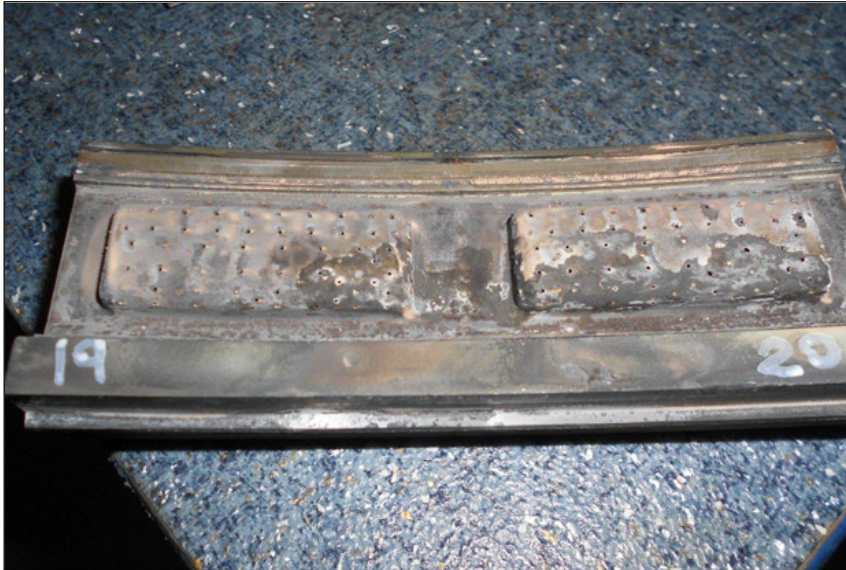
Figure 6: Dust accumulation in HPT stage-1 shroud hangers

The HPT stage-1 shroud hangers showed varying levels of obstruction of the baffles³, consistent with dust accumulation (Figure 6).

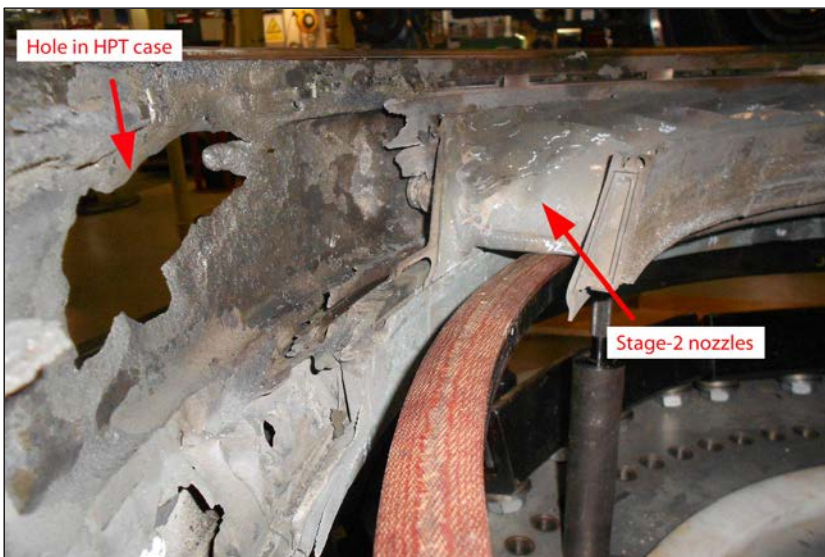
Figure 7: Hole in HPT case and missing stage-2 nozzles

An irregular hole of approximately 4" by 1.5" (100 mm x 37 mm) was located at approximately 9:00 o'clock (aft looking forward) in the HPT case in the plane of the stage-2 nozzles (Figure 7). The hole was not the result of high energy penetration, but was likely the result of erosive oxidation of the case walls as a result of hot flowpath gas getting around the damaged stage-2 nozzles and exposing the inner case surface to greatly elevated temperatures.

The external HPT active clearance control manifold⁴ was heat damaged at the 9:00 o'clock location due to the hole in the HPT case.

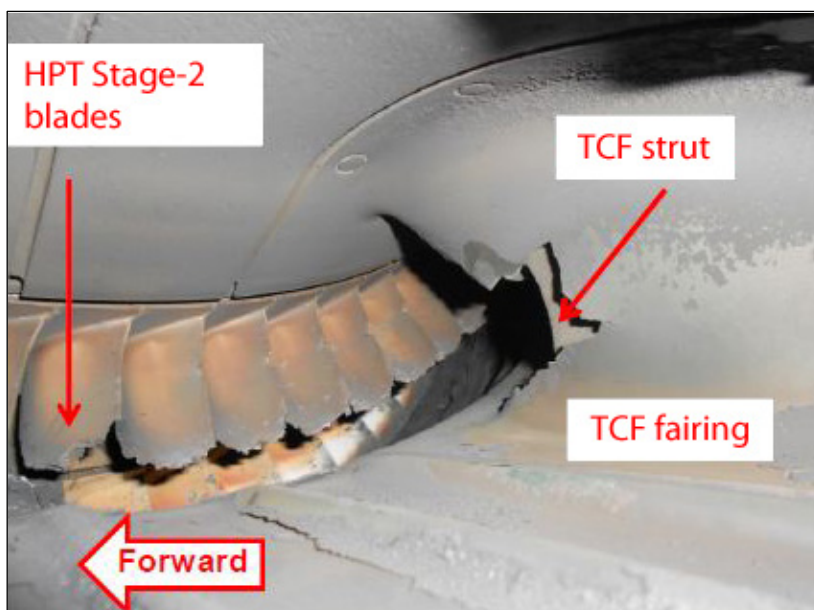
Figure 8: Damage to turbine centre frame (TCF) and HPT stage-2 nozzles

The turbine centre frame (TCF) exhibited extensive impact damage to the panels, fairings and struts. The damage was a result of impinging material liberated from the upstream disruption (Figure 8).
