Left main landing gear collapse involving a Raytheon B200, VH-ZCO

Darwin Airport, Northern Territory, 27 March 2013

ATSB Transport Safety Report
Aviation Occurrence Investigation
AO-2013-062
Final – 17 September

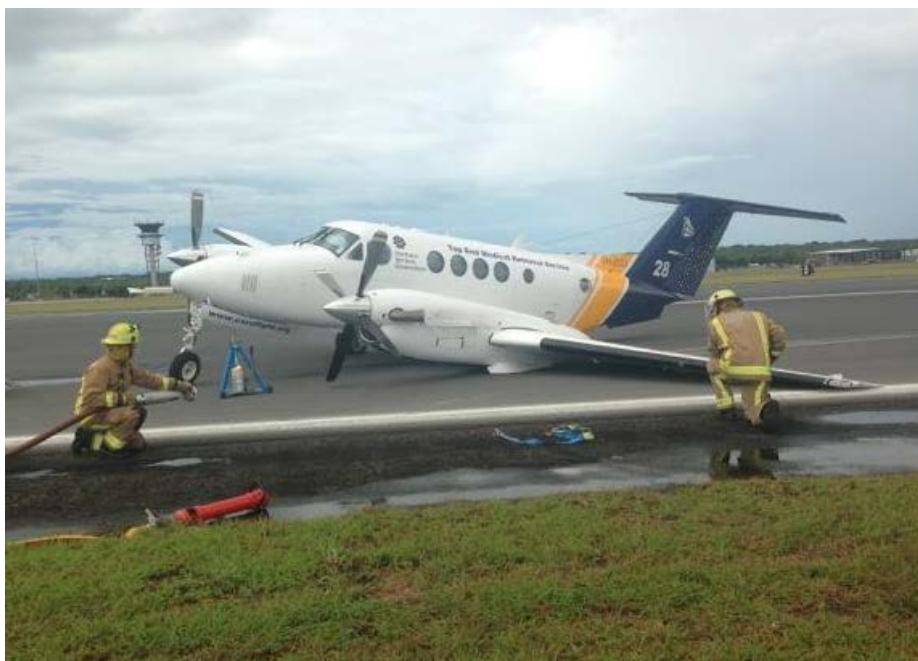
Figure 1: VH-ZCO on runway 29 at Darwin

The pilot reported that on landing, the right main landing gear wheel touched down first and when the left landing gear wheel touched down the pilot felt the left side of the aircraft start to sink. The pilot arrested the sink, transferred the weight to the right landing gear, shut down the left engine and feathered the left propeller. The pilot then shut down the right engine and feathered the right propeller. The left wing then contacted the runway and the aircraft skidded to a stop. The pilot and flight nurses evacuated the aircraft via the overwing exit. The aircraft sustained substantial damage, while the pilot and flight nurses were not injured (Figure1).

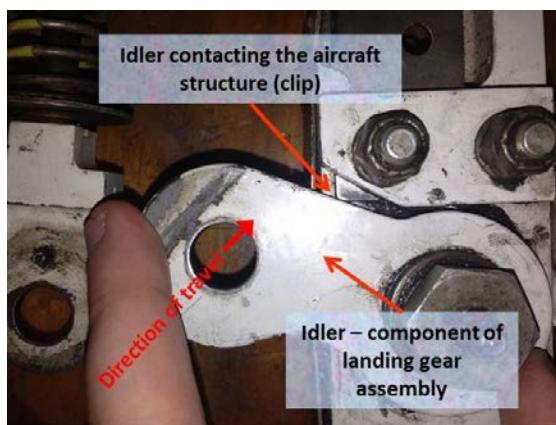
Position found at the accident site

The operator determined that during the last overhaul of the left main landing gear, a washer had not been installed. The operator believed this resulted in the landing gear contacting the aircraft structure preventing the landing gear from locking in the down and locked position (Figure 2). The operator inspected their other B200 aircraft and found another aircraft where the main landing gear was incorrectly assembled.

Figure 2: VH-ZCO main landing gear assembly

The manufacturer was informed of the accident and determined that the missing washer would not have led to the failure of the landing gear to lock down. They believed that it was more likely that the drag brace² was not installed or rigged correctly when installed on ZCO or that another landing gear assembly or maintenance error occurred, causing the circuit breaker to trip, resulting in the accident.

All B200 aircraft were inspected. The main landing gear on one aircraft was found not to be correctly assembled and this was rectified before further flight.

As a result of this occurrence, the aircraft manufacturer has advised the ATSB that the component maintenance manual will be revised to remove the inconsistent numbering.
