Australian Government
Australian Transport Safety Bureau

Aviation Short Investigation Bulletin

Issue 22

AB-2013-132

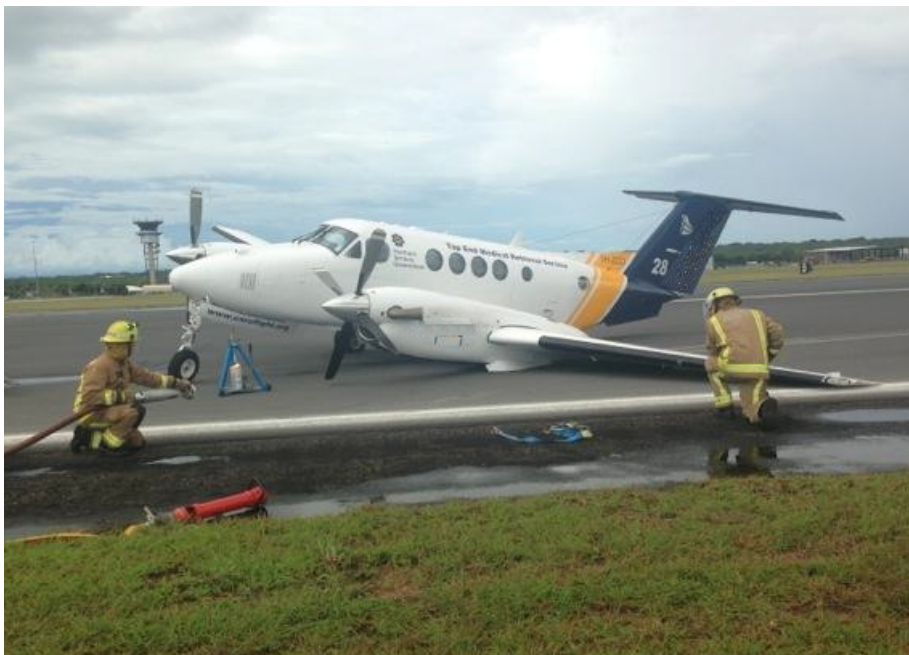
Figure 1: VH-ZCO on runway 29 at Darwin

The pilot reported that on landing, the right main landing gear wheel touched down first and when the left landing gear wheel touched down the pilot felt the left side of the aircraft start to sink. The pilot arrested the sink, transferred the weight to the right landing gear, shut down the left engine and feathered the left propeller. The pilot then shut down the right engine and feathered the right propeller. The left wing then contacted the runway and the aircraft skidded to a stop. The pilot and flight nurses evacuated the aircraft via the overwing exit. The aircraft sustained substantial damage, while the pilot and flight nurses were not injured (Figure1).

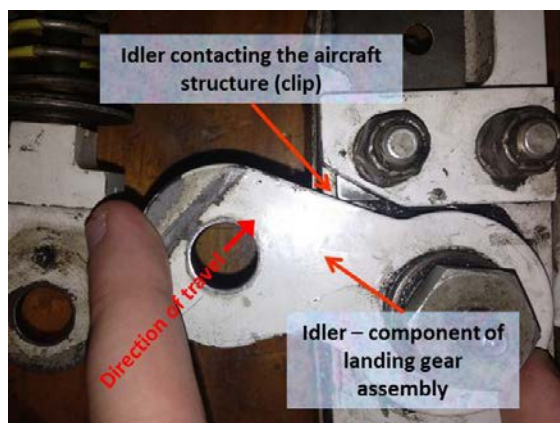
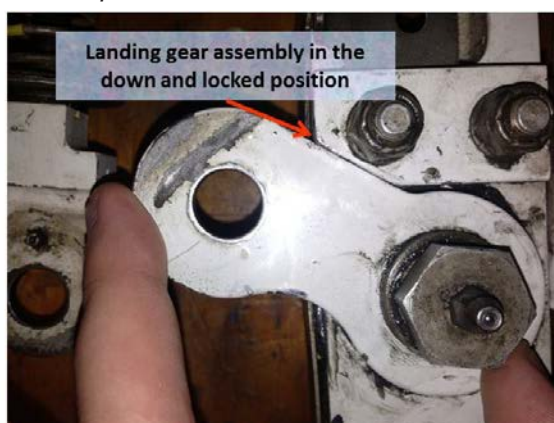
Figure 2: VH-ZCO main landing gear assembly

The operator determined that during the last overhaul of the left main landing gear, a washer had not been installed. The operator believed this resulted in the landing gear contacting the aircraft structure preventing the landing gear from locking in the down and locked position (Figure 2). The operator inspected their other B200 aircraft and found another aircraft where the main landing gear was incorrectly assembled.

Position found at the accident site

Normal position

The manufacturer was informed of the accident and determined that the missing washer would not have led to the failure of the landing gear to lock down. They believed that it was more likely that the drag brace² was not installed or rigged correctly when installed on ZCO or that another landing gear assembly or maintenance error occurred, causing the circuit breaker to trip, resulting in the accident.

The manufacturer reviewed the aircraft component maintenance manual and illustrated parts catalogue; it found that both documents referenced the installation of two washers, although there was an inconsistency in the item numbering. The component maintenance manual and the maintenance manual required a check that the idler fully engaged to the idler stops. In addition, the manufacturer found that the link assembly extension would allow the lock hook to fully engage the lock pin, thereby locking the landing gear down, even with the idler contacting the corner of the clip.

All B200 aircraft were inspected. The main landing gear on one aircraft was found not to be correctly assembled and this was rectified before further flight.

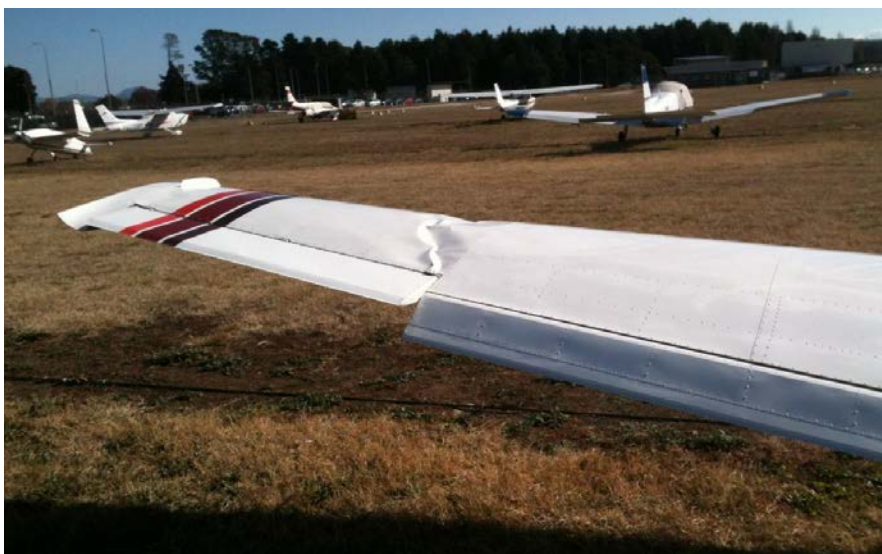
Figure 1: Left wing damage to VH-NFP

An inspection of the aircraft and engine after the accident revealed water in the left wing fuel tank, fuel system and fuel injector lines. The pilot reported that he contacted the Mooney Service Centre and was advised that incorrect re-sealing of the M20 series aircraft fuel tanks could allow 1 to 2 litres of water to be retained in the wing, which could not be drained.

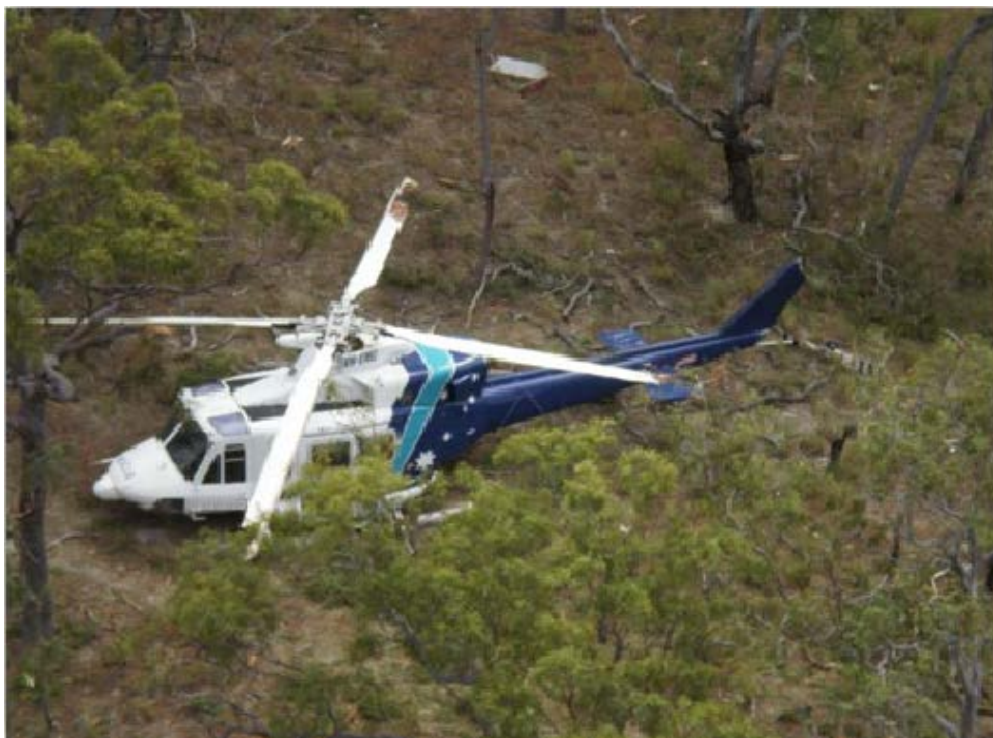
Figure 1: Helicopter at accident site

The training pilot reported that he took the controls to assist with the go-around and then became aware of the trees in his peripheral vision. The training pilot called 'brace, brace, brace' as the helicopter descended into the trees. The helicopter impacted the ground heavily and remained upright. The crew shut down the helicopter. To assist the rescuers in locating the helicopter, the crew discharged flares from the accident site. The crew were uninjured and the helicopter was substantially damaged.
