TECHNICAL ANALYSIS REPORT 17/03

Bolt Fracture High Pressure Turbine Disk Assembly

**Pratt & Whitney Canada PW118A
Engine s/n 115120**

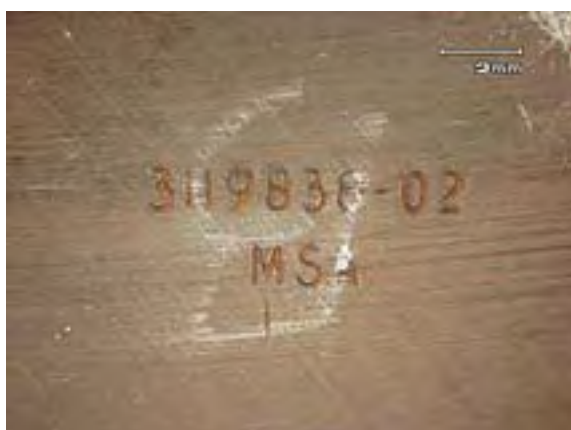
Previous failures of the turbine bolts have involved the initiation and growth of fatigue cracks from the fillet between the shank and head. Service Bulletin, P&WC S.B. No. 20498R1, revision 1, Apr 08/91, introduced a program of bolt modification/rework to minimise the magnitude of stress under the bolt head by increasing the fillet radius. The bolts from engine s/n 115120 were identified with part number 3119838-02, the correct part number for new bolts post service bulletin 20498R1.

Figure 1. One of the turbine bolts from engine s/n 115120 head showing the part number on the bolt head.

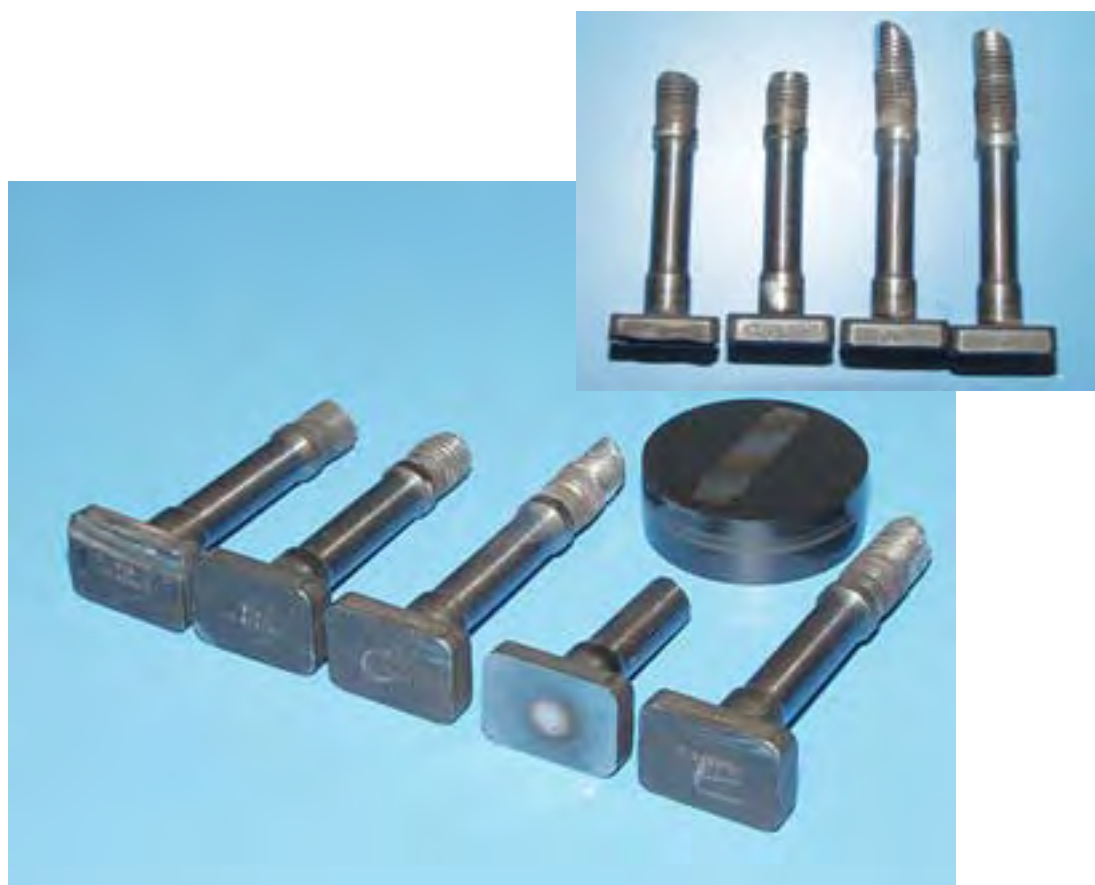
Two of the bolts had fractured in a location generally consistent with the bearing face of the installed nut. The remaining three bolts had been damaged by the process used to remove the nuts. These bolts exhibited some thread root cracking but had not fractured, see figure 2. A metallographic specimen had been prepared from one of the intact bolts.

Figure 2. The turbine bolts as received. The bolts had been identified A through E (arranged left to right in the figure).

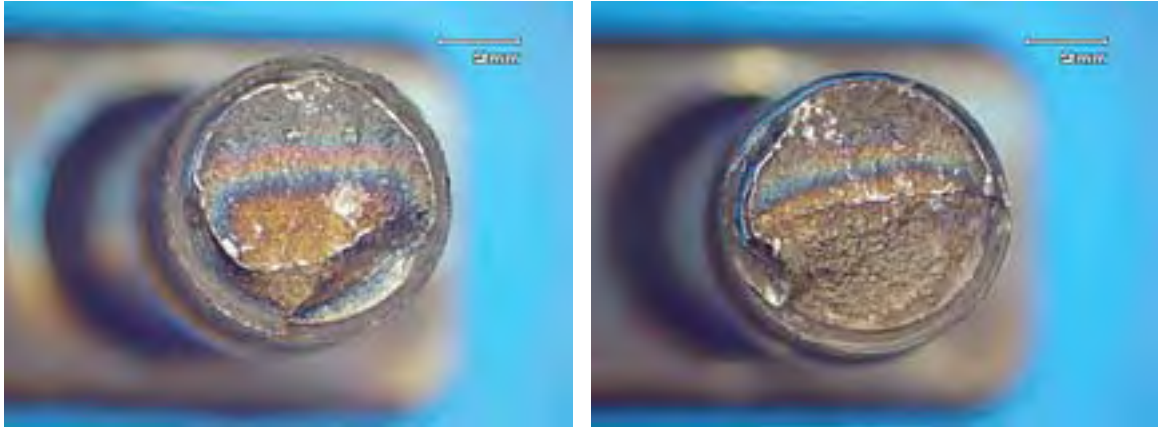
Fatigue crack initiation and growth caused the fracture of the two bolts, see figure 3. The features of the primary fatigue initiation sites were obliterated by the mechanical effects of the progressive loss of structural integrity of the turbine assembly and/or the processes required to remove the bolts from the assembly.

Figure 3. The fatigue fracture surfaces of bolts A (left) and B (right). The interference colours on the fracture surfaces indicate a gradation in oxide film thickness on the fracture surfaces, from thick at the fatigue crack origin, to thin at the final fracture zone.

The failure of the bolts used in the assembly of the high-pressure turbine disk was caused by fatigue crack growth. Crack initiation occurred in the thread roots in the vicinity of the bearing face of the nuts.

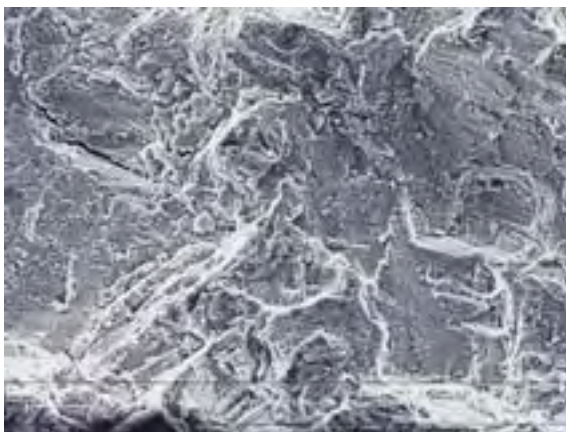
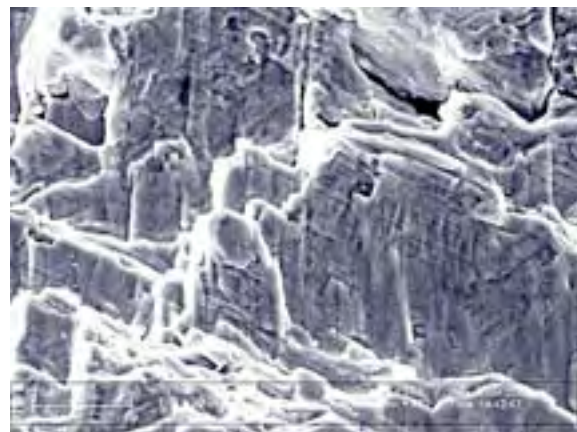
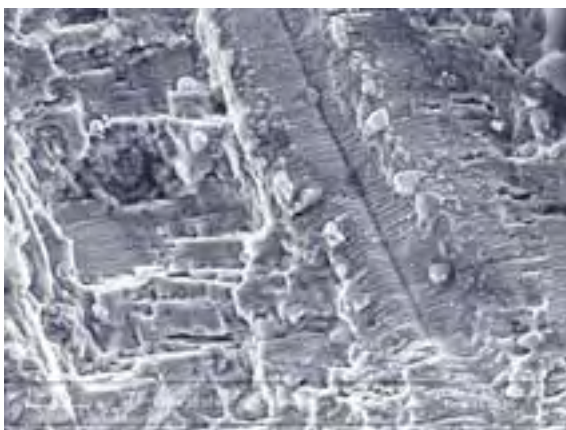
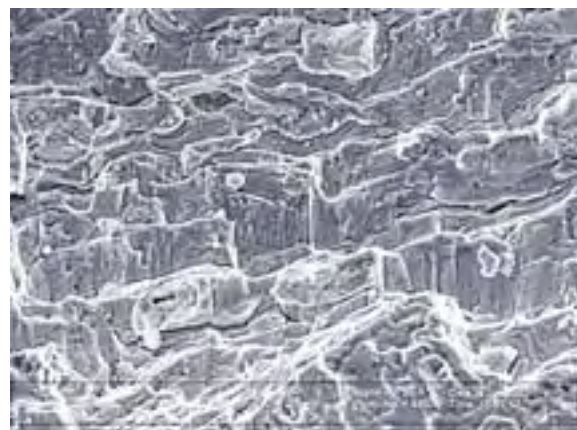
Figure 4. Scanning electron micrographs showing typical features of the fatigue fractures, bolts A and B.

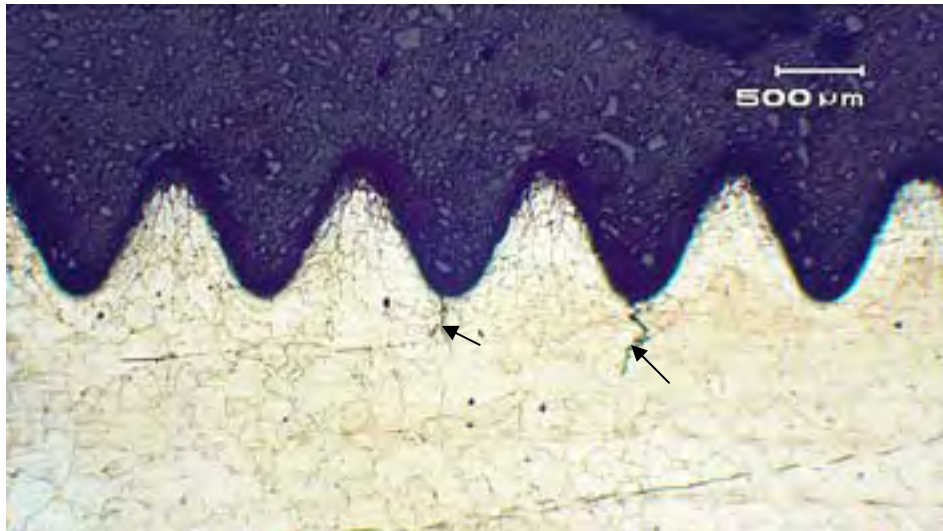
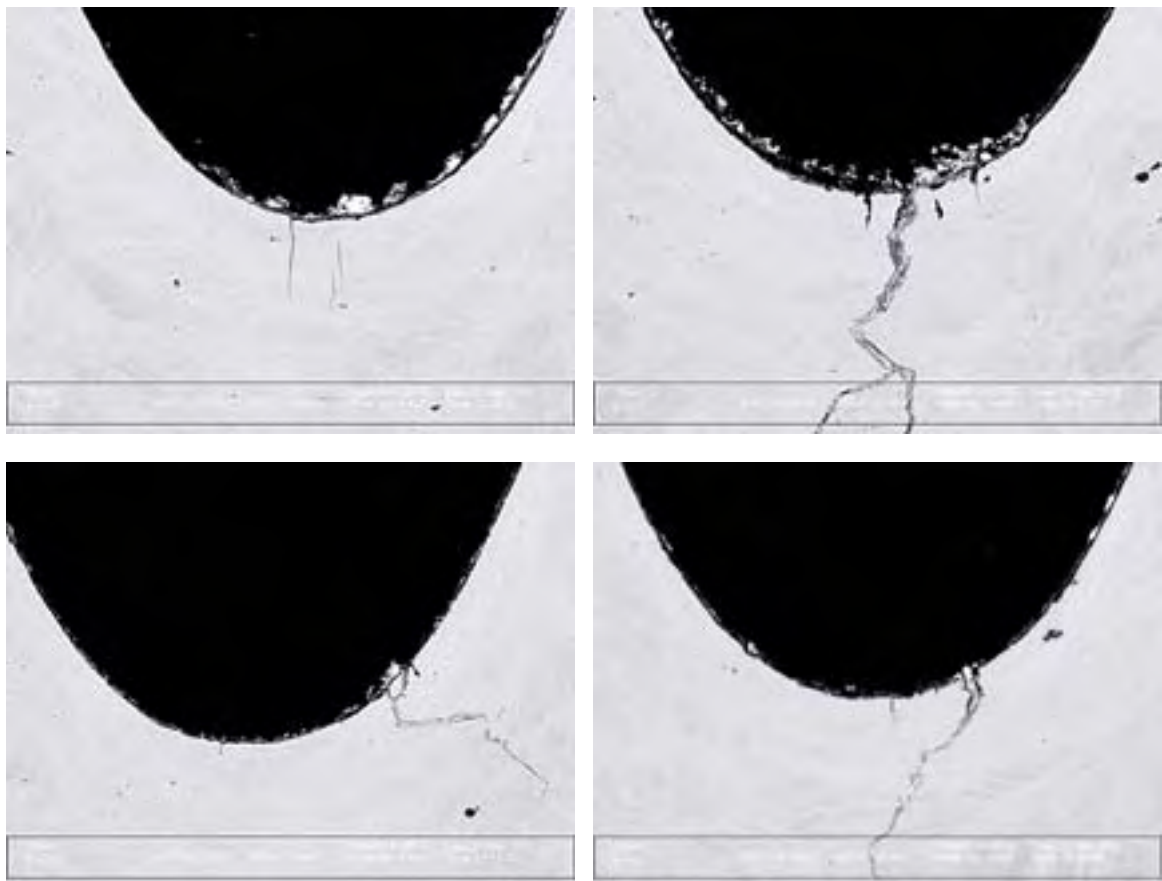
Figure 5. Metallographic section taken through the threaded section of bolt D by PW&C

It was apparent from an examination of the metallographic specimen that crack-like defects had been created in the thread roots by a corrosion cracking mechanism, see figure 5.

(b) Scanning electron micrographs of the metallographic section after repolishing by ATSB showing the nature of cracking in adjacent threads.

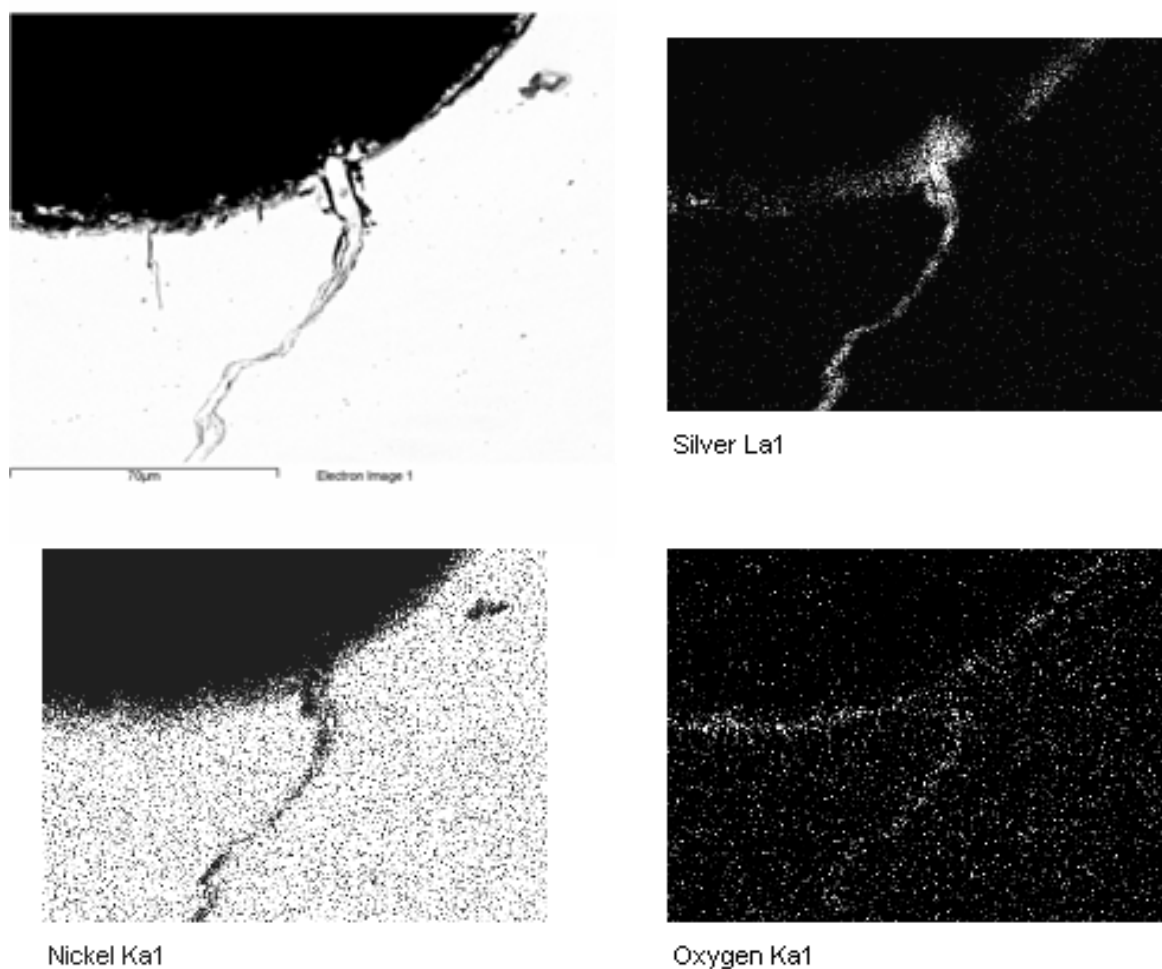
Detailed examination of the crack-like defects in the metallographic section revealed that the defects were filled with a mixture of oxide and silver, see figure 6. The elements sulphur and silver were detected on the thread surface.

Figure 6. Xray analysis elemental distribution maps for nickel silver and oxygen. The image shown, upper left, is a back scattered electron image.

The PWC report concluded that element sulphur on the threaded surface was associated with a compound derived from environmental contamination. The presence of silver was assumed to be a result of the displacement of silver plating from the installed nut.

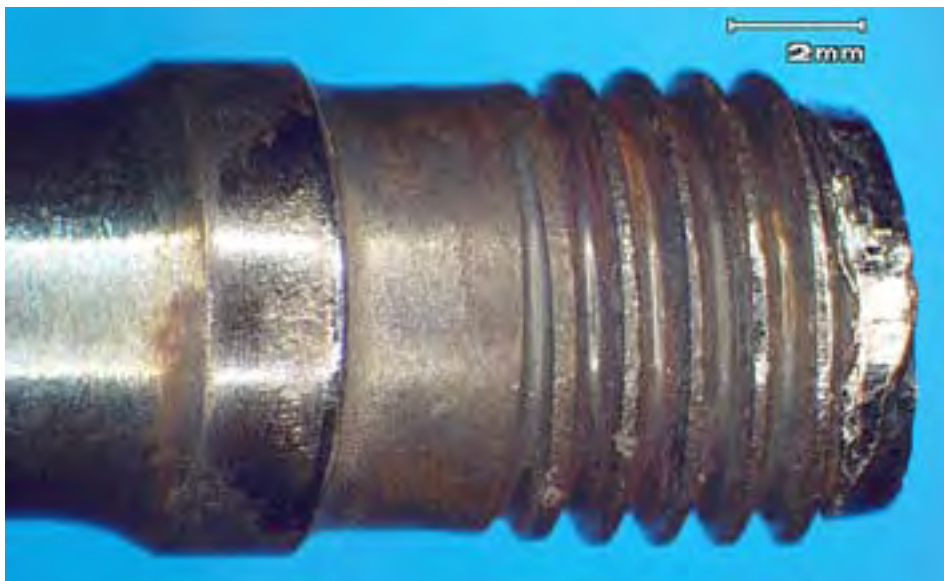
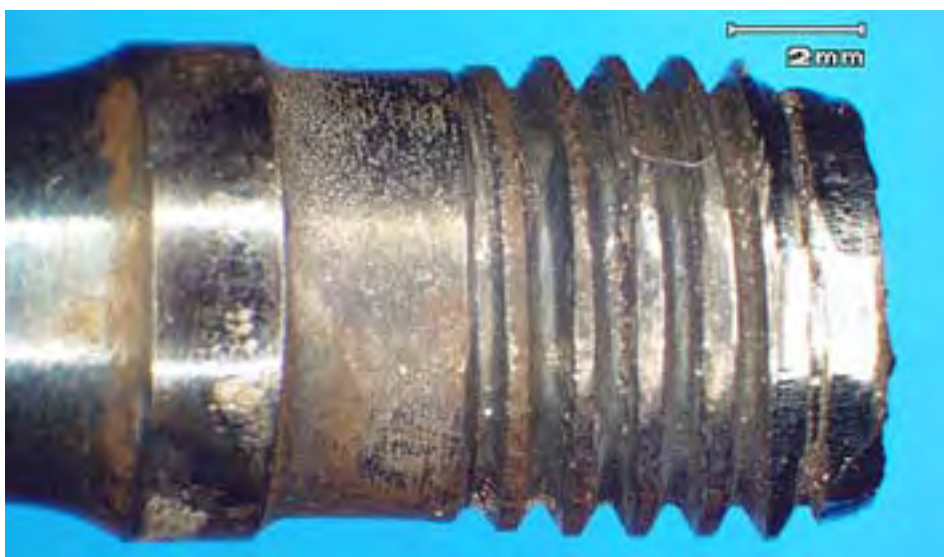
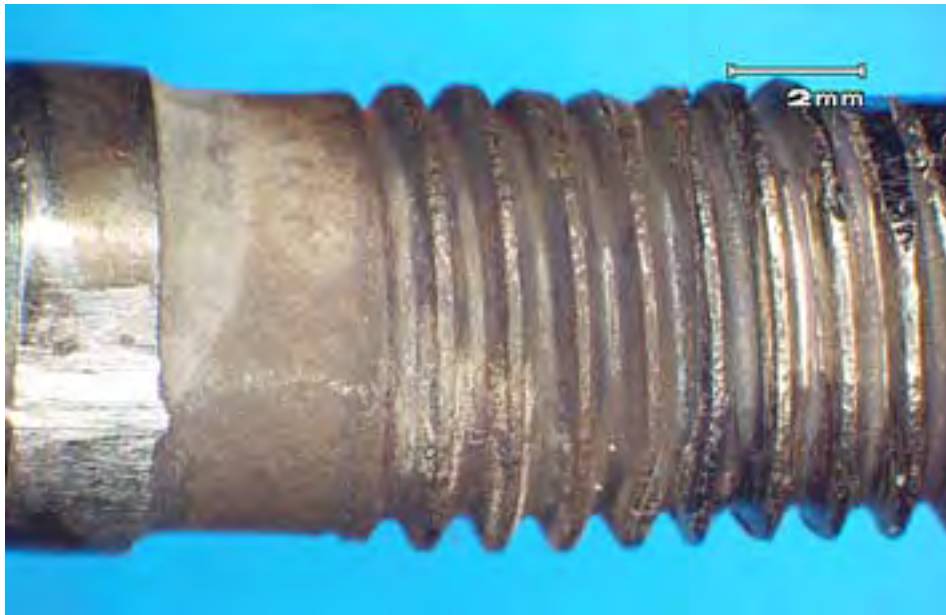
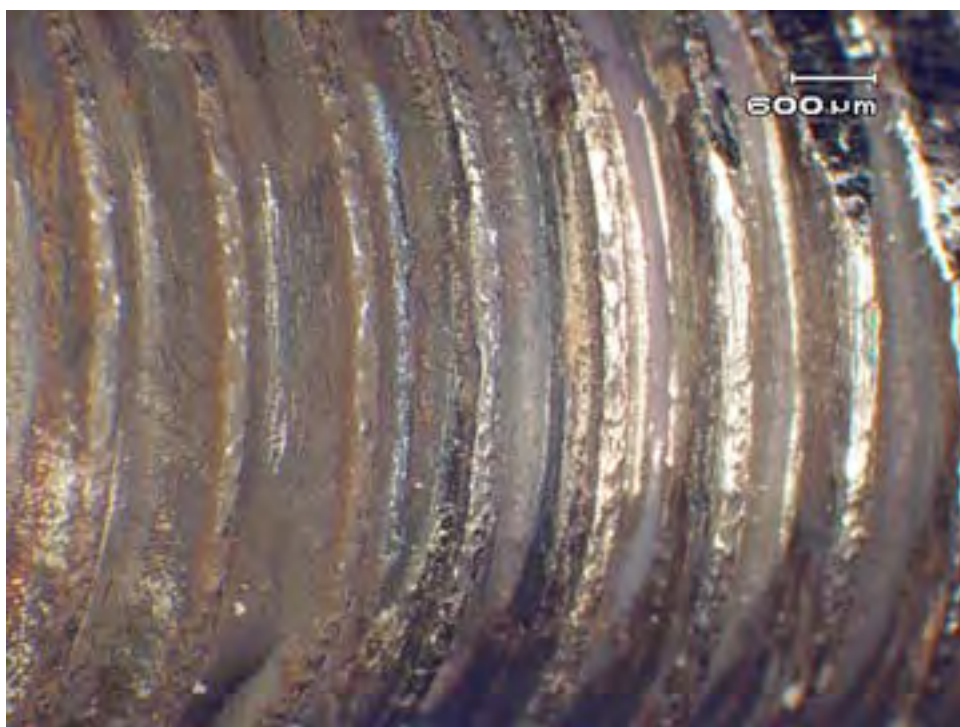
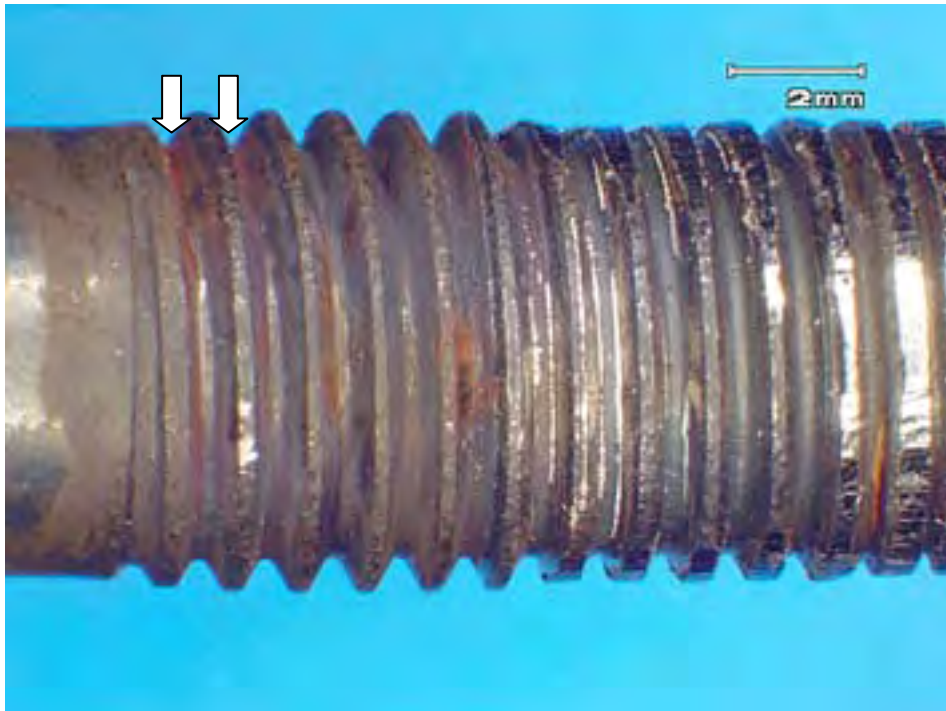
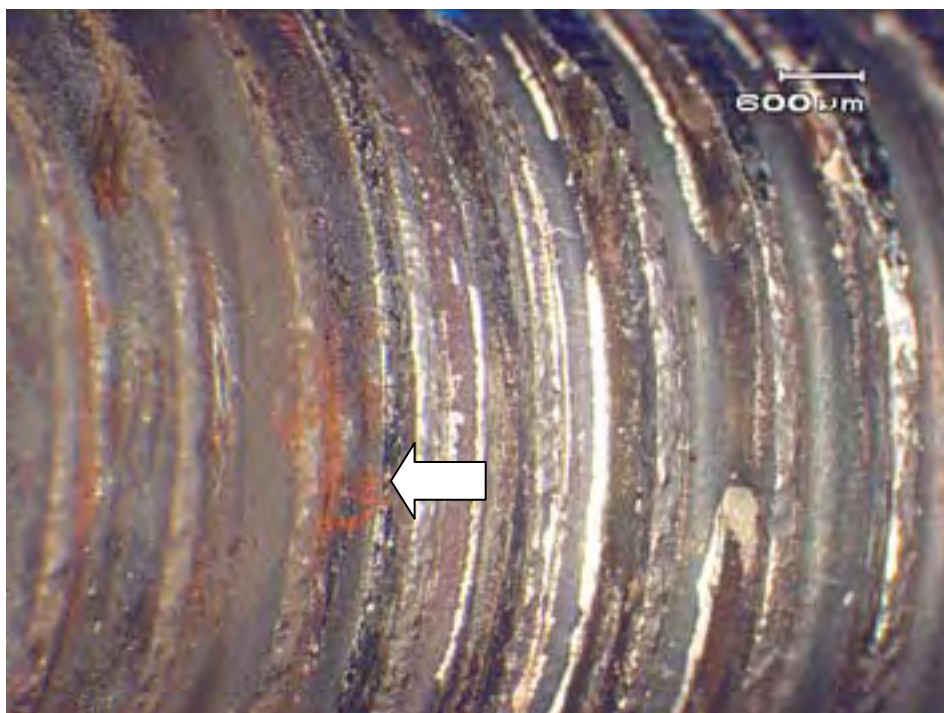
Examination of the threaded sections of all bolts revealed the presence of a compound or, the residue of a compound, on the thread surfaces under the nuts and within the bolted joint, see figure 7. The exposed region of thread within the bolted joint is not in contact with the installed nut. The region of the bolted joint is exposed only to compressor bleed air during normal operation.

The material was greasy in nature. Fine nodular deposits of a compound containing both sulphur and silver along with silicon and carbonaceous material were apparent when the threads were examined at high magnifications in a scanning electron microscope. The silver was in a form that allowed it to penetrate the crack-like defects and be interspersed with the oxides in the defect suggesting that the silver be of a colloidal form.

The nature of deposits on the threaded sections of the bolts is consistent with the application of a silver-based thread lubricant. This form of thread lubricant differs from the lubricant specified in the engine assembly procedures – turbine engine oil.

In recognition of the adverse effect of applying thread lubricants that differ from those specified by the engine manufacturer, the engine service centre that assembled engine s/n 115120 has alerted workshop staff and clearly highlighted instructions in workpackages.

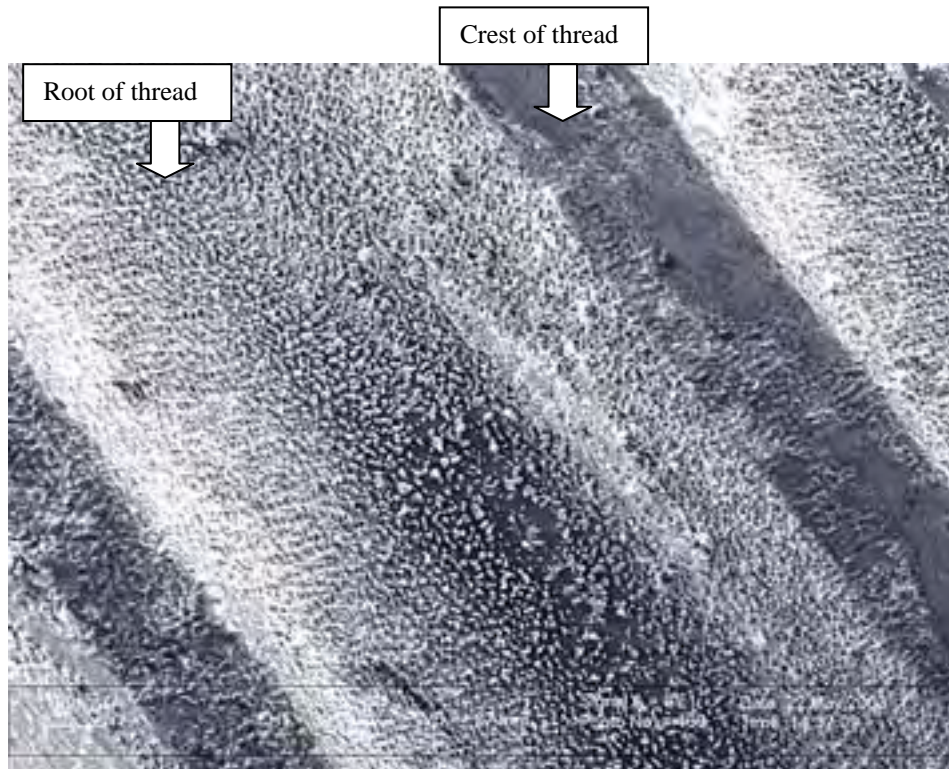
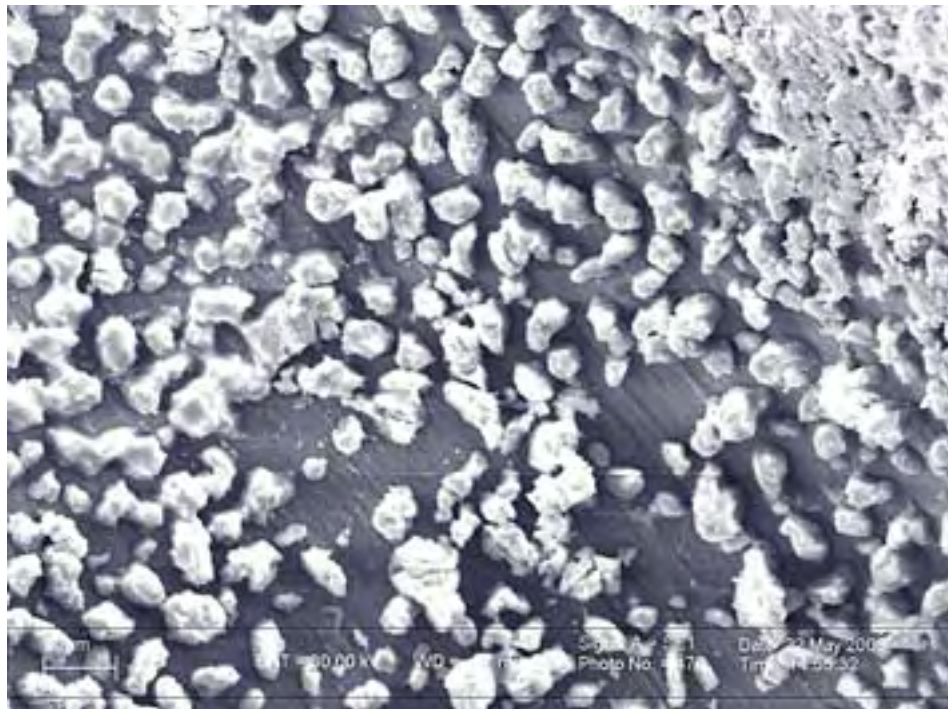
Figure 7g. Scanning electron micrograph showing the nature of thread deposits on the thread within the bolted joint

Figure 7h. Scanning electron micrograph showing the thread deposits at higher magnification.

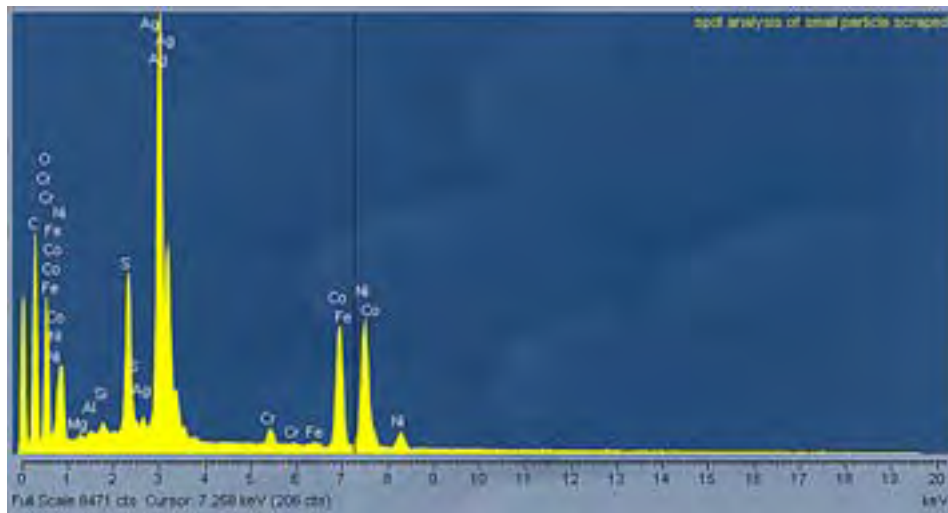
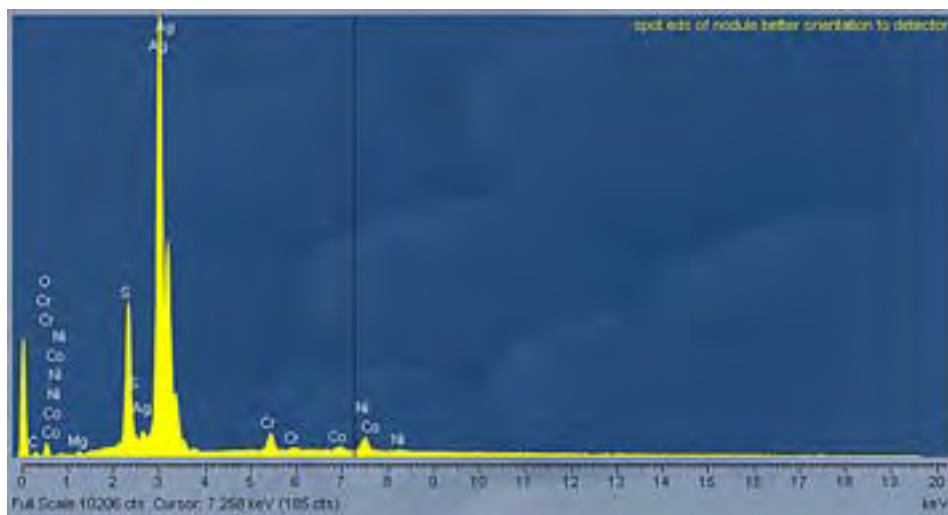
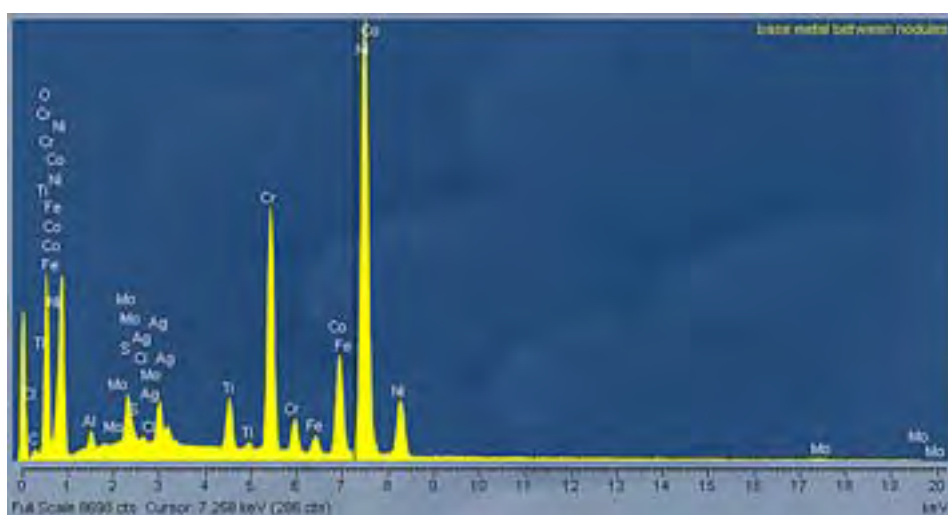
Figure 8. Energy dispersive X-ray spectra of thread deposits and thread base metal.

The results of washing the bolts in hydrocarbon solvent and water indicate that the “greasy” residue on the bolt threads was soluble in water. Energy dispersive X-Ray analysis of material gently removed from the thread surface, by scraping with a scalpel, revealed that the elements silver and sulphur were the major constituent of the material, see figure 8 and figure 10.

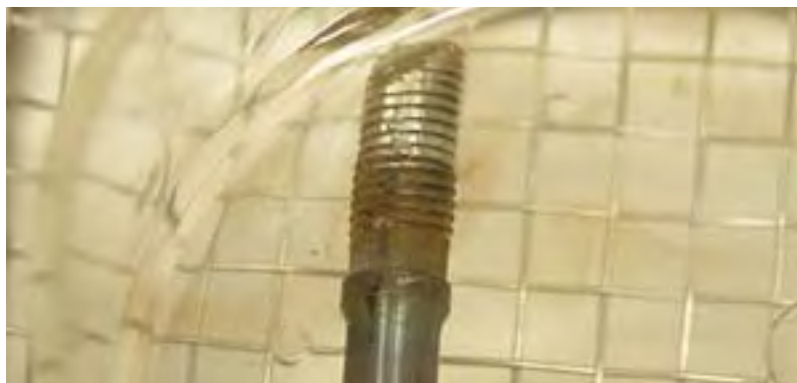
During the examination of the bolt threads it was noted that the residue present on the threads was not removed by washing in hydrocarbon solvents. It was found, however, that the residue was removed by washing in water, see figure 9.

Figure 8. Bolt E being agitated in distilled water. Note the reddish solute being removed from the threaded section of the bolt.

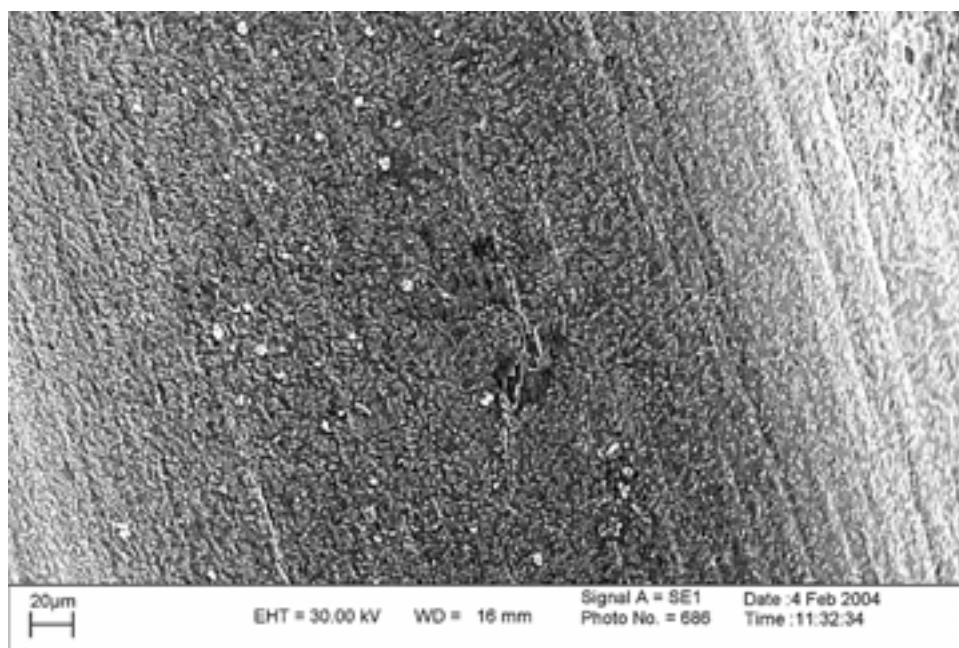
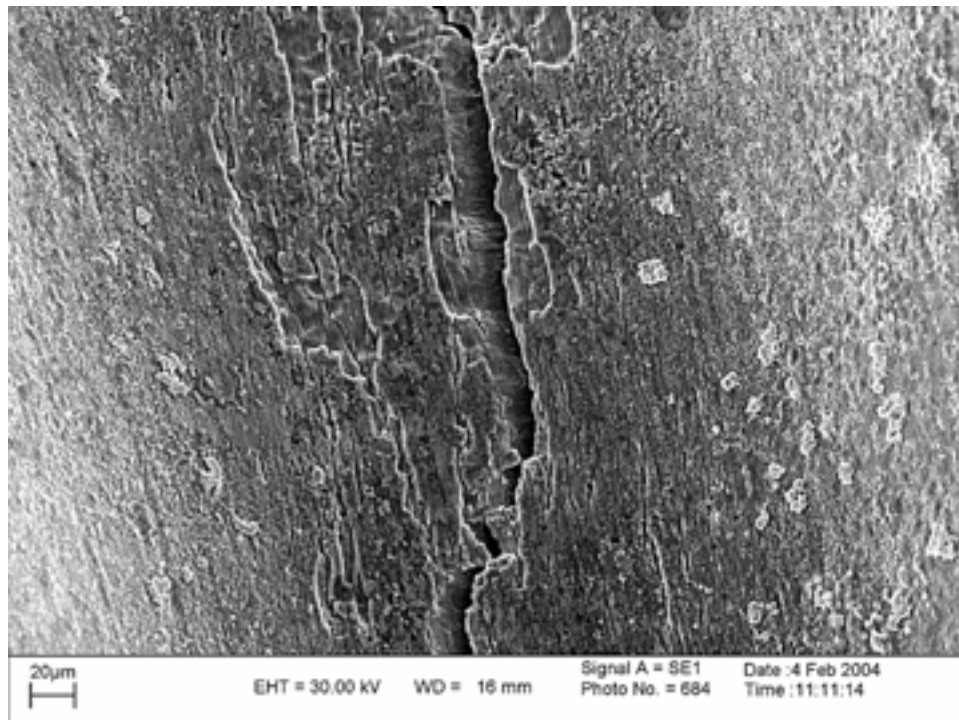
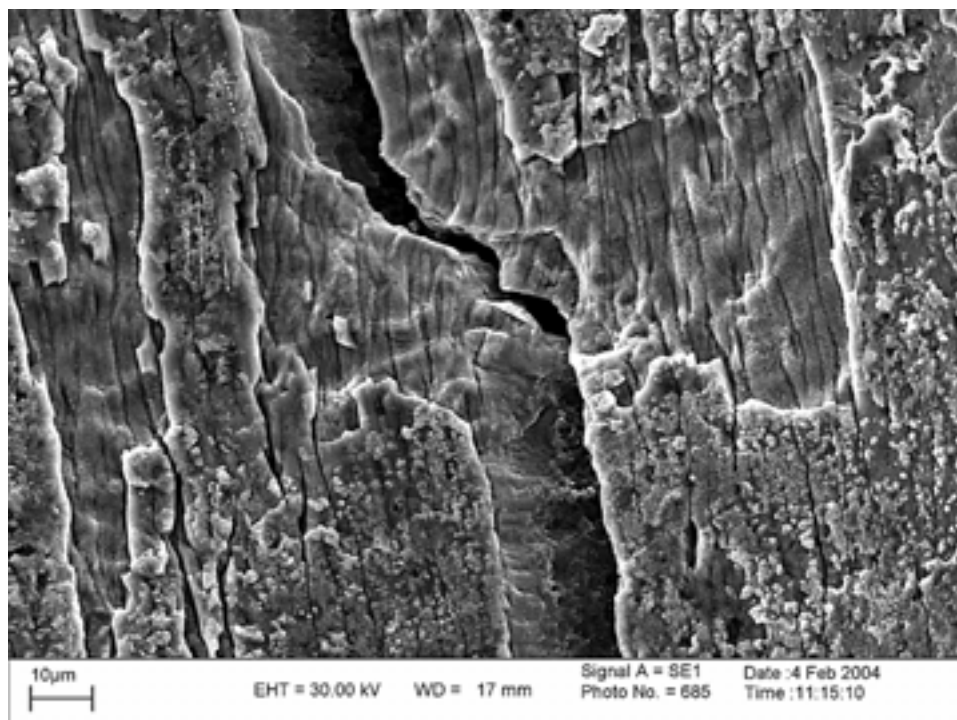
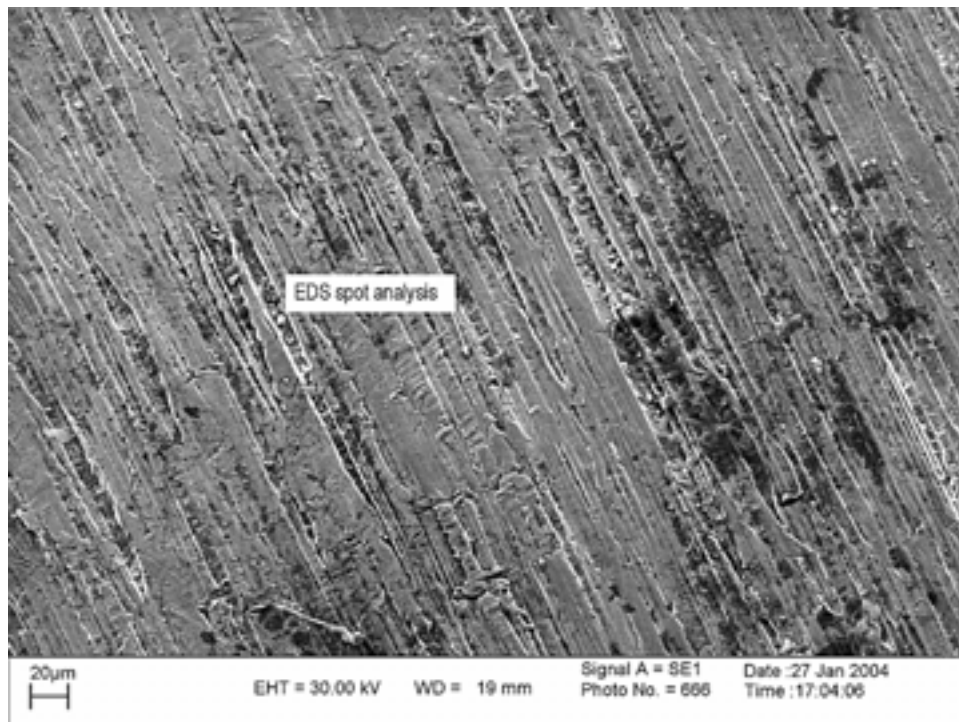
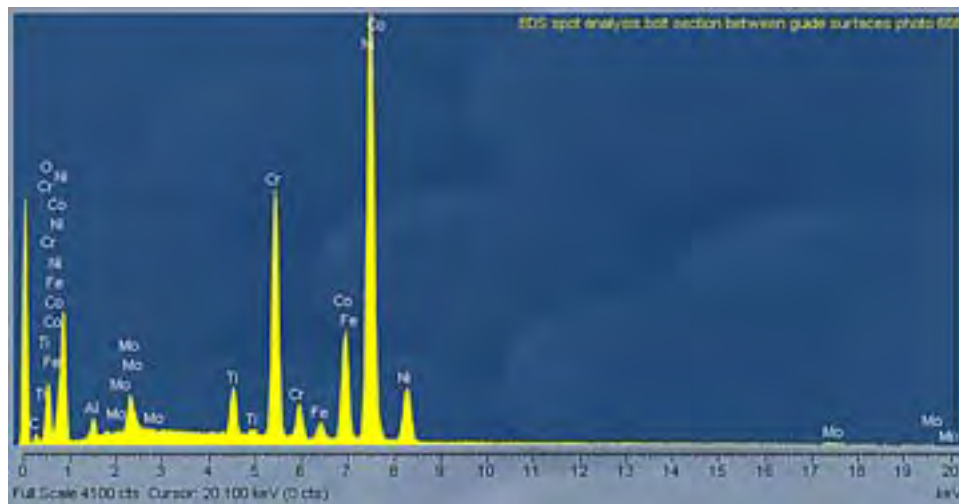
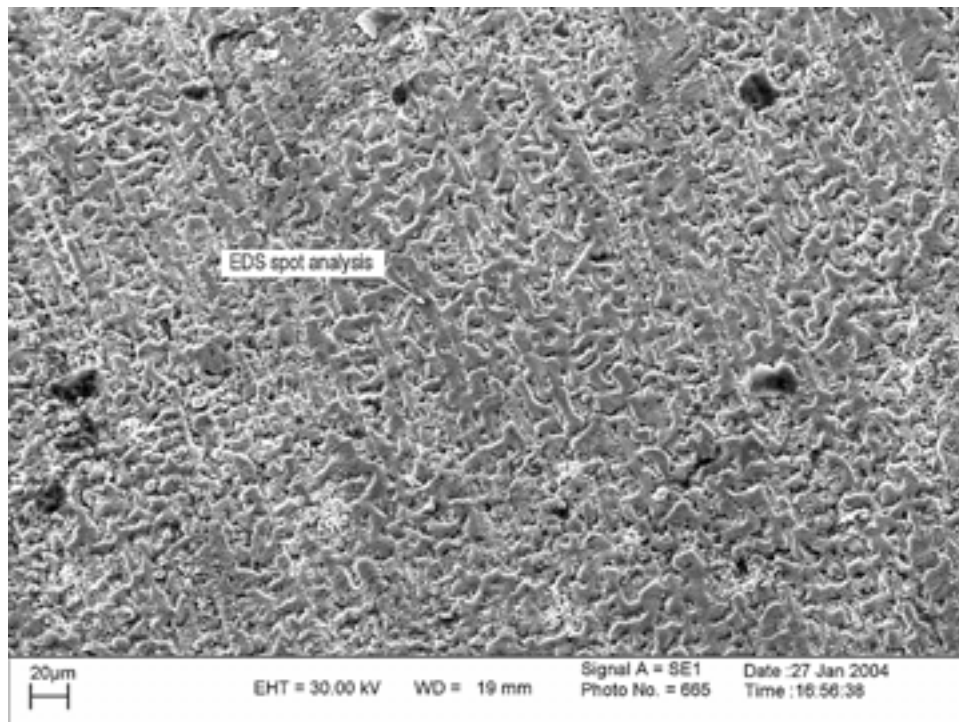
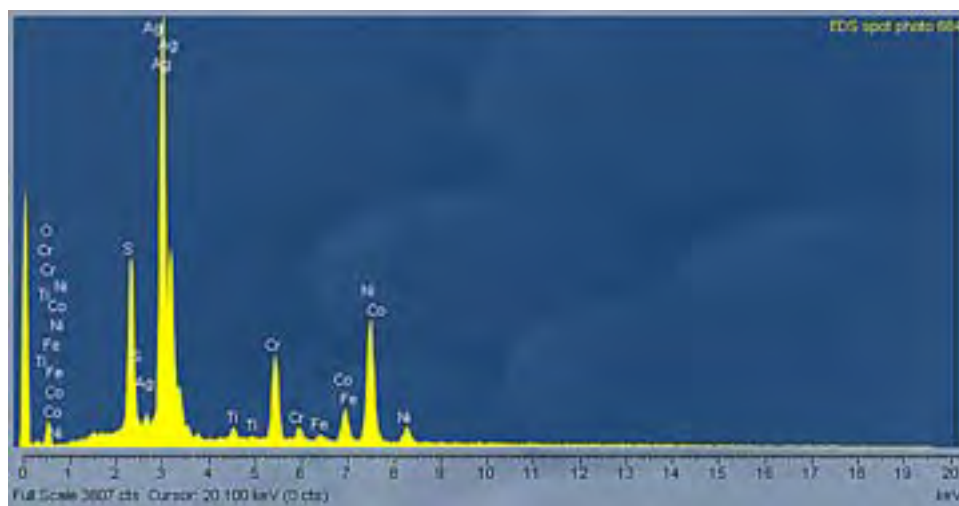
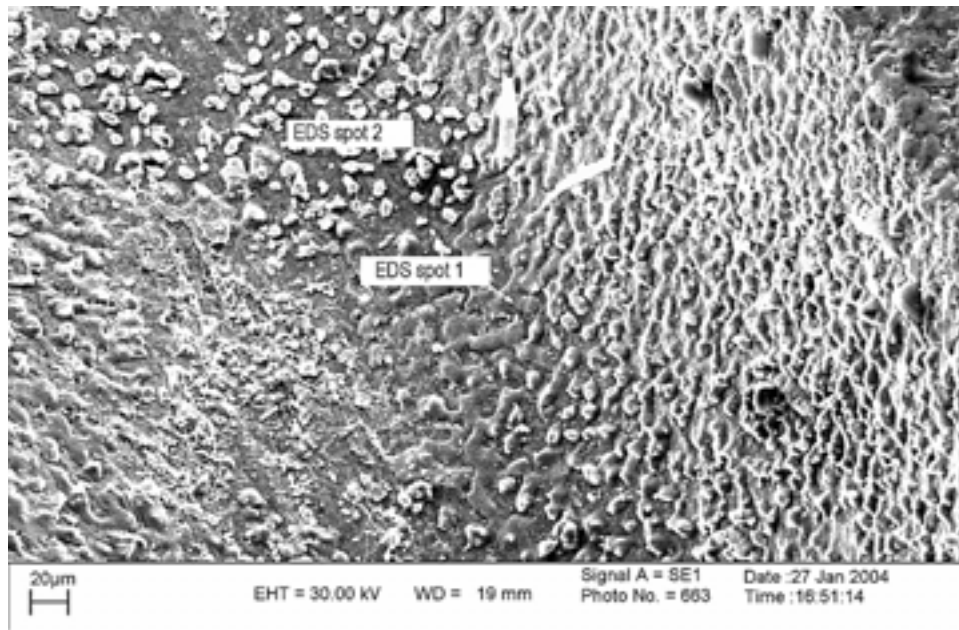
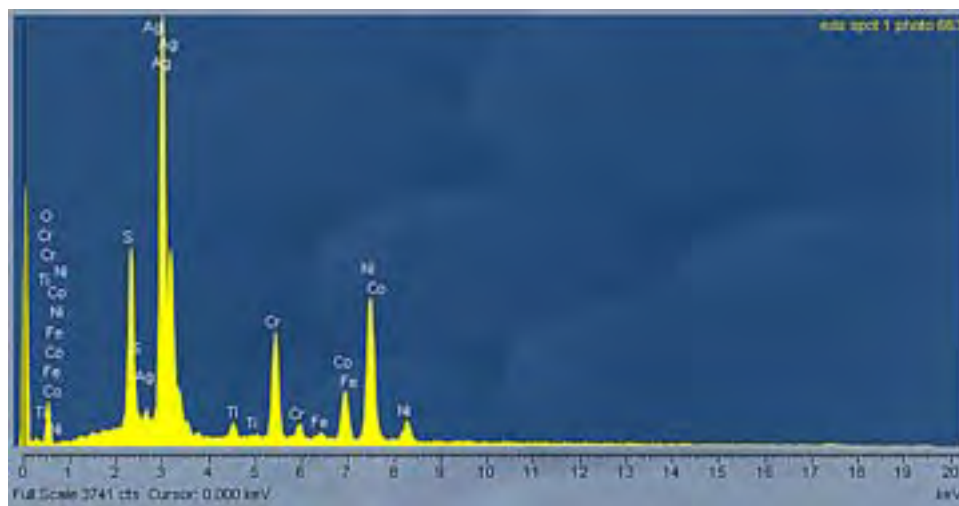
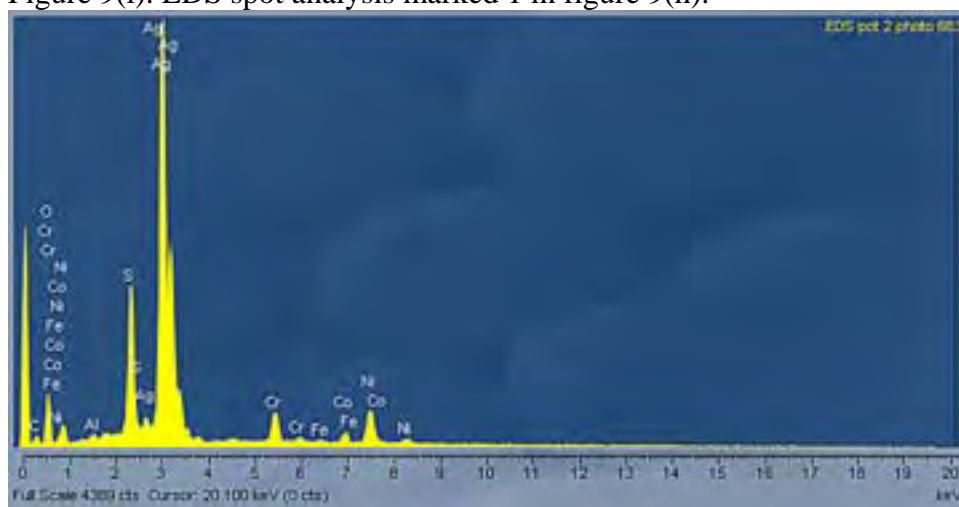
Examination of water washed threads in a scanning electron microscope revealed that the “greasy” material had been removed. It was notable that the oxide film formed on the thread was markedly different to that form on the remainder of the bolt, see figure 9. The oxidation resistance of nickel alloys exposed to elevated temperatures depends on the formation of a thin, tightly adherent, oxide film. The alloying additions of chromium and aluminium are made to promote this form of oxide film formation.

Figure 9(b) Bolt B thread root showing the nature of the oxide film and cracking from the root radius.

It is apparent that the reaction of a compound or compounds based on the elements of silver and sulphur, caused the abnormal oxidation of the threaded sections of the bolts.

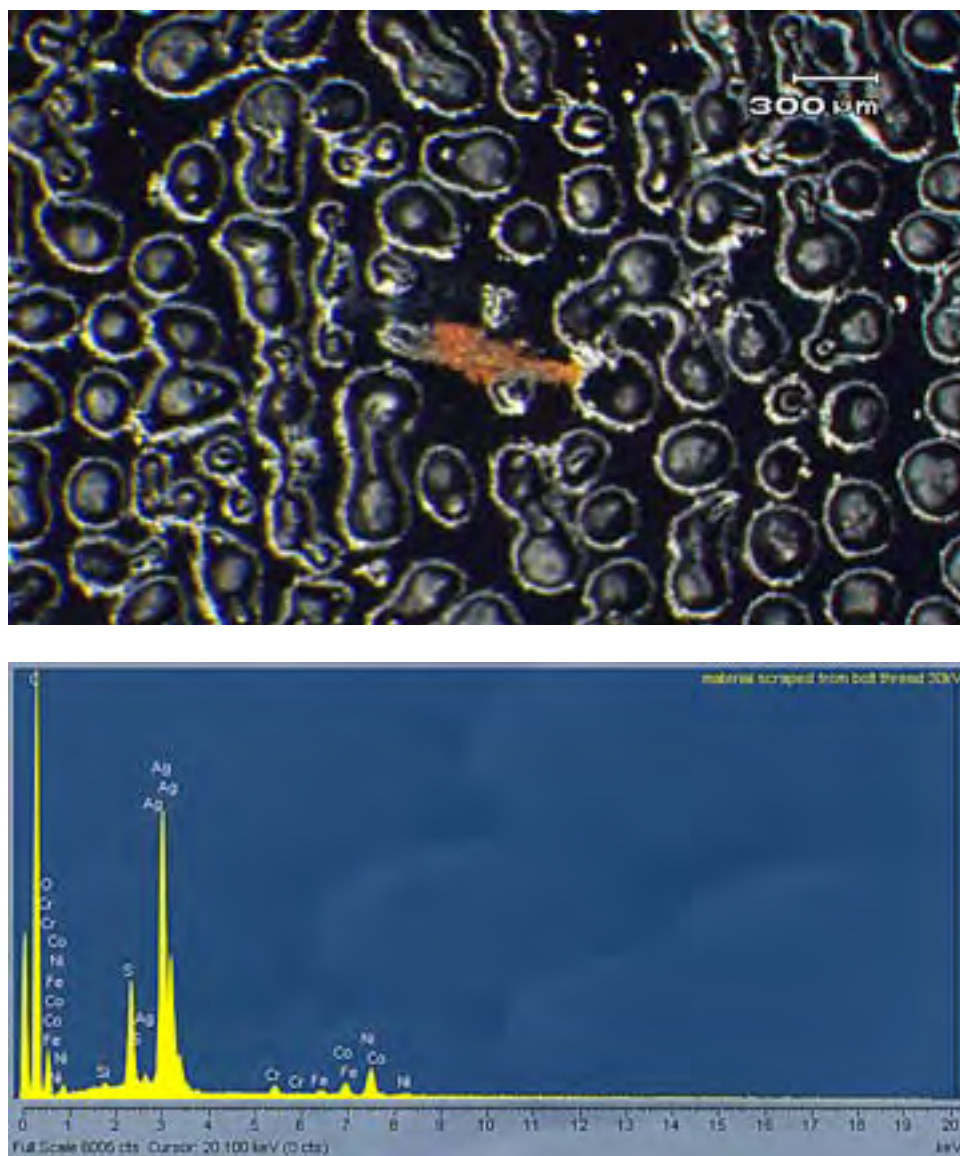
Figure 10. Material removed from the thread of a bolt after water washing placed on carbon tape for EDS analysis (top), EDS spectrum (bottom).

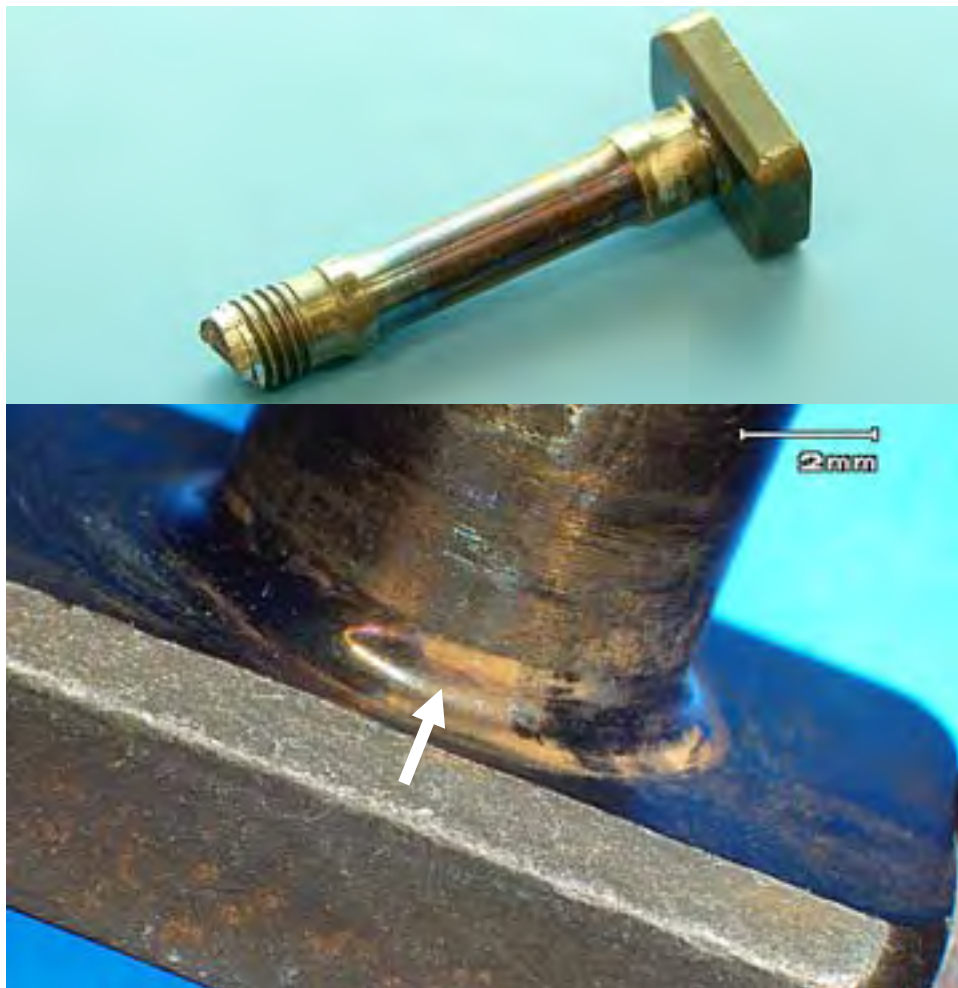
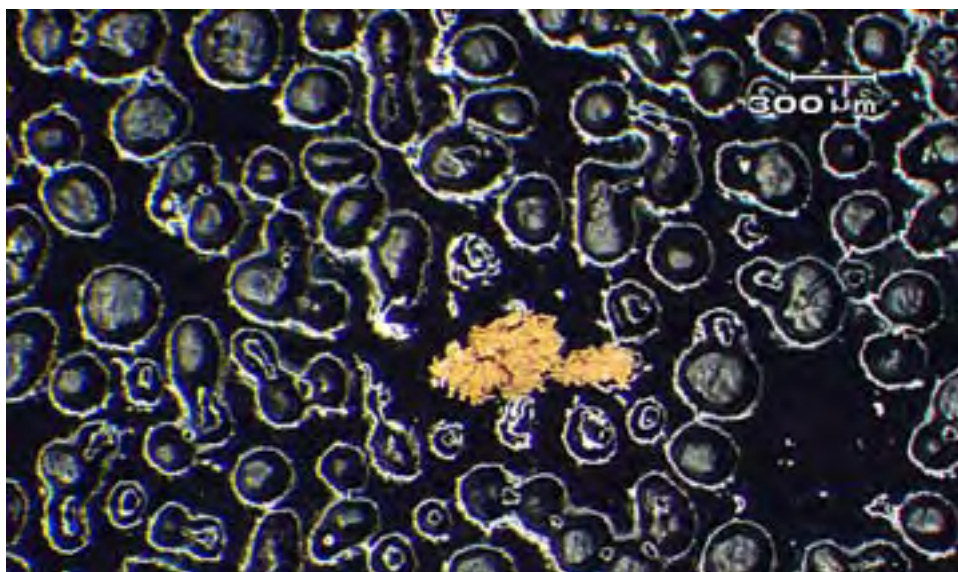
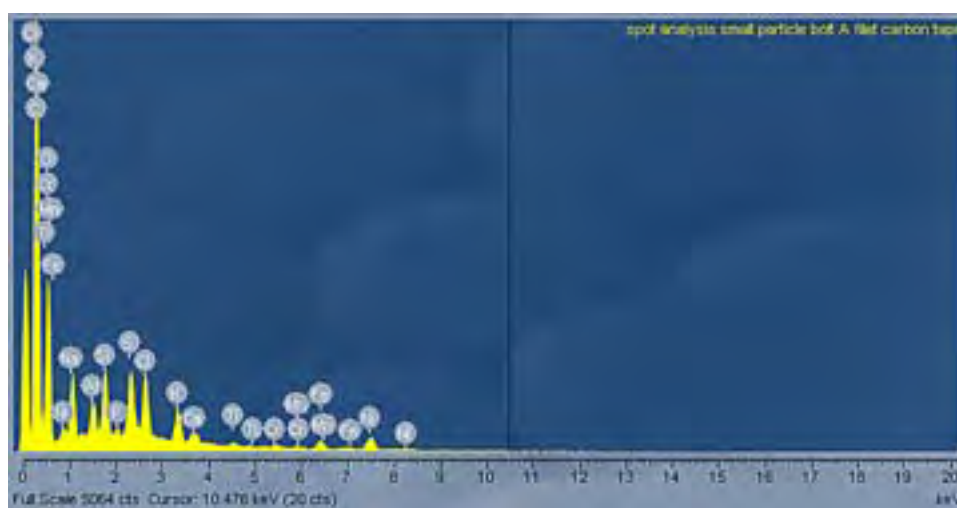
Figure 11(a). Extent of dust deposit in the bolt head fillet.

Sulphur is present in the dust deposit, probably as a sulphate, along with sodium and chlorine, probably as salt. These two compounds are common in maritime environments. The remaining elements are typical of various mineral oxides present in dust. The sample was taken from a bolt that had not been washed in water.

Examination of the bolt head fillet, where dust had been deposited, revealed that the presence of the dust deposit had not resulted in any abnormal oxidation of the bolt surface.
