TECHNICAL ANALYSIS REPORT

Report No. 05/04

Occurrence No. 200305447

**Examination of failed Integrated Nozzle Assembly  
and Thrust Reverser components from a  
RB211-524 Turbofan Engine**

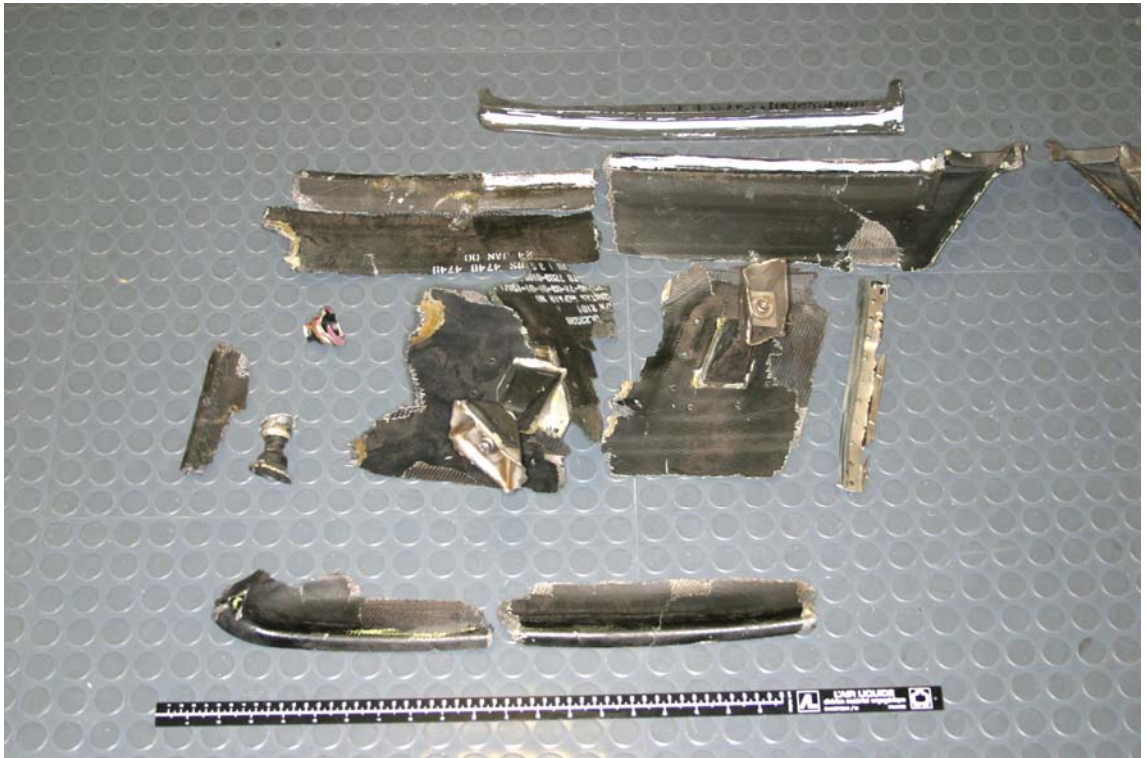
**Figure 1.** Received remnants of the INA drive fairing – side 1.

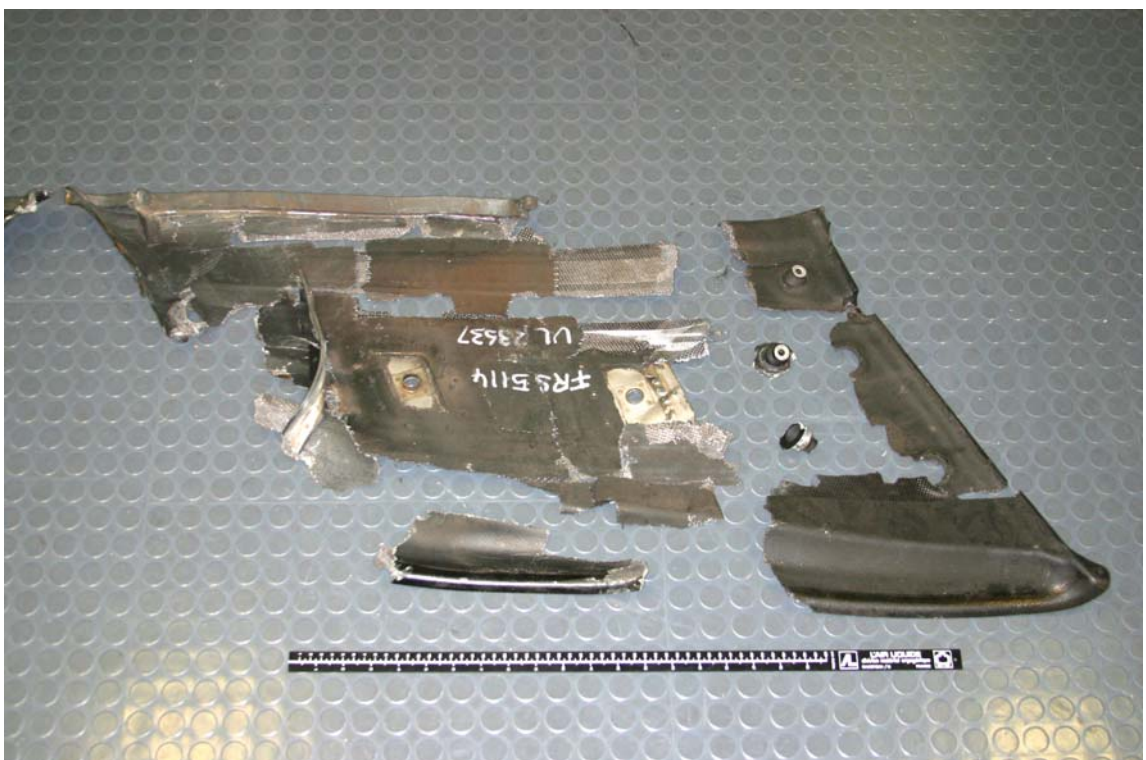
**Figure 2.** Received remnants of the INA drive fairing – side 2.

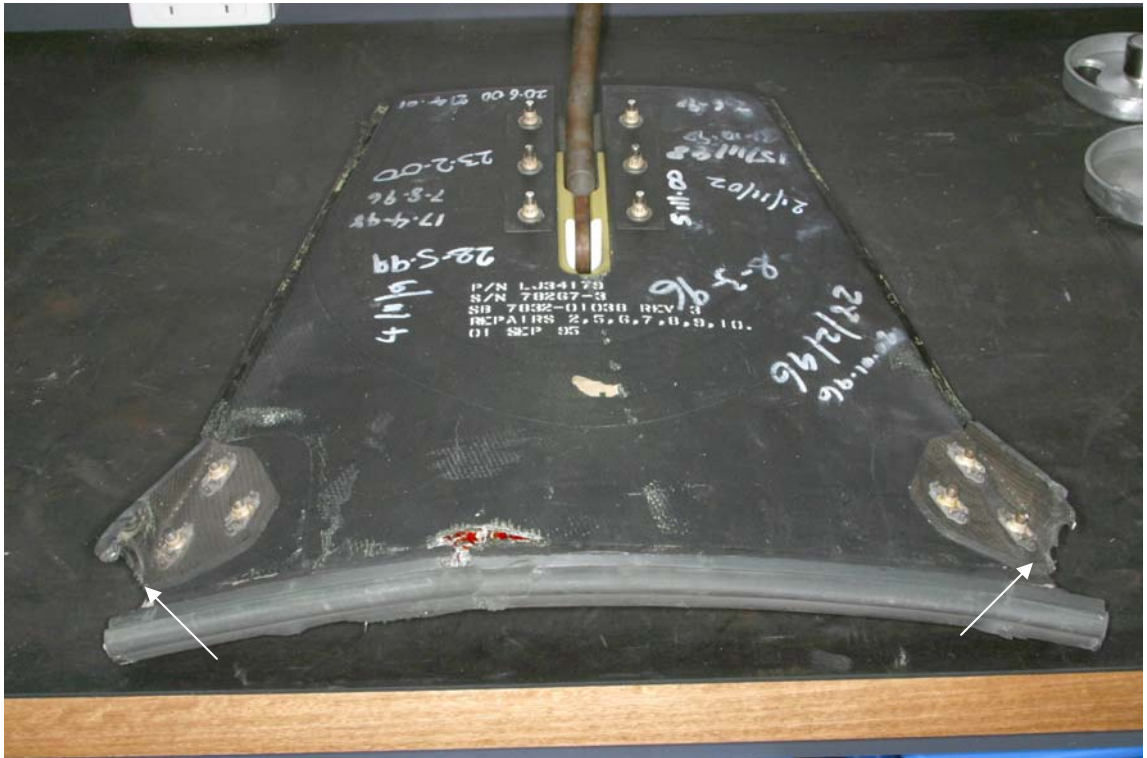
**Figure 4.** Thrust reverser blocker door showing failure of hinge points.

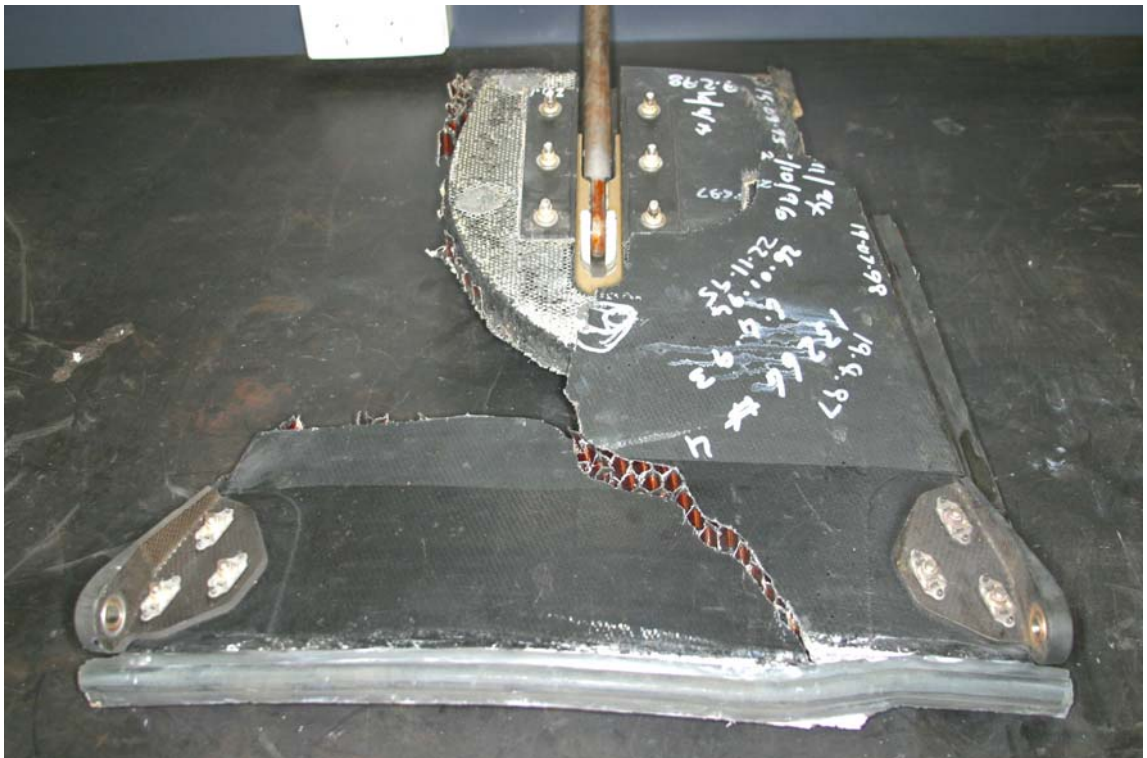
**Figure 5.** Blocker door major sections illustrating nature of break-up.

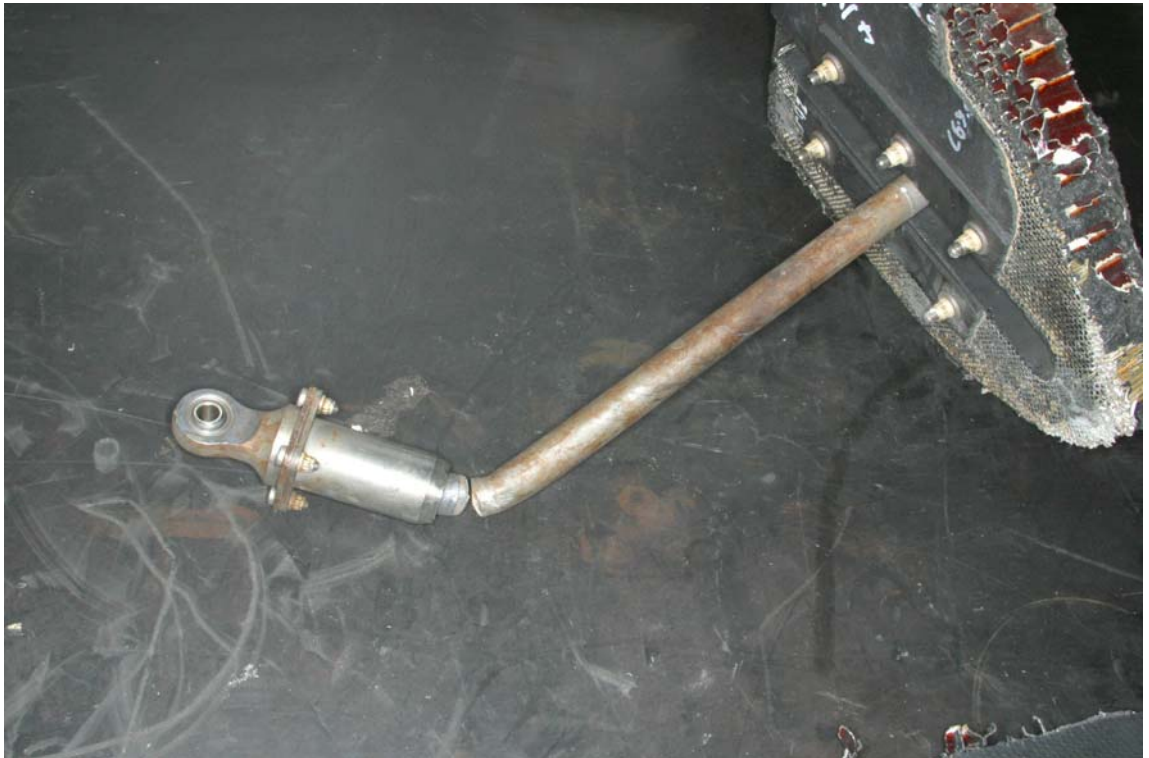
**Figure 6.** Blocker door actuator rod bending failure.

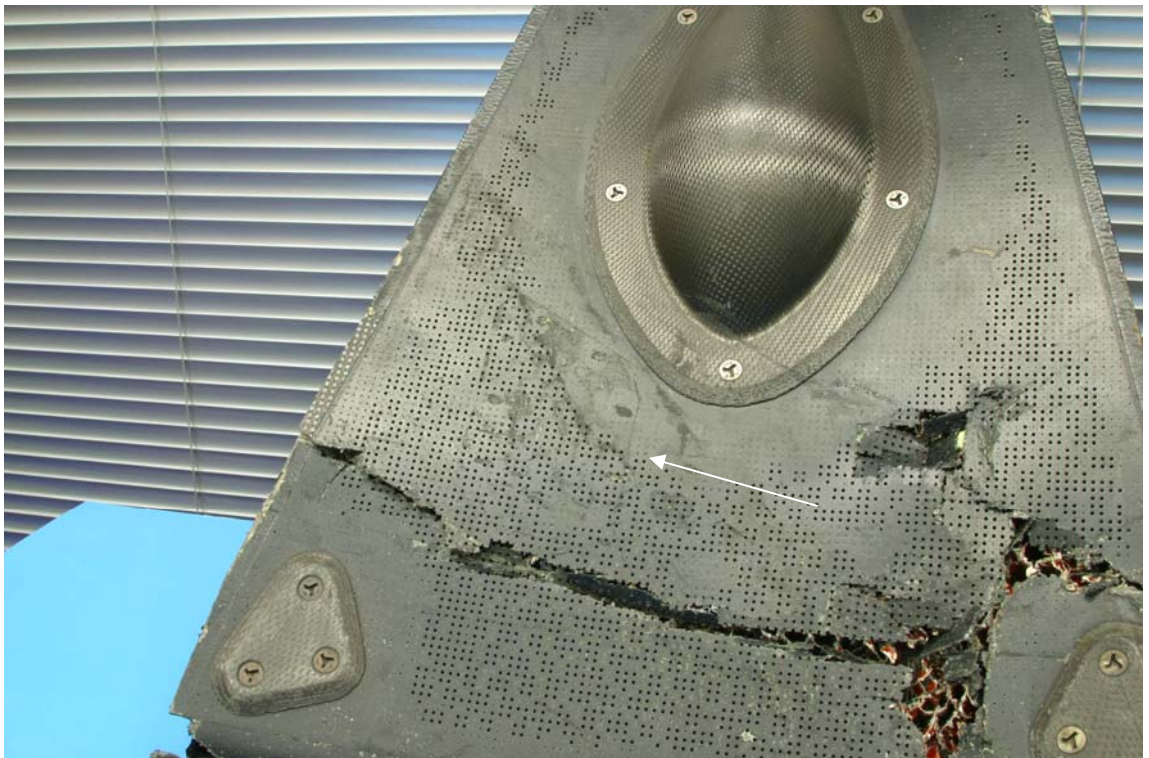
**Figure 7.** Inward facing surface of blocker door showing impact witness mark from a drive fairing panel (arrowed).

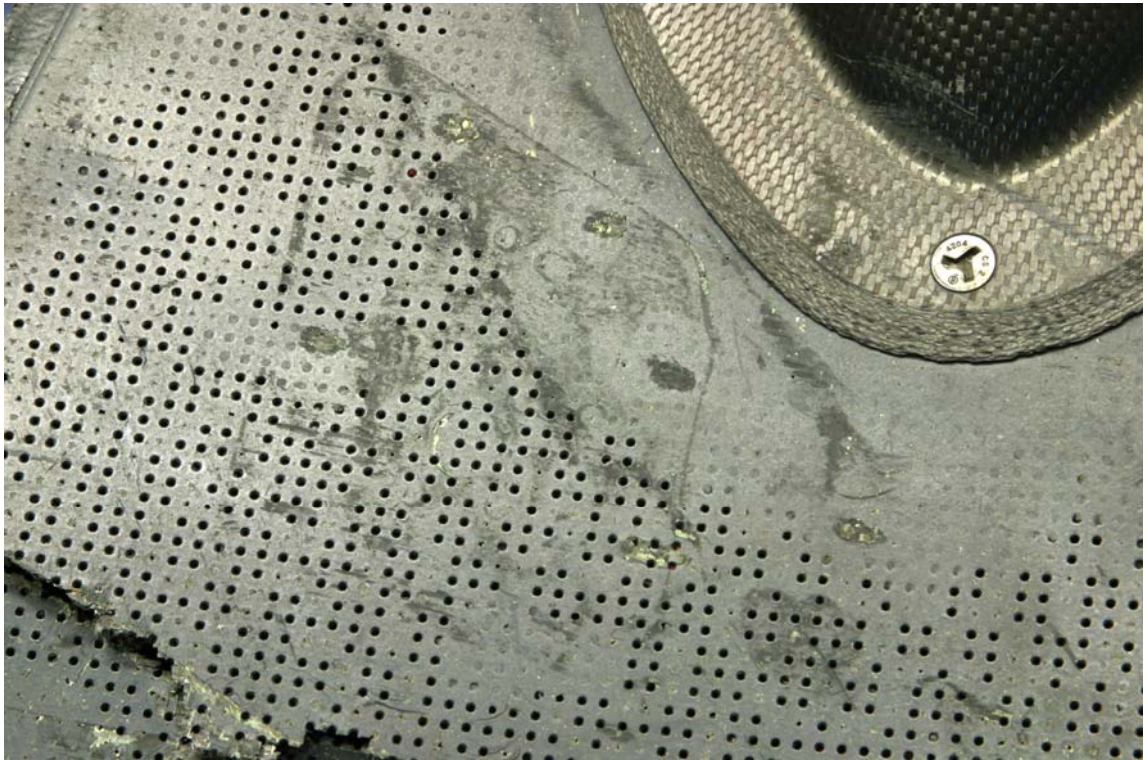
**Figure 8.** Close view of the impact mark shown in figure 7 above. Compare with figure 14 showing the drive fairing panel.

Destruction of the fairing shells was extensive, with many small fragments produced during the failure sequence. Both central towers had separated from their base flanges on the inside of one panel half (figures 10, 11). Closer inspection revealed evidence of progressive cracking around the separated bases of both towers, with one tower showing evidence of that cracking around the complete circumference (figure 12). The adjacent tower presented mixed areas of ductile overload failure of the riveted connection and cracking around the edges of the base flanges (figure 13). The cracked areas showed minimal associated ductility. The outside faces of the fairing shells where the bolt towers had been affixed were reinforced with a rhomboidal shaped plate through which the fitting had been riveted (figure 14). The impression of one of these plates was found on the external surface of one of the thrust reverser blocker doors (figure 8).

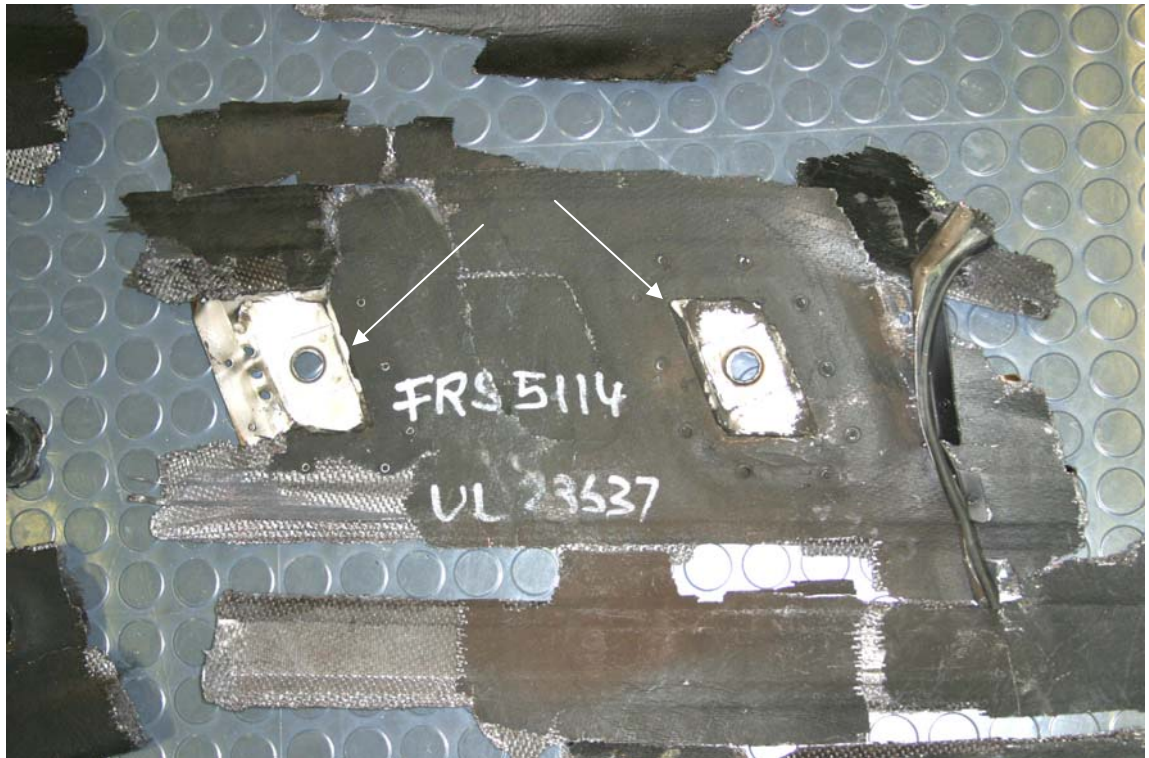
**Figure 10.** Inside surfaces of a drive fairing panel. Note the complete separation of the central bolt towers from their base panels.

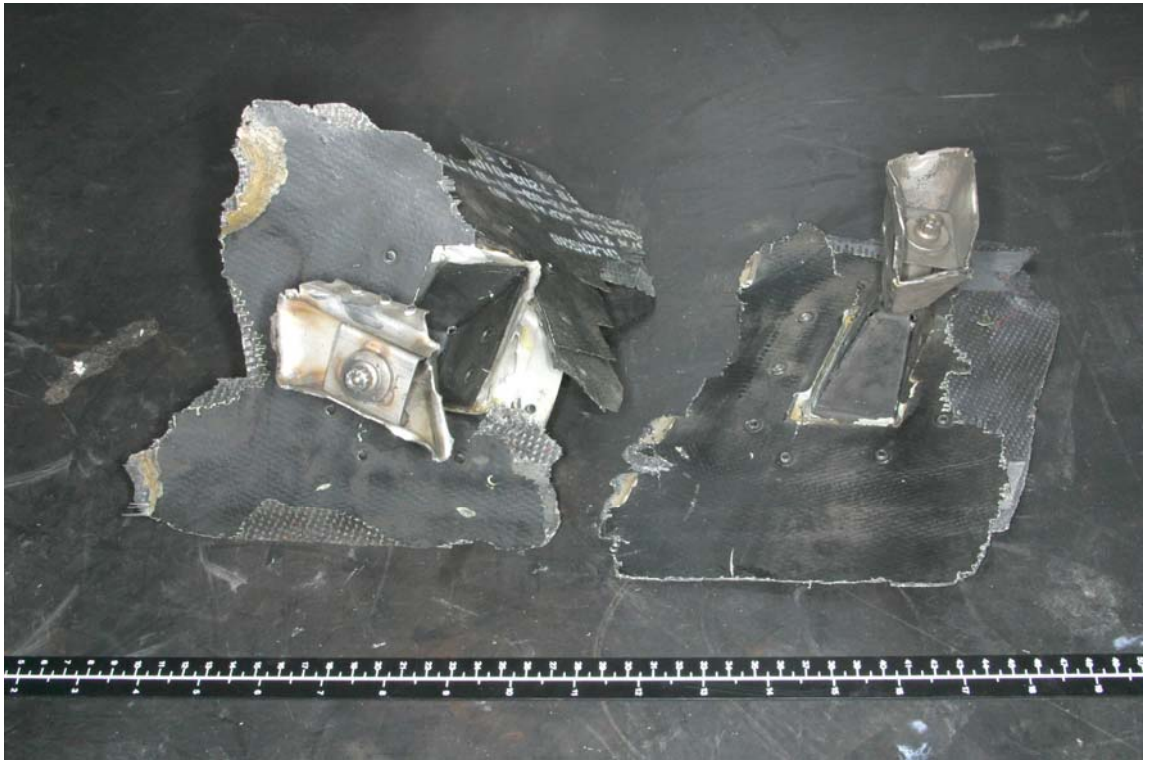
**Figure 11.** Separated drive fairing bolt towers.

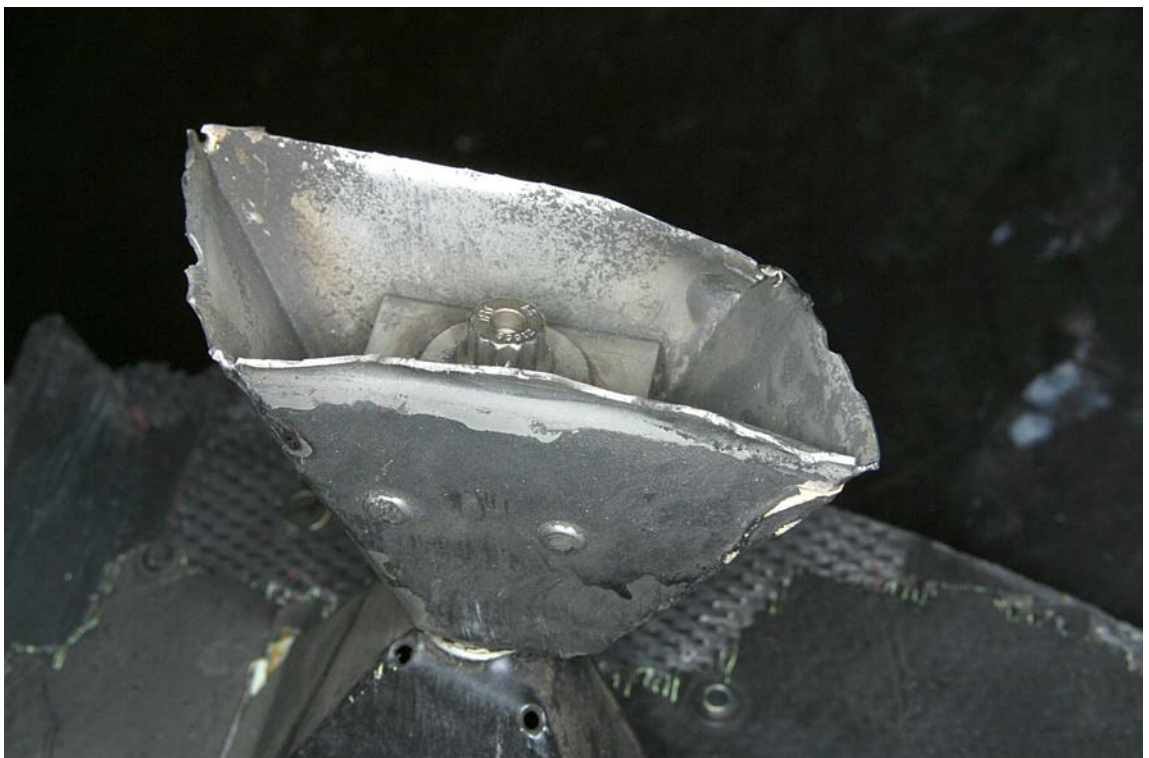
**Figure 12.** Base of a bolt tower illustrating the failure and separation from the flange transition.

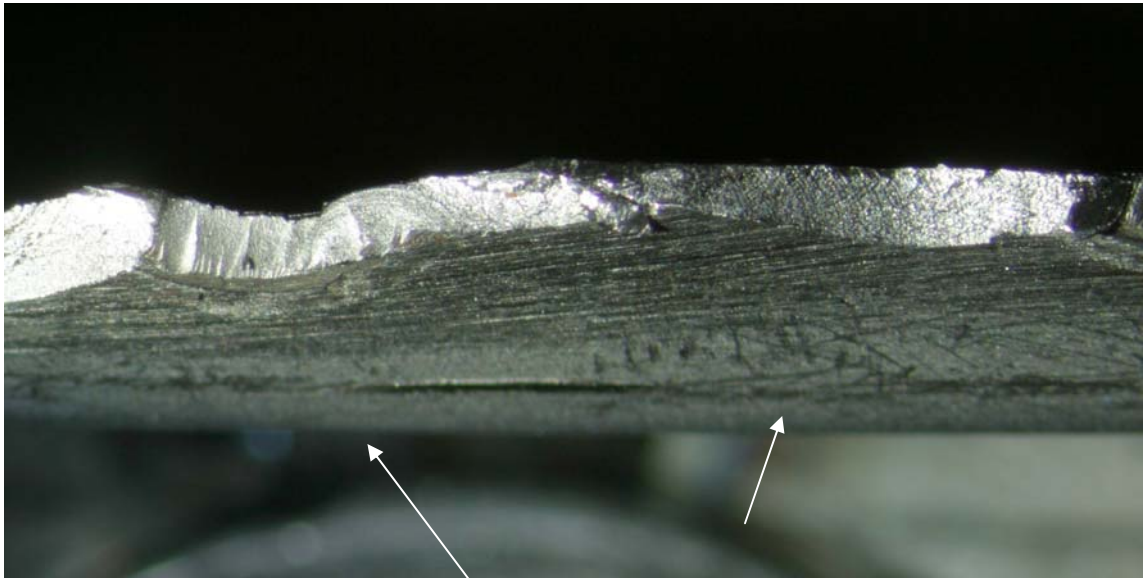
Low-power stereomicroscopic examination of the cracked and fractured drive fairing bolt towers found clear evidence of fatigue cracking along the folded transitions between the tower body and the mounting flanges (figures 15, 16).

**Figure 15.** Typical area of cracking / fracture presented along the bolt tower flange transition radius region. Note the clear fatigue crack progression marks and the ratchet marks associated with a crack initiation site.

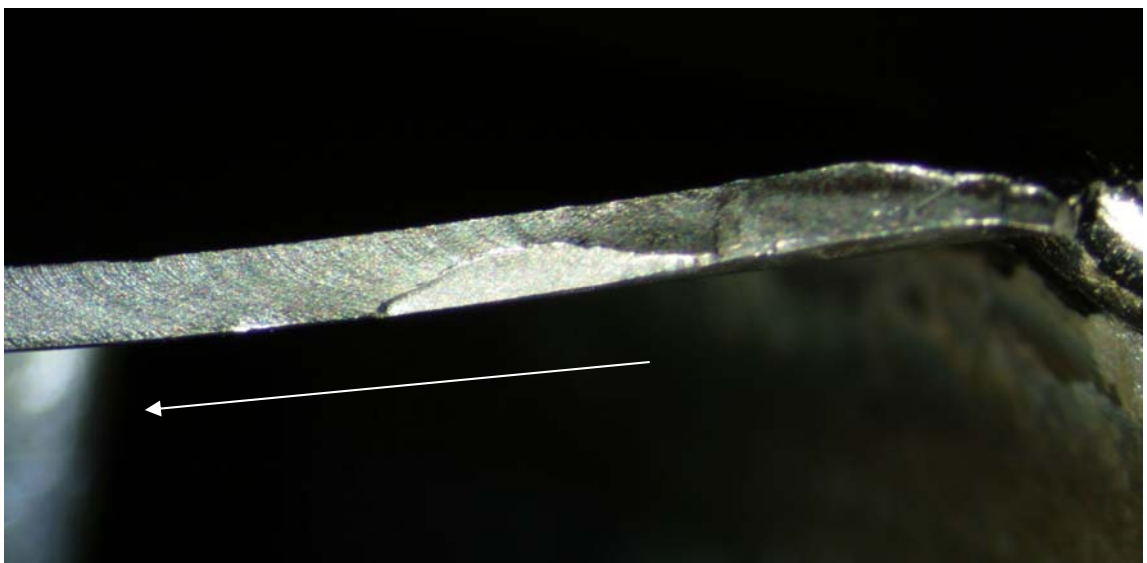
**Figure 16.** Fatigue crack progression marks extending away from a corner welded region of a fairing bolt tower (arrowed).

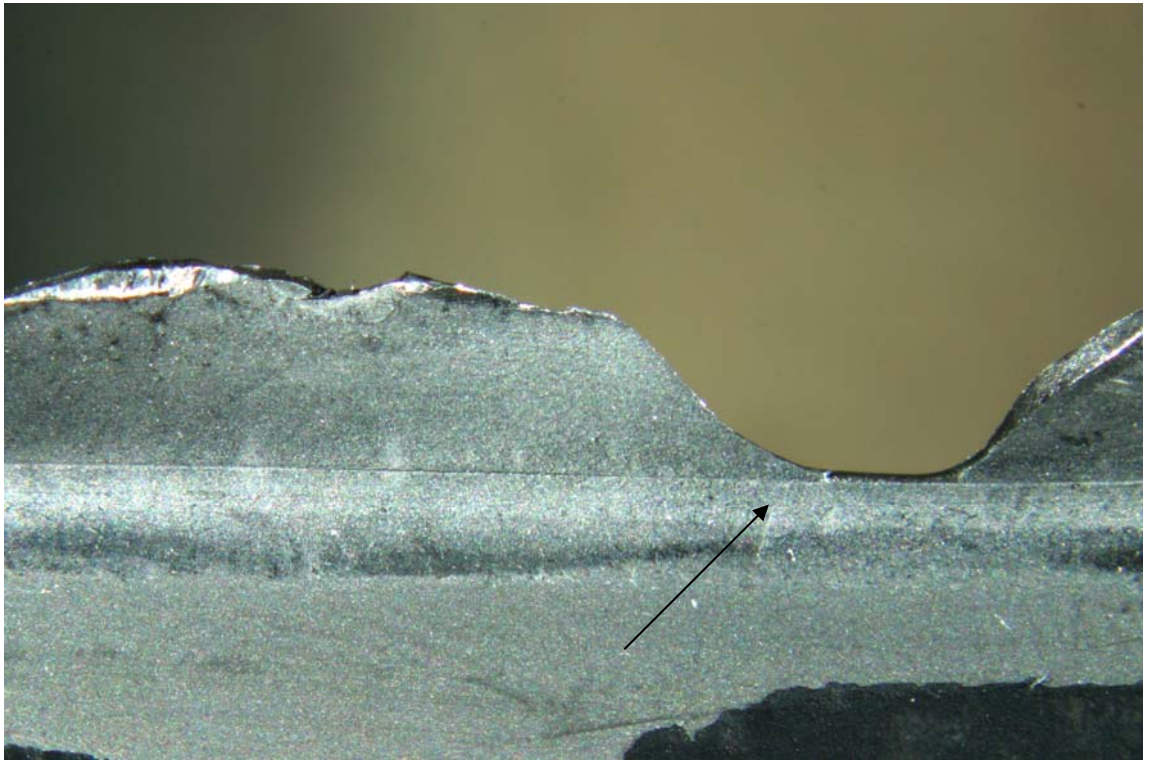
The bolt towers had been produced as fabricated items from folded and welded stainless steel plate. In some areas, the folding operation used to produce the base flanges had created shallow embossed lines from which fatigue cracking had initiated (figure 17). The weld terminations at the base of the tower corners were also a source of crack initiation (figure 18). Stereomicroscopic examination revealed several regions of crack propagation along the tower bases, extending away from the corner welds.

**Figure 17.** Fracture profile along the transition radius. Note the tooling mark from which fatigue cracking had initiated in some areas.

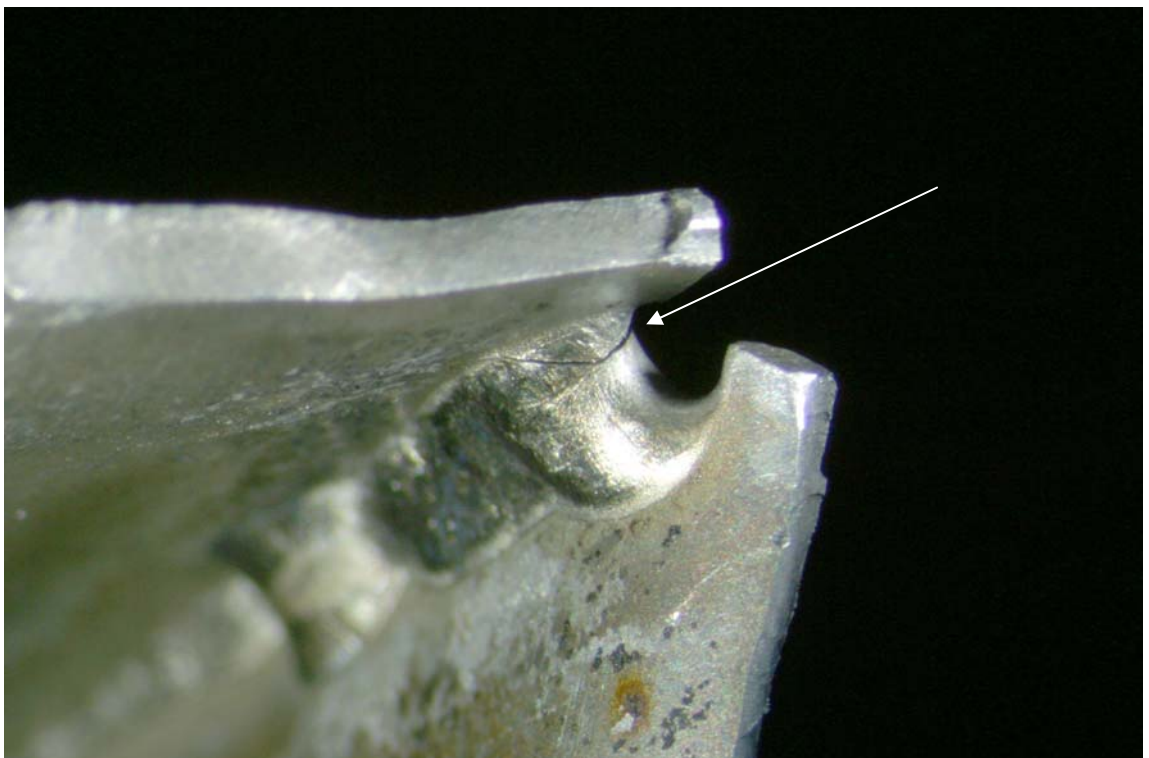
**Figure 18.** Fatigue cracking associated with a weld termination at the base of a bolt tower corner.
