# Departure from controlled flight and collision with terrain involving Ayres Corp. S2R-G10 Thrush VH-WDD

36 km NW of Moree, New South Wales | 11 April 2012

AO-2012-049

Final – 23 October 2013

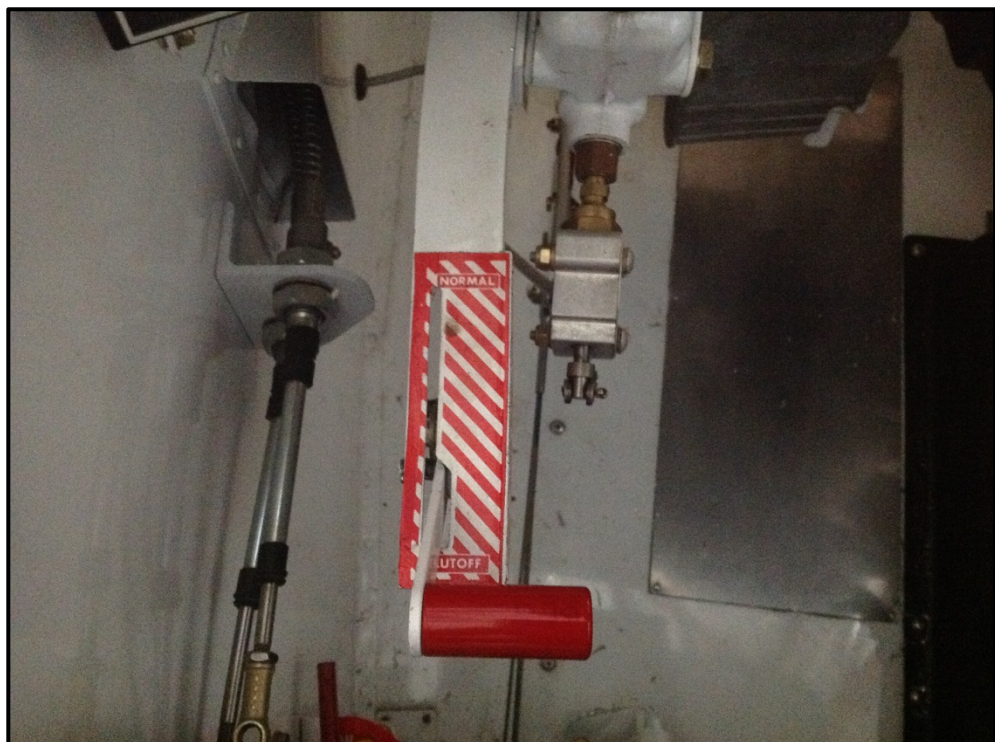
**Figure 3: Emergency cut-off lever in the cut-off position (example aircraft)**

Additionally, the S2R-G10 was fitted with an emergency cut-off lever which, when pulled to the cut-off detent, would shut down the engine by shutting off fuel flow and feather the propeller by relieving oil pressure to the propeller (Figure 3).

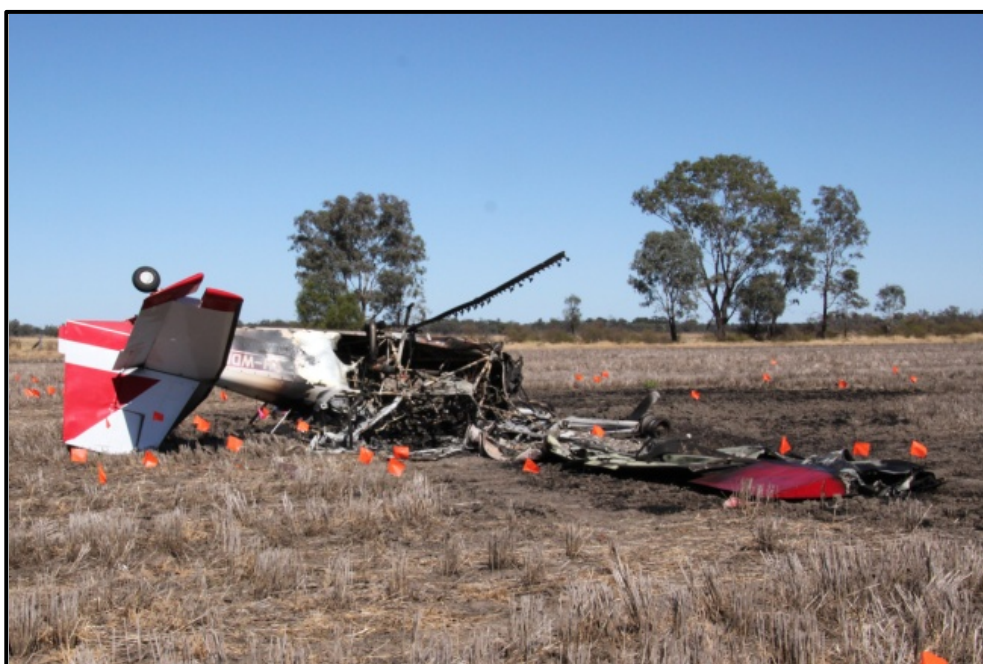
**Figure 4: Aircraft wreckage**

Examination of the wreckage indicated that the aircraft impacted terrain while inverted and rotating clockwise. The ground impact marks and aircraft damage were consistent with a near-vertical and low to moderate-speed impact, at a steep nose-down, inverted angle (Figure 4). The accident was not considered survivable.

All of the major aircraft components were accounted for at the site with no evidence of pre-impact damage observed. There was no evidence of birdstrike or wirestrike. Flight control continuity was established from the cockpit section to the tail section and both wing control surfaces.

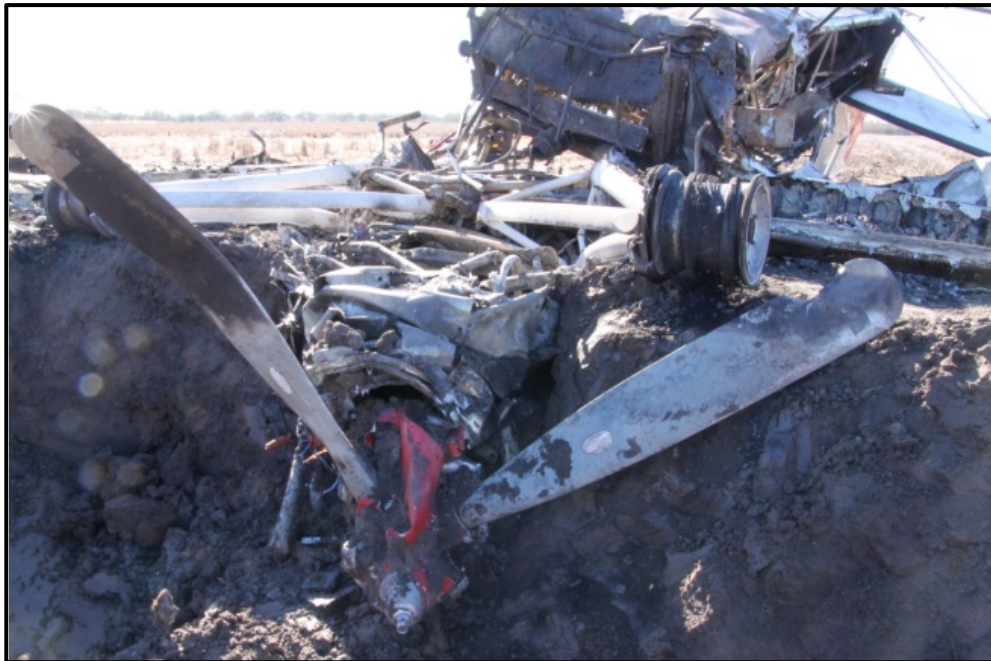
**Figure 5: Aircraft engine and propeller**

On-site external examination of the aircraft's propeller and engine revealed no pre-impact anomalies (Figure 5). Two of the four propeller blades had broken off at their blade cuffs. On examination, all four propeller blades were found to be at a similar, mid-range pitch angle and exhibited minor bending. One blade's trailing edge had an impact puncture in a rearwards direction consistent with ground impact.

The engine was imbedded about 1 m into hard soil in an inverted position and was bent to the aircraft's right, consistent with left yaw at impact. There was no visible damage to the engine compressor first stage or last stage turbine blades and there was no evidence of an internal failure. The propeller and engine were removed from the site for later examination.
