# Collision between a motor vehicle and freight train 9261

Brown Street level crossing, Allansford, Victoria | 19 March 2013

## ATSB Transport Safety Report

RO-2013-011

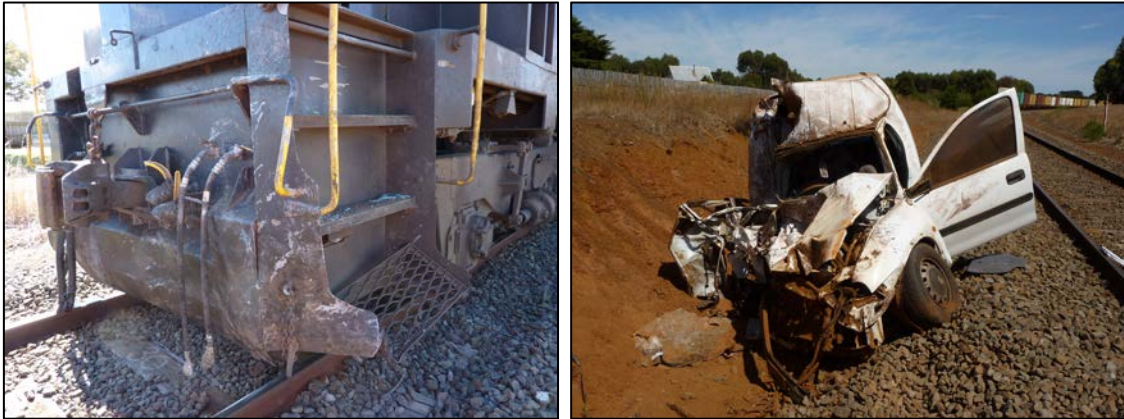
**Figure 2: Damage to lead locomotive T378 and the motor vehicle**

The driver of the motor vehicle was fatally injured. Minor damage was sustained by the lead locomotive (Figure 2). There were no injuries to the train crew.

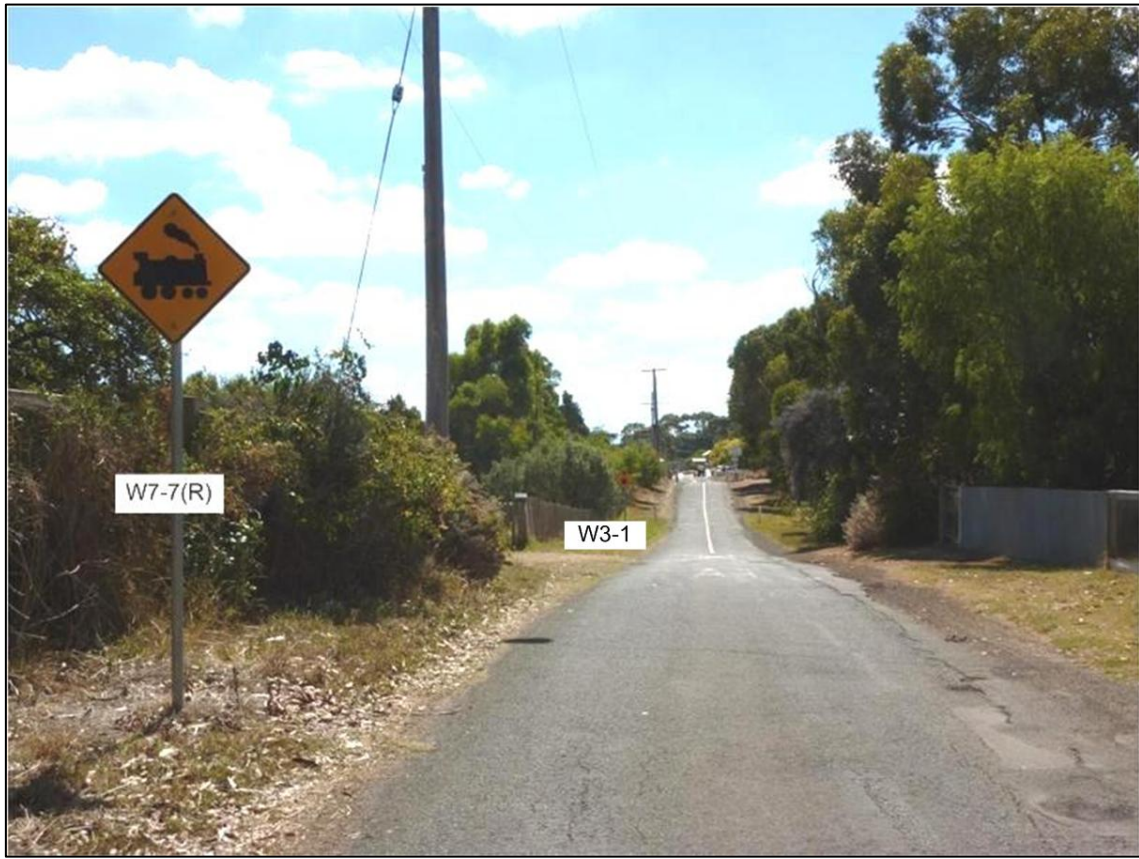
**Figure 4: Brown Street level crossing (approach from the south)**

Brown Street has a sign-posted speed limit of 50km/h. Other traffic controls installed on the approach from the south of the Brown Street level crossing (Figure 4) included a *Railway Crossing Ahead (W7-7)* sign located 136 m before the Stop line. A *Stop Sign Ahead (W3-1)* sign was located as the second warning sign about 88 m in advance of the Stop line. Just beyond the Stop line, a *Railway Crossing Stop Assembly (RX-2)* and *Railway Crossing Width Marker Assembly (RX-9)* were located as required. The Stop line was marked 9.6 m from the nearest rail.

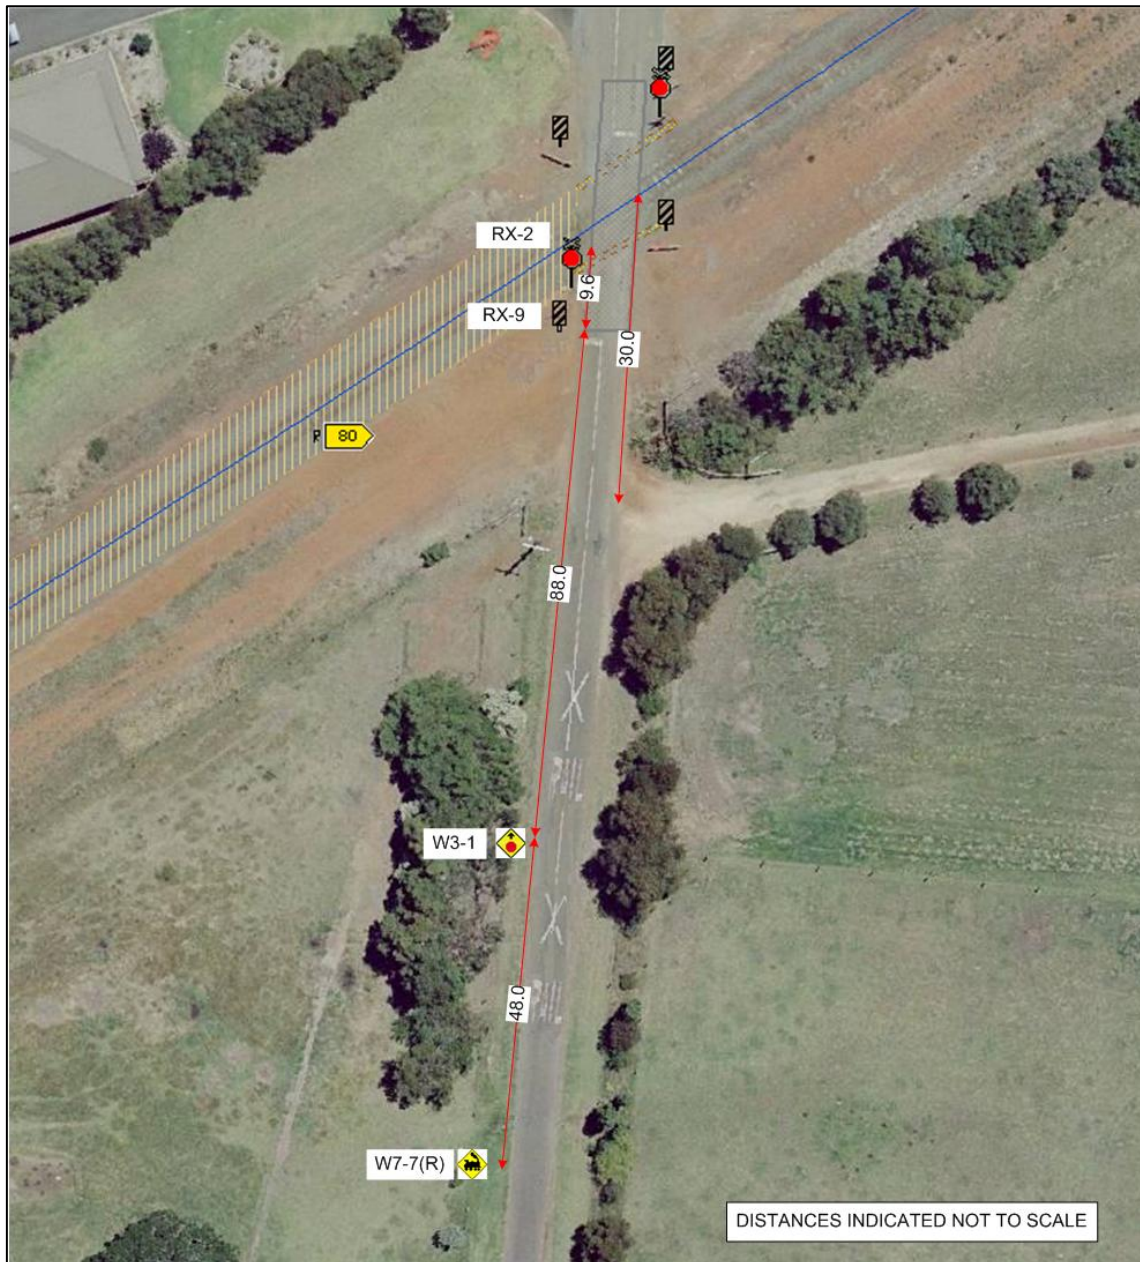
**Figure 5: Signage and road markings on approach to Brown Street level crossing from south**

The 'RAIL X' road markings were located on the middle of the road (Figure 5). The positioning of the road markings was inconsistent with the requirements of AS 1742.7-2007, but this is not unusual for narrow roads.

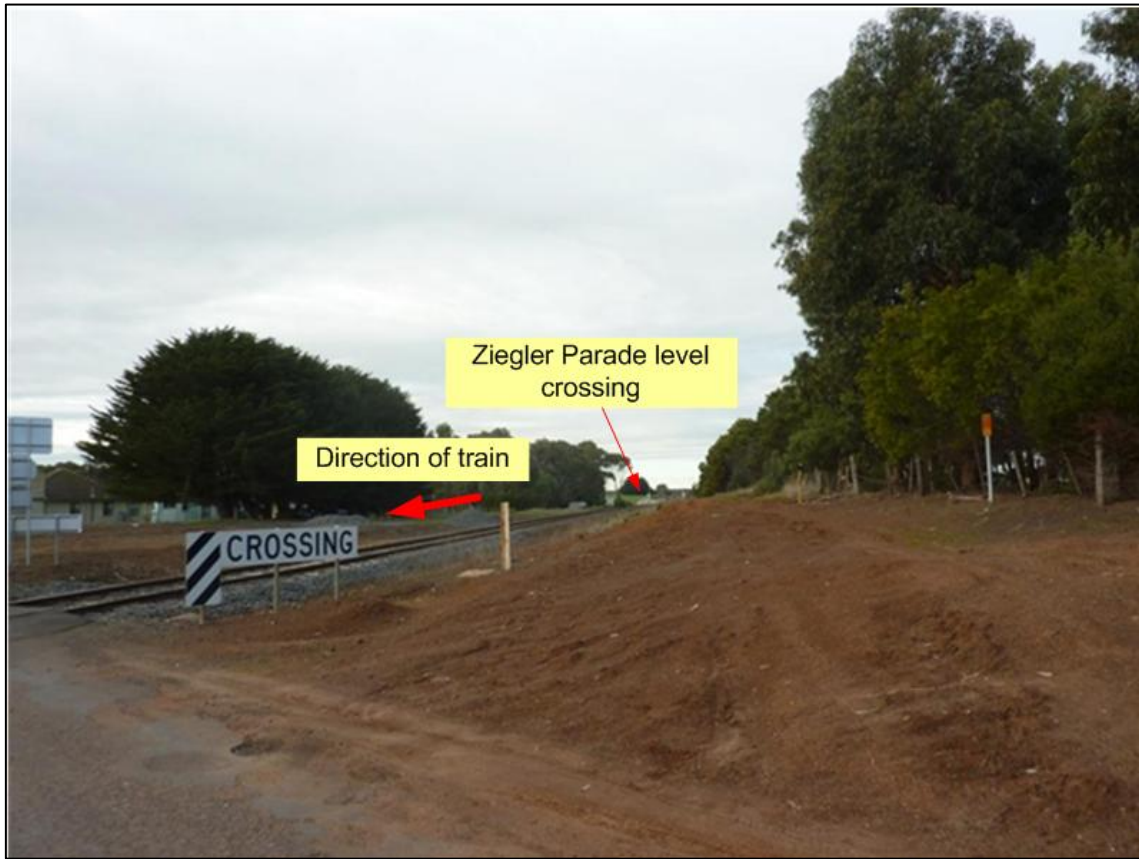
**Figure 6: Sighting from Brown Street level crossing Stop line to the east**

When approaching the level crossing from the south, the sighting of the rail track in both the easterly and westerly directions was obscured by vegetation and the surrounding landscape, until the road vehicle was stopped at the Stop line. Once at the Stop line there is clear sighting available to the driver of the rail track in the easterly direction (Figure 6).

From the Stop line south of the Brown Street level crossing, and looking east, the Ziegler parade level crossing which is located 360 m from Brown Street level crossing could be clearly seen (Figure 6) and the Princes Highway overhead bridge located approximately 950 m from the Brown Street level crossing could also be sighted by a diligent observer. Therefore, the available sighting exceeded the minimum sighting requirements specified in the AS 1742.7-2007.

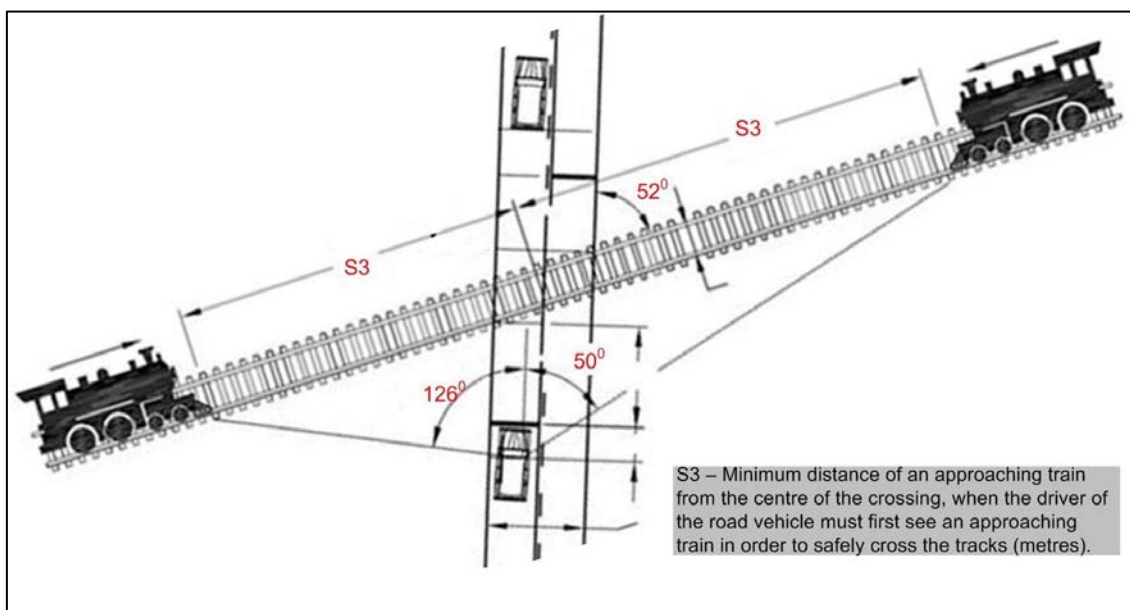
Figure 7: Sighting angles calculated as per 1742.7

The directional alignment of Brown Street is approximately 8° east of north and forms an angle of 52° with the rail tracks. The AS 1742.7-2007 specifies maximum sighting angles to the left and right measured at the stop line to ensure that an approaching train can be sighted without excessive head movement by a vehicle driver or sight obstructed by parts of the vehicle itself. An assessment of the Brown Street level crossing's geometry revealed a viewing angle of 50° to the right which is well within the maximum angle of 140° specified by the standard. However, the viewing angle to the left of the crossing was calculated at 126°, which is above the maximum allowable angle of 110° (Figure 7).

Safety information was released to the Warrnambool City Council and V/Line (Appendix A) advising of the non-compliances with the AS 1742.2-2007, and that a significant risk of a collision existed at this level crossing. In response, the Warrnambool City Council advised that this level crossing would be closed to road traffic until fitted with active traffic controls.

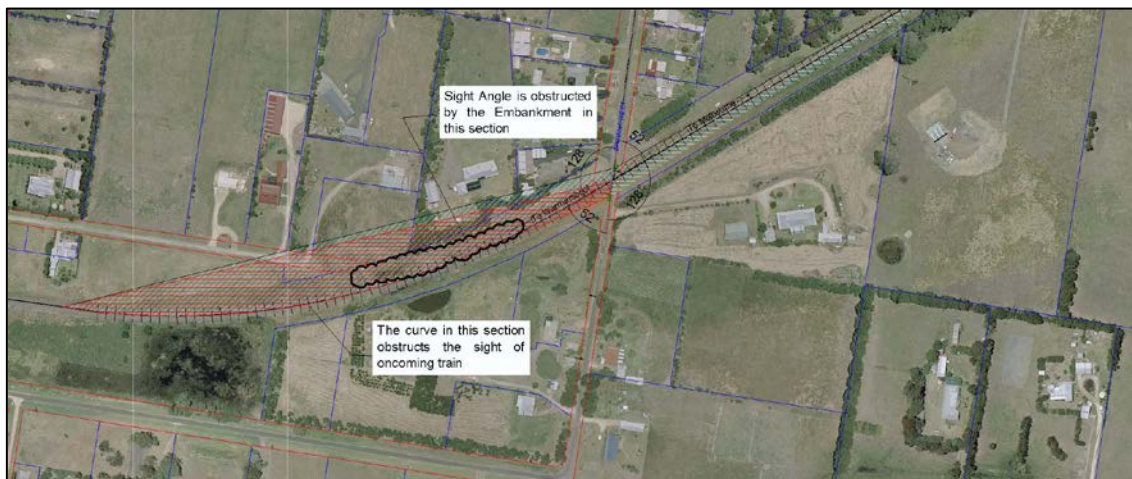
**Figure 8: Sighting to west from Stop line south of Brown Street**

When at the Stop lines south of the Brown Street level crossing and looking west, the minimum sighting distances specified by the Standard were not met due to track curvature and the embankment (Figure 8).

In this occurrence, the sighting from a road vehicle at the Stop line looking towards the approaching train met the requirements of the AS 1742.7-2007. However, for other road and rail approach scenarios sighting was affected by track curvature and topography to the west and the angle of the road-rail intersection. This crossing had therefore, and appropriately, been identified as a crossing that had sighting issues. Where sighting distances are inadequate for crossings with passive controls, AS1742.7-2007 states that if the crossing is to remain open, alternative measures such as restoration of sight distance by sight benching in cuttings, clearing, geometric alteration of the crossing or active control should be considered.

In this instance, the crossing had been identified for upgrade to active crossing protection to address the sighting issues; however no action had been taken to manage the risk until the implementation of the upgrade. During the investigation, the Chief Investigator, Transport Safety (Vic) released safety information (Appendix A) to the Warrnambool City Council and V/Line, advising them of the existing risk of collision at the Brown Street level crossing. In response, the Warrnambool City Council advised that they had closed the Brown Street level crossing to road traffic until it is equipped with active traffic controls.
