Aviation Short Investigation Bulletin

Issue 23

AB-2013-166

Final – 31 October 2013

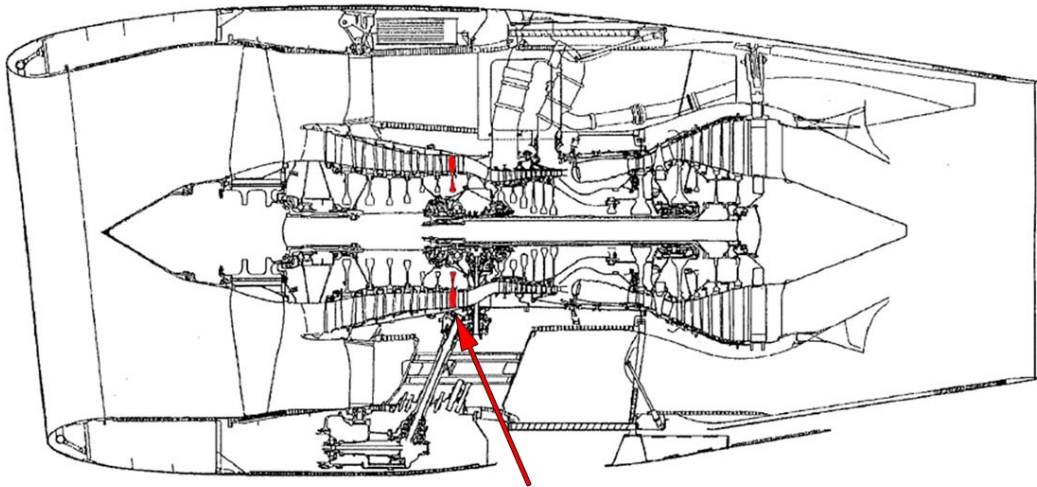
Figure 1: RB211-524 engine with stage 7 IPC rotor highlighted

The initial inspection showed that a single, stage 7 intermediate pressure compressor (IPC) blade had separated from its slot in the compressor disc (Figure 1). Disassembly of the engine confirmed the blade release and revealed significant damage to the remaining IPC blades as well as to the surrounding components.

The investigation concluded that the released stage 7, IPC blade had most probably been locked in place at an offset angle to the engine axis during assembly. The offset installation resulted in localised wear and significantly increased bedding stresses between the blade and disc. The increased stresses resulted in the initiation and propagation of a fatigue crack through the blade root until the blade was released under normal operational loads.

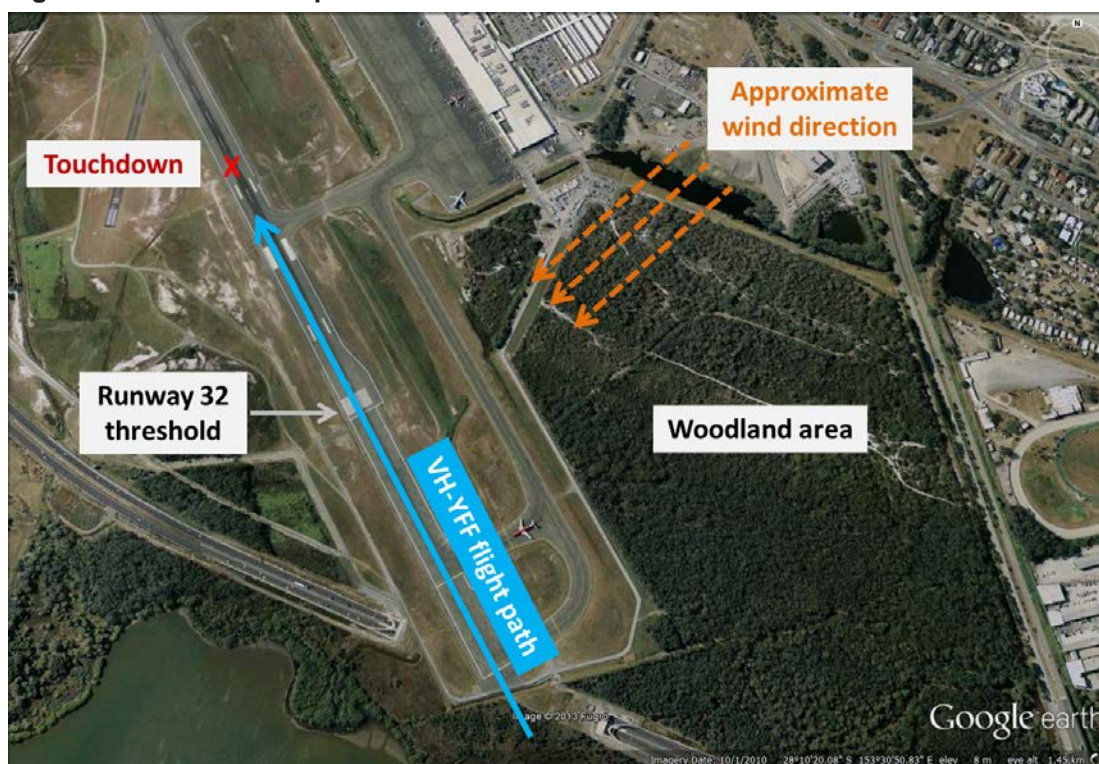
Figure 1: Gold Coast Airport and VH-YFF touchdown location

At about 2229, the aircraft touched down about 200 m further along the runway than intended (Figure 1). The autobrakes activated and the captain selected reverse thrust. The FO recalled the aircraft touched down on, or slightly right of the runway centreline. At that time, they were experiencing light rain.

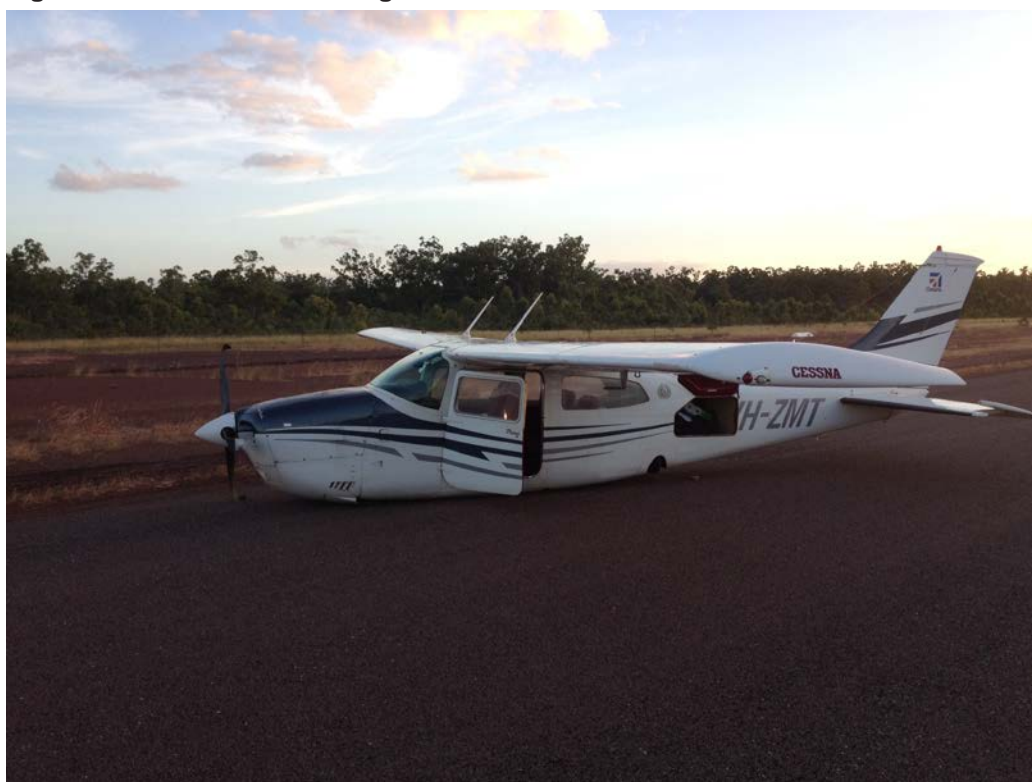
Figure 1: VH-ZMT after landing

At about 100 ft, the pilot reduced the engine power to the idle position. During the landing flare,¹ the pilot felt that it was unusually smooth and the aircraft sank further than normal. The aircraft touched down and the pilot reported hearing a scraping sound and noticed that the propeller had come into contact with the ground. He then realised that the aircraft had landed with the landing gear retracted. The pilot stated that the aircraft's landing gear warning horn² did not sound at any stage during the landing.

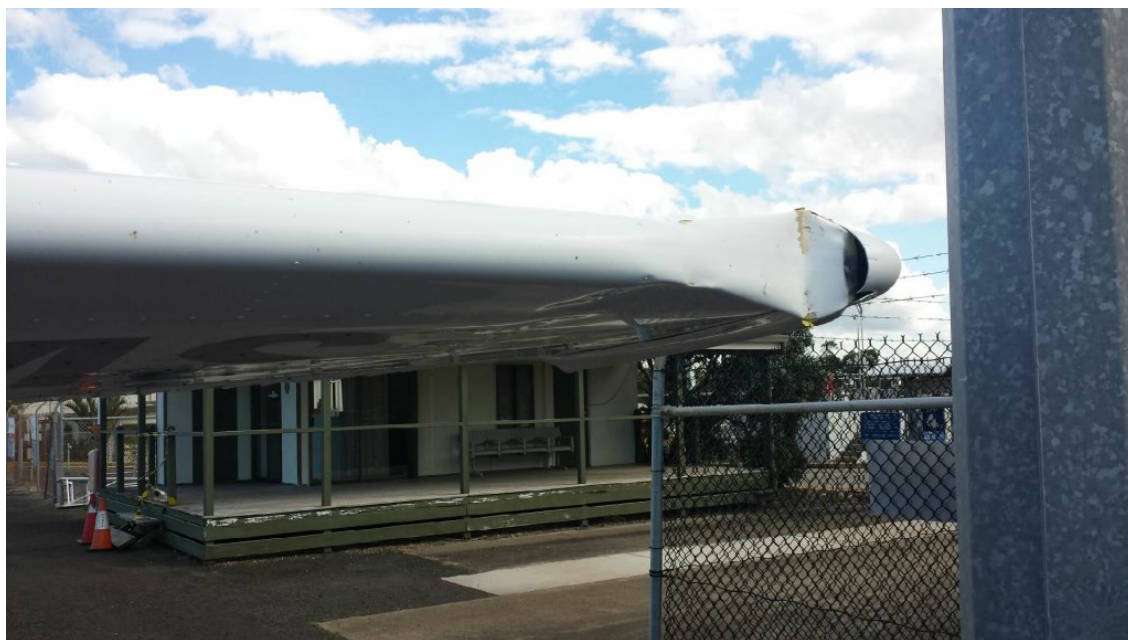
Figure 1: Aircraft wing damage and power pole

Other aircraft were operating in the area and the pilot wanted to ensure he remained clear of them. The pilot noted a fence and power pole on his left, and then focused on an aircraft taxiing in front of IMS. While the pilot was watching the other aircraft taxiing, he advised that IMS may have rolled forward unnoticed. When the pilot commenced a right turn, the aircraft was past the end of the fence and as he turned the aircraft, the left wing collided with a power pole.

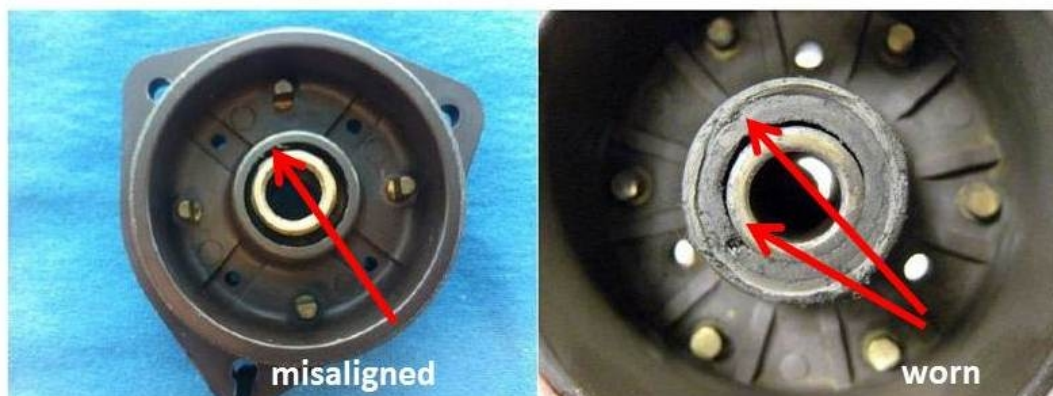
Figure 2: Two examples of unserviceable distributor blocks

- The left magneto had been replaced twice since December 2012. The distributor block had been overhauled 32.1 hours prior to the accident.
- A detailed inspection of the magnetos found the right magneto was operating normally, but the left magneto had failed. The left magneto distributor block bearing had excessive movement beyond normal tolerances. This movement had allowed the timing gear to disengage and re-engage during operation, resulting in the significant alteration of the magneto timing. The incorrect timing may have opposed the operation of the right magneto, which could have resulted in an engine stall.

The Civil Aviation Safety Authority (CASA) is aware of the existing problem with Teledyne Continental Motors and Champion Aerospace (Slick) magnetos. A search of the CASA Service Difficulty Report (SDR) database over the 24 months to June 2013 revealed nearly 45 per cent of ignition failures were attributed to magneto failures. On 24 July 2013, CASA issued Airworthiness Bulletin (AWB) No: 74-005, page 4 & 5, paragraph 3.3 – *Distributor Block Bearing Failures*. This AWB highlights many magneto related issues and indicates that despite close inspection of new distributor blocks, there is no way to determine if they will prove to be reliable. The AWB notes that this is currently the matter of an active on-going investigation in conjunction with manufacturers. Further reading is available at: www.casa.gov.au/wcmswr/_assets/main/airworth/awb/74/005.pdf

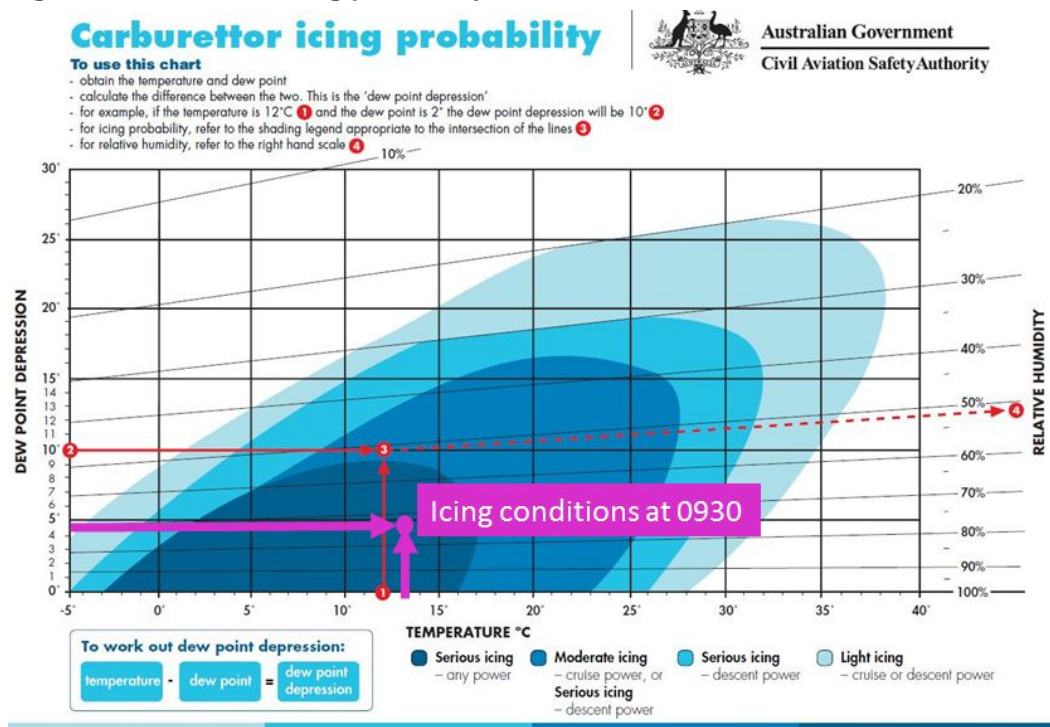
Figure 1: Carburettor icing probability

According to the Carburettor Icing Probability chart (Figure 1), the conditions indicated a serious probability of carburettor icing at any power.

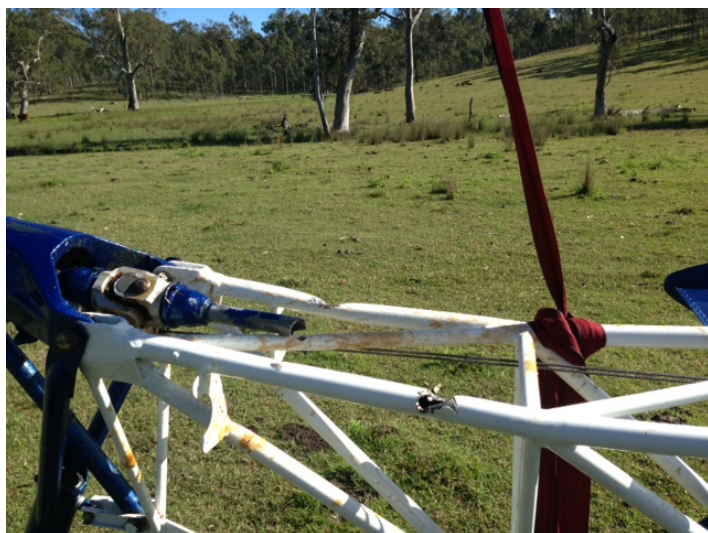
Figure 2: Damage to VH-KHJ

The insurance assessor considered that the weather conditions were an incipient cause of the incident. At the time, the temperature and dew point indicated a risk of serious carburettor icing. The pilot reported that he would have expected the engine to run roughly if carburettor icing was present.

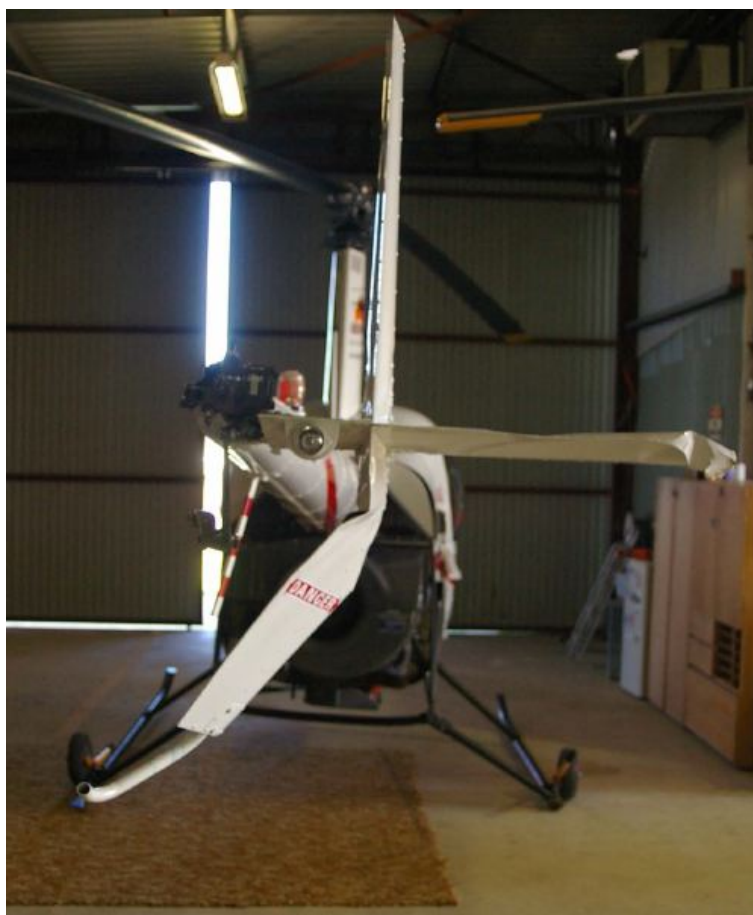
Figure 2: VH-EGN damage

The helicopter was shut down and the student exited. The student was not injured, but the helicopter sustained substantial damage (Figure 2).
