Wirestrike involving Cessna 172 VH-TKI

13 km NE of Bendigo, Victoria | 29 October 2012

ATSB Transport Safety Report
Aviation Occurrence Investigation
AO-2012-142
Final – 7 November 2013

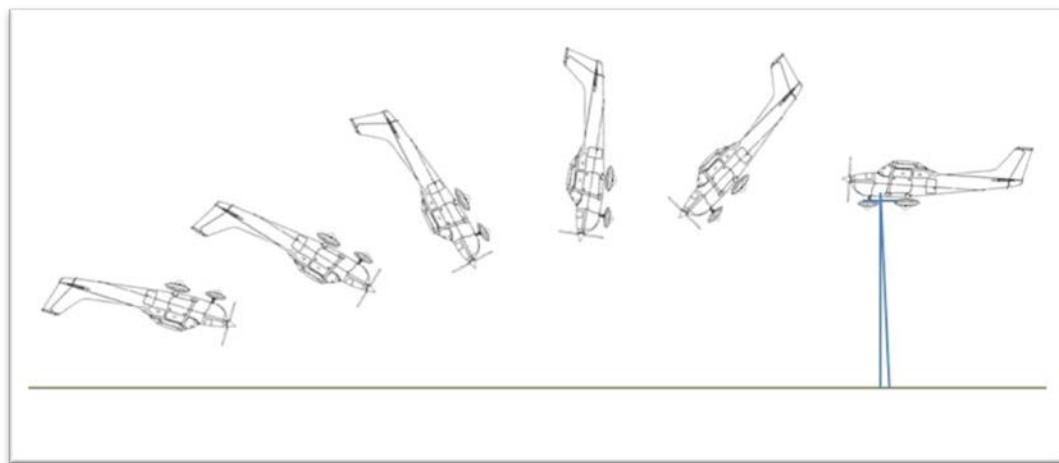
Figure 2: Depiction of the wirestrike sequence

Soon after passing the tree line, the aircraft struck a powerline, which arrested the aircraft's forward speed. The aircraft rotated around the powerline and impacted the ground almost inverted.

The owner of the ALA was positioned close to the landing end of the strip and witnessed the accident. He described losing sight of TKI on final as it passed behind the trees along the side of the road. He stated that the engine note was 'normal' on final approach and that the aircraft reappeared from behind the trees before dropping slightly over the trees, contacting the powerline and rotating about the nose (Figure 2).

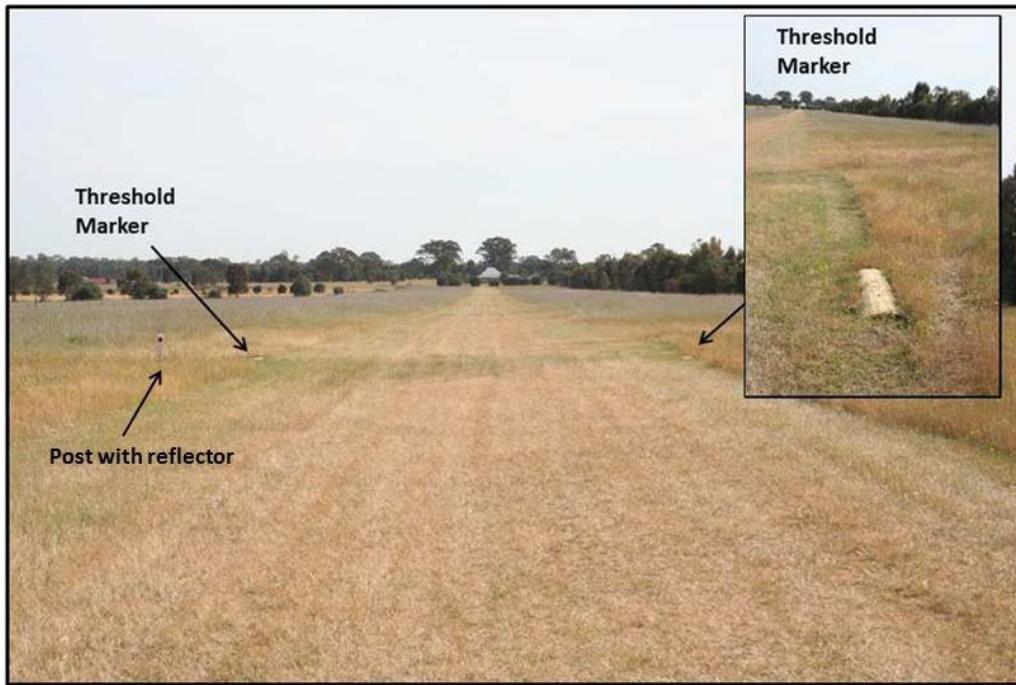
Figure 4: Threshold markings looking north

The owner of the ALA reported that the threshold was permanently displaced to the north due to the proximity of the maintenance facility, the position of the powerline and trees and the location of a culvert and associated bump in the surface of the airstrip. Although easily distinguished from directly above, the threshold markers were partially obscured by grass when viewed from the final approach perspective (Figure 4).

South of the threshold markers, the undershoot area was mown for a further 180 m back to the fence line, giving the undershoot the same appearance as the airstrip. This mown area provided extra take-off length to the north but was not intended to be used for landing from the south. A wind sock was located close to the threshold markers (Figure 3).

In response to this accident, the owner of the ALA has made significant changes to the runway markings, landing permission procedures affecting operations at the ALA and the available safety and firefighting equipment. In addition, markers have been erected near the powerline.

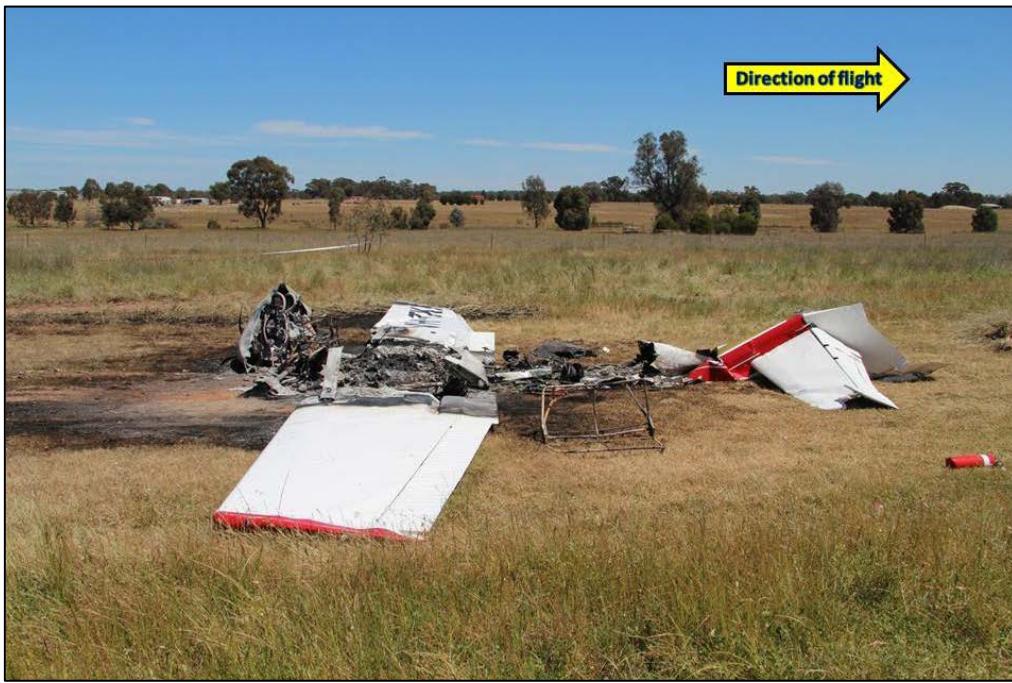
Figure 5: Aircraft wreckage

A post-impact, fuel-fed, fire consumed the entire fuselage (Figure 5). An inspection of the flight control systems found no pre-impact defects. Aileron and elevator trim settings could not be accurately assessed due to the distortion of the airframe. The flaps appeared to be extended just beyond the fully retracted position and measurement of the flap actuator thread section correlated with a flap position of about 2°. This may have indicated that the flap selector moved from the landing setting to the retracted position during the accident sequence before the loss of electrical power left the flaps in the 2° position.

In summary, the inspection of the aircraft did not identify any pre-impact anomalies.

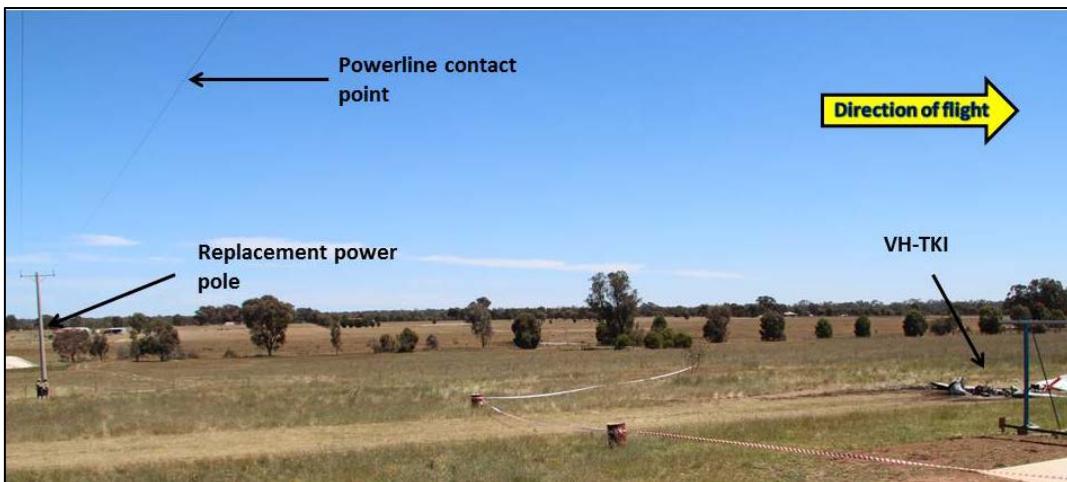
Figure 6: Powerlines and wreckage

Indentation marks on the powerline indicated that the aircraft struck the second wire of the two line, high-tension powerlines (Figure 6). The powerlines were strung about 8 m above ground level over the undershoot area, running at an angle of 75° to the airstrip centreline.

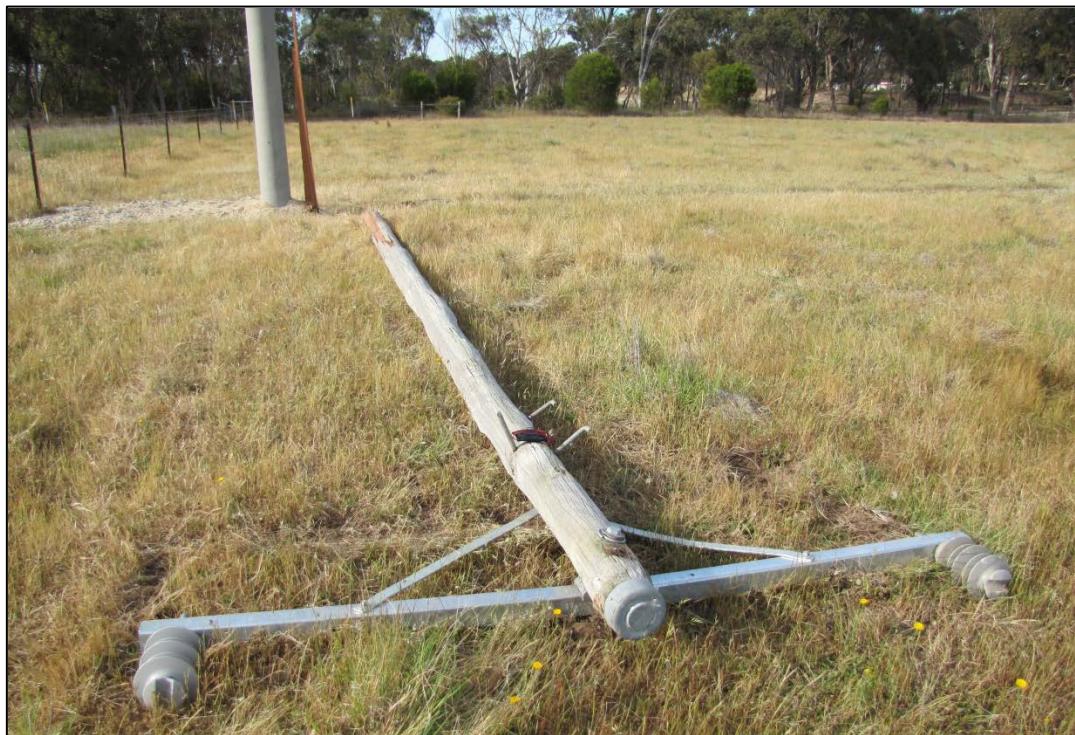
Figure 7: Broken power pole with the replacement pole in the background

The powerline did not break when contacted by the aircraft; however, the power pole closest to the powerline contact point and east of the airstrip centreline fractured at its base (Figure 7). The fractured power pole was replaced before the ATSB arrived at the accident site to allow the restoration of electrical power to the local area. The replacement power pole was longer than the original and as a consequence, the powerline was reinstated approximately 1 m higher than the original position.

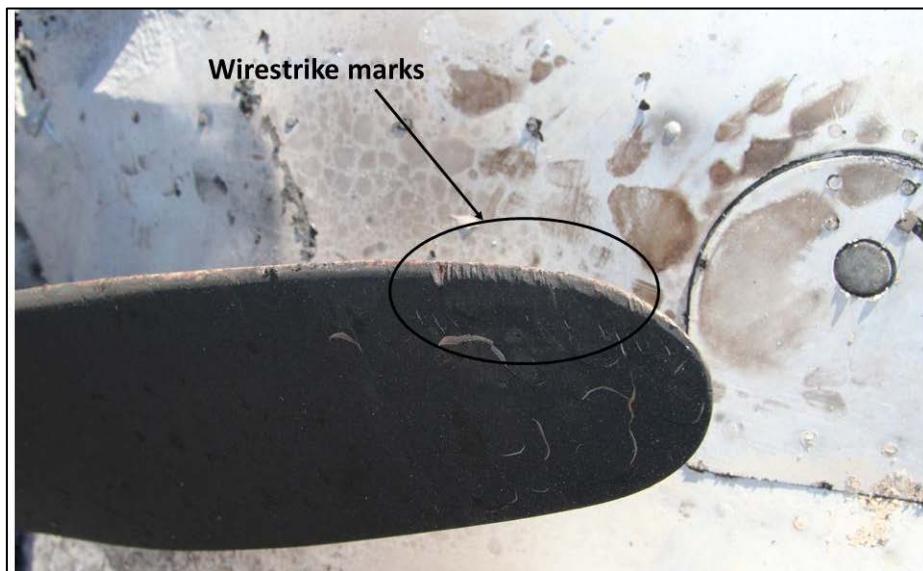
Figure 8: Propeller blade tip with wirestrike damage

Wirestrike damage was evident in two locations on the aircraft wreckage. These were a wire indentation marking on one of the propeller blade tips (Figure 8), and scratch-type markings on the nose landing gear strut (Figure 9). The markings showed that the powerline made contact with the lower part of the aircraft.

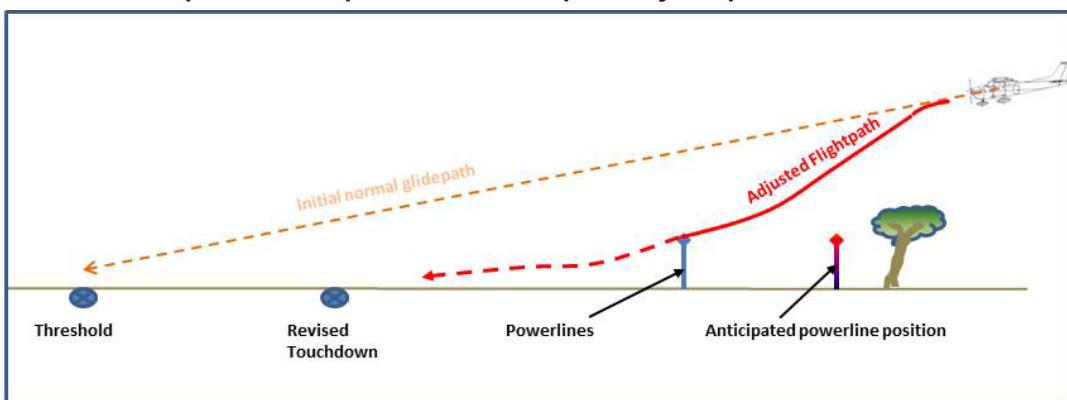
Figure 12: Depiction of the aircraft's flight path and the actual position of the powerline compared to the position as anticipated by the pilot

Finally, the likelihood for more discernible threshold markings to have reduced the likelihood that the pilot would attempt a landing in the undershoot area is highlighted.

Although the PIC could not recall the specific details in the ALA diagram, he had flown into the ALA on three previous occasions and it is reasonable to expect that he had some firsthand knowledge of the ALA and its hazards. The PIC's recollection of the exact position of the hazards, in particular the powerline, was reflective of the pilot's planning for his previous departures to the south. That was, if he cleared the trees on climb out, then he would also clear the powerlines. However, the location of the powerline 47 m before the treeline on departure would suggest that this logic was incorrect. Indeed, application of this logic to a landing from the south increased the risk of a wirestrike on landing, as the powerline was now 47 m into the undershoot and upwind of the treeline. In the event, the PIC reported that he was not specifically considering the powerlines when he made the decision to adjust the aircraft's glide path and 'dip down' after passing the tree line.
