Multiple SPAD by freight train 9837

Hurlstone Park, New South Wales | 30 January 2013

ATSB Transport Safety Report

RO-2013-003

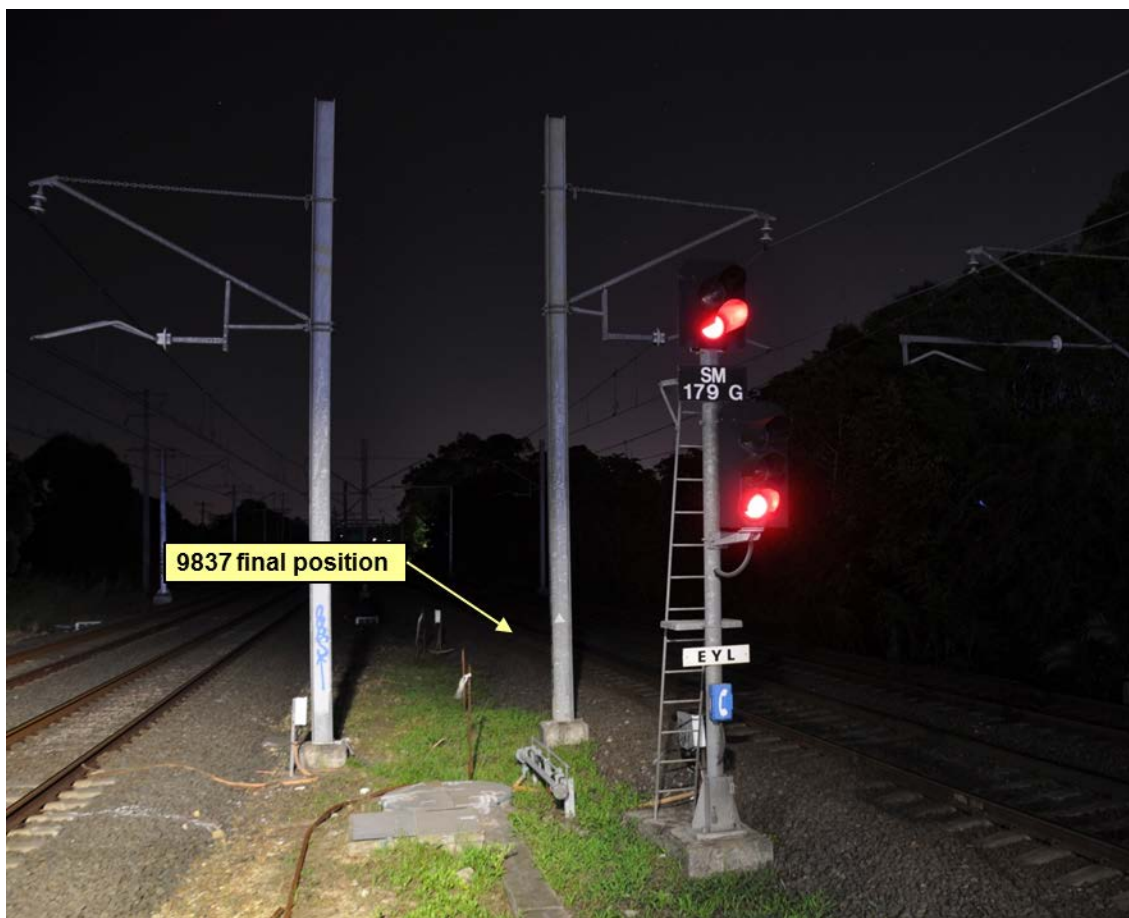
Figure 2: Signal SM179G and final position of front of 9837 after the SPAD

The train came to a stand approximately 33 m past signal SM179G, which was 701 m past the first signal at stop and 310 m past the second signal at stop. Signal SM179G was not passed at stop as it was showing a clear aspect. It is an automatic signal which means it is one that cannot be controlled by the area controller but instead operates according to track circuits. The configuration of the tracks and signals at Hurlstone Park is shown below (Figure 4).

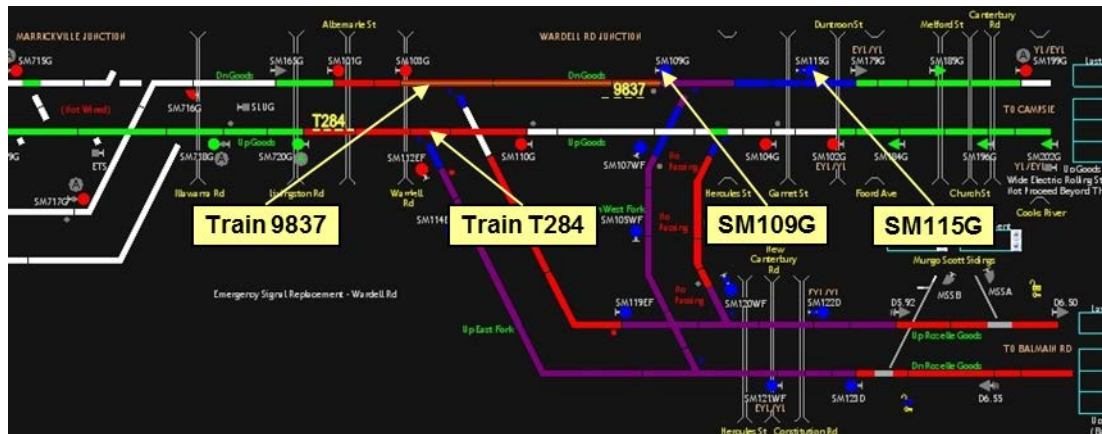
Figure 6: ATRICS replay, showing train 9837 approaching signal SM109G

The ATRICS system has a replay capability which investigators used to review the operation of the system and trains on the night of the incident. Figure 6 shows train 9837 approaching the first of the two stopped and blocked protecting signals, SM109G.

Examination of the ATRICS replay revealed that, when the area controller utilised a command in ATRICS to block signals SM109G and SM115G, the track beyond those signals, in the usual direction of travel, changed from white to blue, indicating a block on the section. The colour changes demonstrate there is recognition of physical changes to the track conditions at the software level.

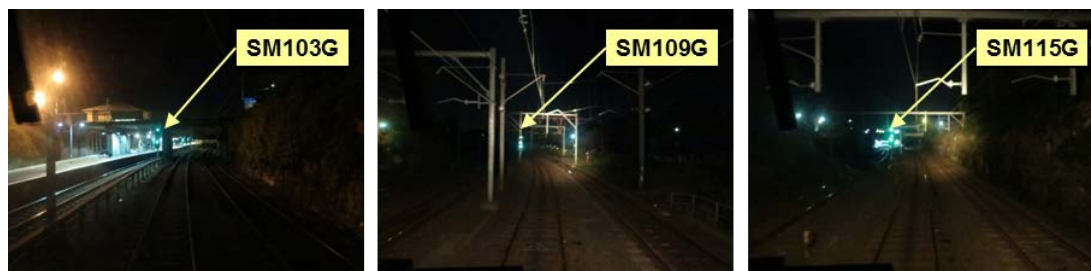
Figure 7: Signals approaching Hurlstone Park

The signal engineer also conducted signal sighting tests on 31 January 2013 at 0400 to replicate the conditions on the morning of the incident. He found signal SM103G to be operational with: 'no obstructions or impediment to sighting.' There was clear sighting differentiation between this signal and another nearby signal SM171B on the Down Bankstown line. There was no report of any signal malfunction or problem with signal visibility with any other signal in the vicinity of the incident.

NSW Office of Transport Safety Investigations (OTSI) investigators travelled in the front cab of a locomotive on 7 March 2013 at 2200 and conducted an inspection of the signals during similar lighting conditions experienced during the incident. Photographs were taken of the key signals (Figure 7). They observed that the signal indications were clearly visible, there were no physical impediments to visibility, and that ambient or background lighting was unlikely to have caused any confusion between signals.
