Hard landing involving Robinson R44, VH-HYR

15 km N of Broome Airport Western Australia, 7 September 2012

ATSB Transport Safety Report

AO-2012-117

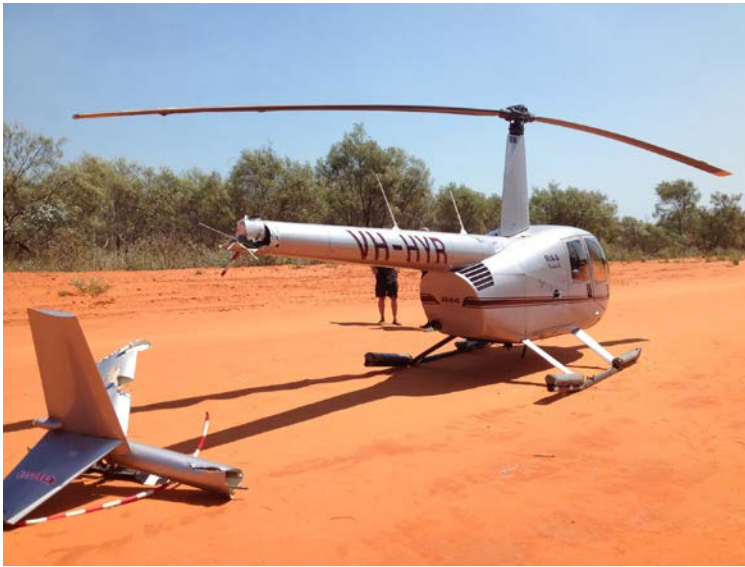
Figure 1: VH-HYR

The pilot planned on performing a power recovery⁷ and terminated the autorotation at about 10 feet above the ground with 0 knots groundspeed,⁸ at the same time winding on throttle to increase the engine RPM, however the engine did not respond. The low rotor RPM light and horn activated and the pilot increased the collective lever in attempt to utilise the remaining rotor RPM to cushion the landing. However, the helicopter landed heavily and the main rotor severed the tail boom. All occupants exited the helicopter without injury.

The ATSB did not attend the accident site or examine the aircraft and the reason for the accident could not be conclusively established. A malfunction within the governor assembly was not able to be ruled out. However, it is considered likely that the engine's right magneto may have malfunctioned by providing an incorrect signal to the governor assembly which manifested as a governor failure.
