Windshear-related hard landing involving Fokker 100, VH-NQE

Nifty Aerodrome, WA | 19 October 2012

ATSB Transport Safety Report
Aviation Occurrence Investigation
AO-2012-137
Final – 6 February 2014

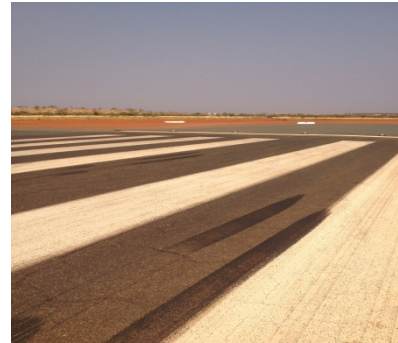
Aircraft touchdown markings

The aircraft touched down on the runway threshold, almost 300 m short of the normal touchdown point, and bounced. The high rate of descent at initial touchdown resulted in a hard landing with significant aircraft damage. There were no reported injuries to passengers or crew.

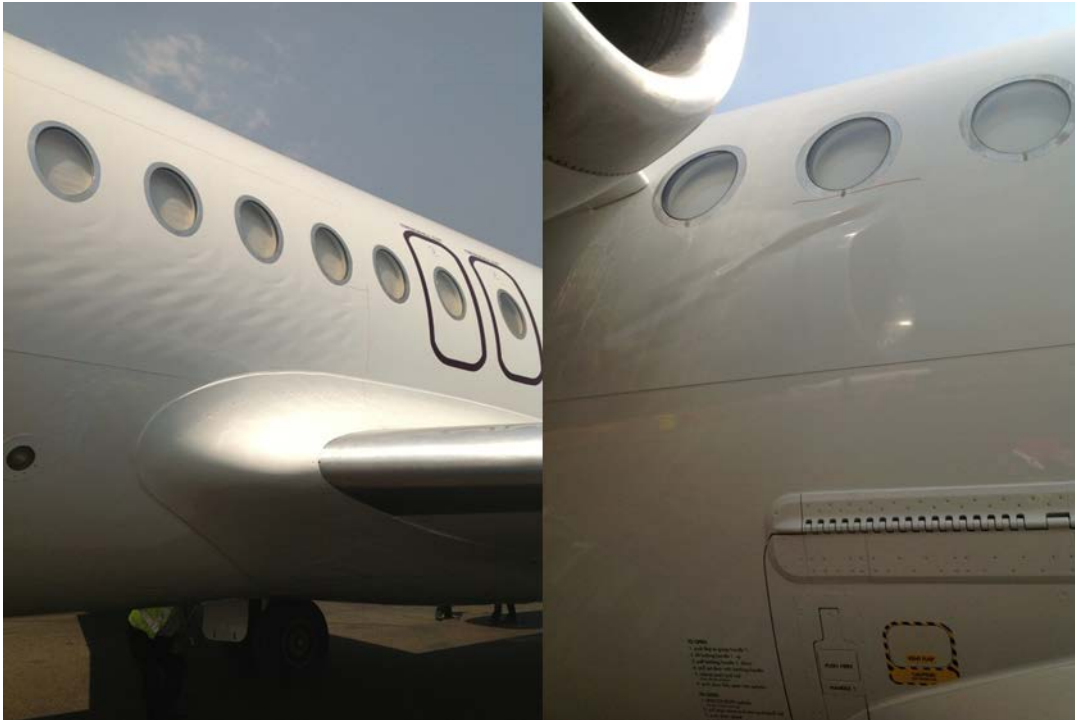
Figure 3: Aircraft skin damage, fuselage fore and aft

The aircraft's rate of descent immediately prior to touchdown was about 1,000 ft/min. The maximum recorded loading at touchdown was 4.23 g. As a result, the aircraft sustained significant damage to sections of the wings, main landing gear and fuselage.

The hard landing resulted in wrinkling to numerous skin panels, both forward and aft of the aircraft's centre section, and deformation to several structural beams (Figure 3). The main landing gear, inboard landing gear doors and skin panels on the aircraft's belly fairing sustained compression damage (Figure 4).

Following consultation with the aircraft manufacturer and on-site repairs, the aircraft was ferried to Singapore where repairs were completed by an agent of the aircraft manufacturer.
